MAŁGORZATA KIJOWSKA-STRUGAŁA (SZYMBARK)

IMPACT OF DOWNPOURS ON FLUVIAL PROCESSES IN THE POLISH CARPATHIANS AS EXEMPLIFIED BY THE BYSTRZANKA STREAM

Key words: downpours, fluvial processes, Bystrzanka stream, Polish Carpathians

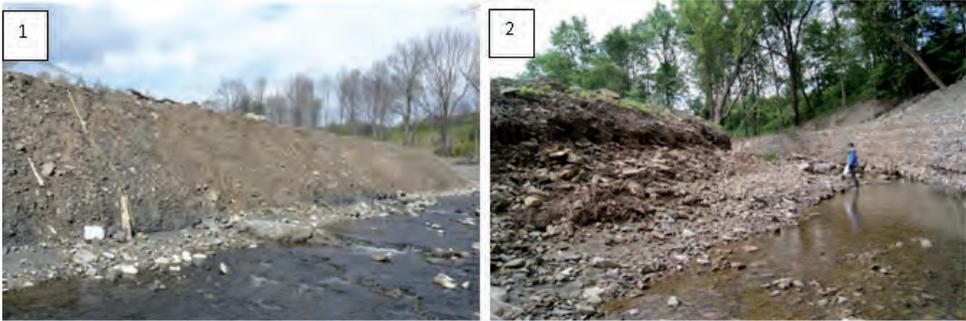
Fig. 7. Erosion of banks in the Bystrzanka during the flood in 2010 (1 – April 2010, 2 – June 2010)
(Photo M. Kijowska-Strugała)

High discharge values have caused significant transformations of the Bystrzanka channel. Numerous cut banks occurred at an irregular fashion along the whole length of the stream. Significant bank cuts over 7 m high were connected to the development of bank landslides up to 4 m high that occurred due to the soil being completely saturated with water. The newly formed cut banks along the whole length of the channel most often reached the height of 2 m (about 50%). A definite correlation was observed between water erosion and the concave part of the meanders, where the process was the most intense. The water level rises caused severe erosion of unstable, newly formed banks on the opposite

side of the gabions erected in 2009 about 700 m and 1200 m from the mouth of the Bystrzanka, thus removing the weathered material that was brought there during the works in 2009 (Fig. 7). The channel width decreased by 2 m compared to April 2009. The parts of the channel with rock outcrops functioned as passageways for the bedload transport. Potholes up to 1.5 m high formed below rock ledges and in the mouths of the tributaries.

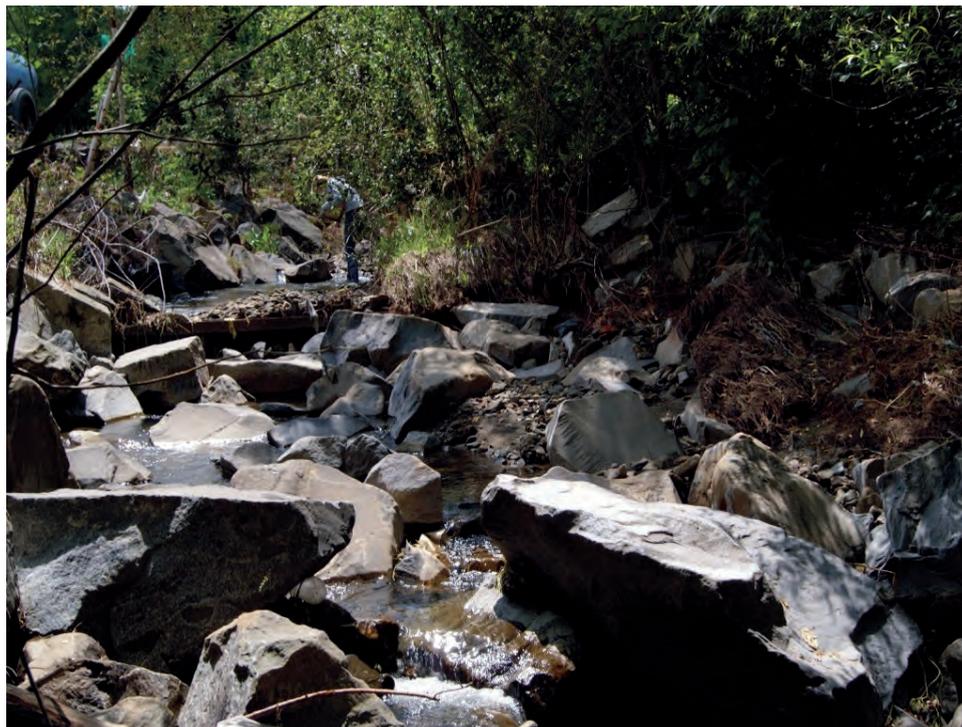
Fig. 8. Accumulated angular boulders in the middle part of the Bystrzanka stream
(Photo M. Kijowska-Strugała)

Point bars and central bars of varied size and shape, depending on channel morphology, were observed along the whole length of the channel and consisted mainly of sand, gravel, and boulders both abraded (in varying degrees) and non-abraded. The surface area of point bars and central bars reached a maximum of 250 m². The combined length of the bars was estimated at about 2450 m, which constituted about 45% of the mapped length of Bystrzanka. Areas of largest bedload deposits were located downstream huge erosive cuts. Slopes adjoining the stream channel were cutted by rills and gullies that transported material from the slopes to the channel, thus forming alluvial fans up to 25 m wide, 5 m long, and about 0.6 m thick. These fans caused the narrowing of the river channel. Their development indicates a significant role of tributaries and gullies in the shaping of the channel. Sediment deposition and a building up of fluvial terraces occurred in areas where the banks were no higher than 1 m. The diameter of the material (sand, gravel, and pebbles) reached about 0.5 m. Also observed was the activation of rotational bank failures at the stream, the fronts of which almost entirely blocked the bottom of the stream. The landslides carried material composed of clay, rubble and boulders, with the addition of many trees and bushes. Numerous areas strewn with wooden debris, e.g., in front of bridges, blocked the transport of material, as did the damaged gabions. The size of sandstone boulders, more than 1 m in diameter, that were found along the whole length of the stream channel indicates the great amount of energy held by the flowing water. These boulders amassed in several places, filing the whole width of the channel (Fig. 8). Because the outflow from the Bystrzanka was blocked by high water level in the Ropa River, a partial accumulation of

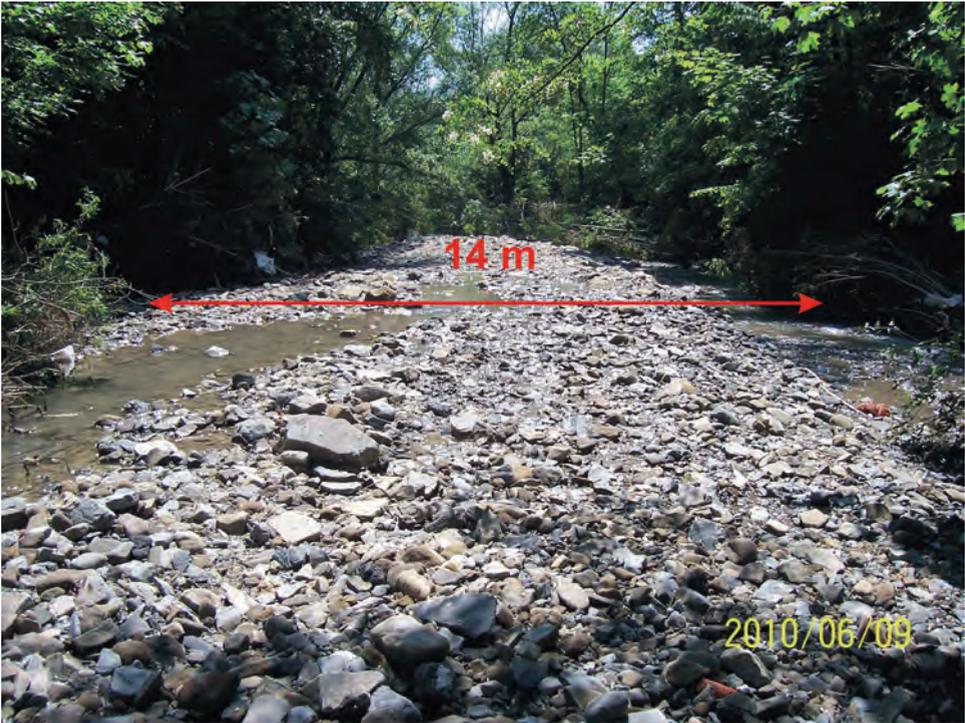
Fig. 9. Newly formed fan in the mouth of the Bystrzanka, formed as a result of the flood in May and June 2010 (Photo E.Gil)

material occurred in the mouth of the Bystrzanka. The material, carried from the catchment, had a surface area of about 950 m² (Fig. 9) and was composed mainly of boulders, gravel, and pebbles.

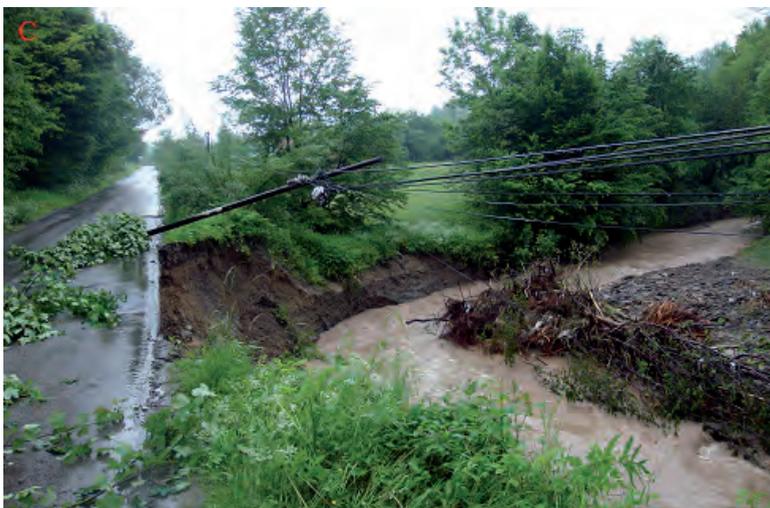
Fig. 10. Geomorphological and economic effects of flood caused by downpours in the middle part of the Bystrzanka. A. Geomorphological plan of transformations in the channel of the Bystrzanka. 1 – direction of runoff, 2 – non-abraded boulders, 3 – gravel and sand, 4 – boulders, 5 – erosive undercut (height in m), 6 – erosive undercut (depth in m), 7 – area of landslide, 8 – weathered areas (landslides), 9 – local road, 10 – river, 11 – tree-covered area, 12 – meadows and grassland, 13 – cross section. B. Cross section of the river channel. C. Road damages

(Source: self-reported data, Photo M. Kijowska-Strugała)

High discharge during the flood also caused damage to the Szymbark-Szalowa local road in the village of Bystra, resulting in the riverbank receding by about 10 m (Fig. 10). The difference between the cross sections of the channel taken before and after the rise amounted to 8 m². At several points along the river, concrete reinforcements of banks were damaged, making it impossible for the local residents to cross the stream. Intense rainfall in 2010 also caused the deterioration of concrete bank reinforcements along the tributaries of Bystrzanka stream. The main role of these reinforcements was to limit the erosion of the stream's bottom and banks that leads to the destabilization of valley slopes and riverbanks.
