THE SPATIO-TEMPORAL DYNAMICS OF THE CIPRNIK COMPLEX LANDSLIDE, TAMAR VALLEY, JULIAN ALPS, SLOVENIA

Abstract. Mass movements represent important processes that shape relief in Alpine areas. In this article, we present the spatio-temporal dynamics of the Ciprnik landslide (Julian Alps, NW Slovenia) and interpret its triggering and evolution. In the study area, mass movement activity is characterised by two phases: normal deposition on the fluvial fans that dominated up to 2000, and a more active phase related to the triggering of the Ciprnik complex landslide and formation of an additional debris-flow fan. The Ciprnik landslide started as a translational movement over the discontinuity plane that was mobilised into a debris-flow. The triggering and slope failure resulted from a combination of tectonics (i.e. dip-slope position of the strata, and strong fracturing), lithology (alternation of thin beds of carbonates and fine-grained clastics), and accumulation of precipitation. The debris-flow fan remains active and interingers with adjacent active fluvial fans.

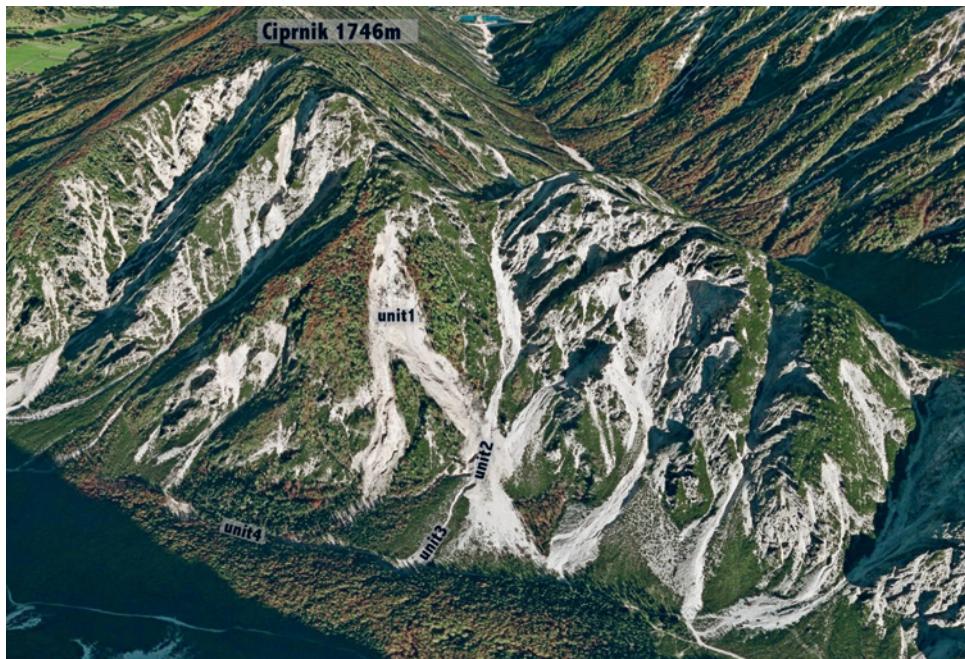
Fig. 1. The study site on W slope of Ciprnik Mt. 1747 m a.s.l., Tamar Valley, Julian Alps

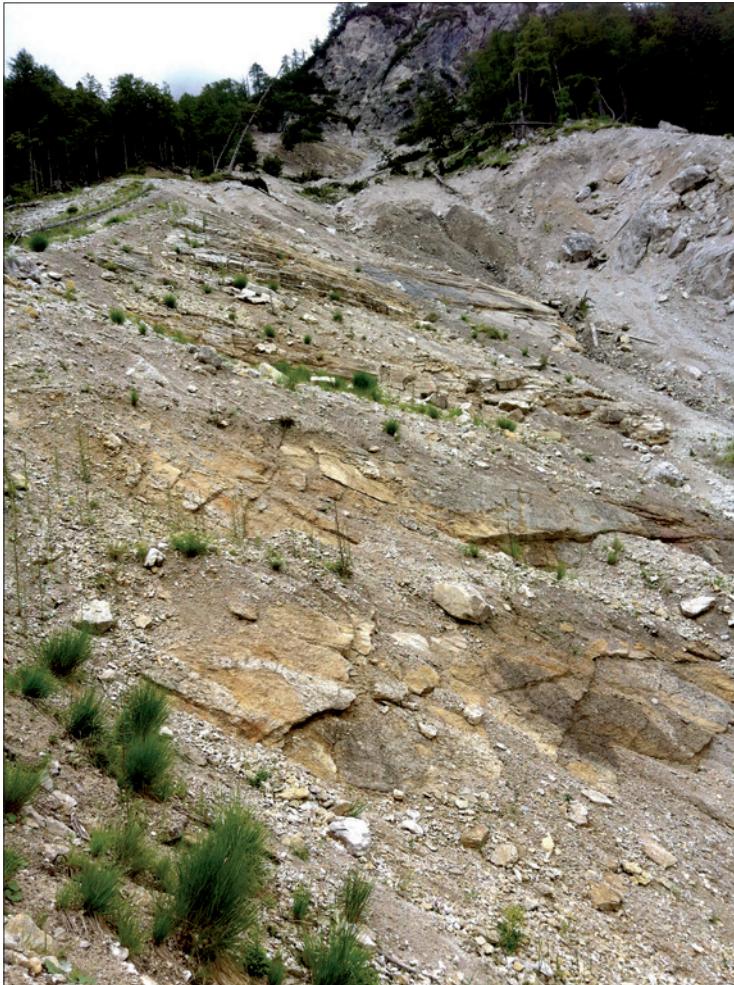
Unit 1 represents the catchment area for the landslide and extends from approximately 1500 m to 1130 m a.s.l., covering an area of around 80,000 m² (Fig. 8). The area is composed of the strongly faulted Tor Formation underlain by faulted Cozen dolomites (Gale et al. 2015). Cozen dolomites are poorly bedded to massive dolomites (bed thickness ranges from decimetre to metre scale) characterised by alternating lime mudstones, fenestral dolomites and stromatolitic and oncoidal dolomites (Gale et al. 2015). The Tor Formation consists of thin to medium-bedded (bed thickness ranges from a few cm to a few 10s cm) alternation of carbonate beds (i.e. limestones, dolomites, marly limestones) and fine-grained clastics (siltstone, claystone and marlstone: Gale et al. 2015). The dip of the beds ranges from 25–40° generally towards the south. The slip plane of landslide is clearly visible in Unit 1 (Figs. 7 and 8). In Unit 1, some loose “left over” debris of very poorly sorted, muddy sandy gravels is also present. Gravel clasts belong to the Tor Formation exclusively.

Fig. 8. Catchment area of the Ciprnik complex landslide (Unit 1 of Fig. 7)

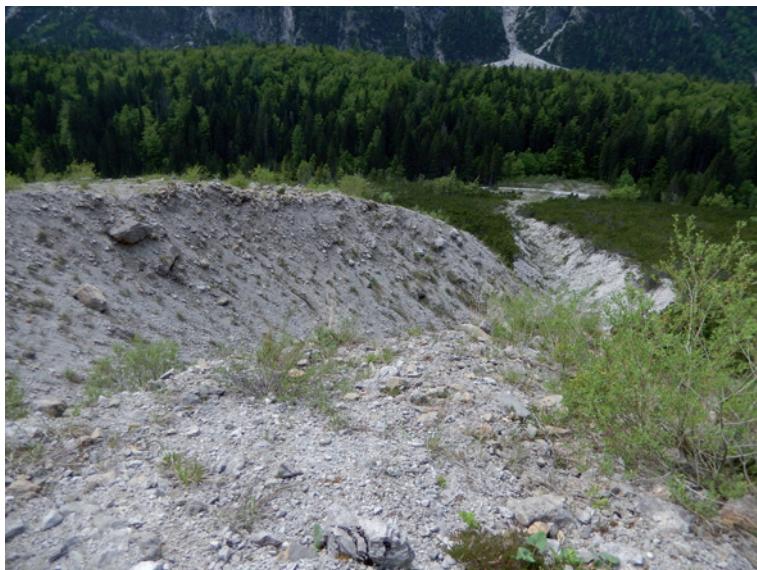
Unit 3 is eroded into deposits of Unit 2 (Figs. 7 and 10). The upper part (Unit 3A) is represented by a partly filled up (to a few metres deep and wide) erosional channel that extends from approximately 1150 m to 1073 m in altitude. The lower part of Unit 3 (Unit 3B) is represented by a fan-shaped body composed of a depositional sequence of poorly sorted muddy gravels in the upper reaches of the fan, while the clasts are finer at the fan end. The clasts are composed of Cozen dolomites and lithologies of the Tor Formation.

Fig. 10. Erosional channel eroded into older debris of Unit 2 (left on the picture) and fluvial fan deposits (Unit 3A of Fig. 7). View downwards

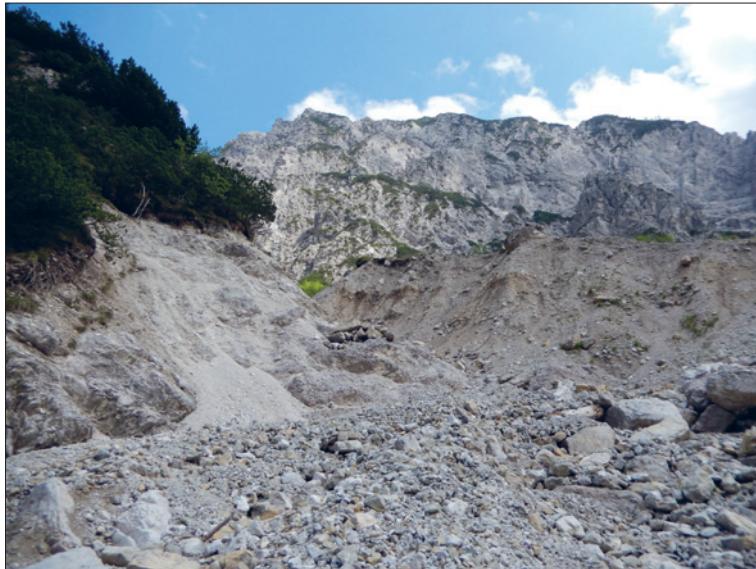
Unit 3. Unit 4 is further divided into three distinct units (Unit 4 A-C: Fig. 7). Unit 4A is a mainly erosional feature characterised by up to a few 10s of metres wide and around 270 m long erosional channel extending from 1130 m to 1060 m in altitude (Fig. 11). The channel is cut into bedrock or into older deposits (i.e. alluvial fan deposits and older debris flow deposits of Units 2 and 3) and is partly filled by poorly sorted muddy gravels, ranging from cm-sized pebbles to

Fig. 11. Erosional channel cut into contact of bedrock (left on the picture) and older mass deposits (Unit 4A of Fig. 7)

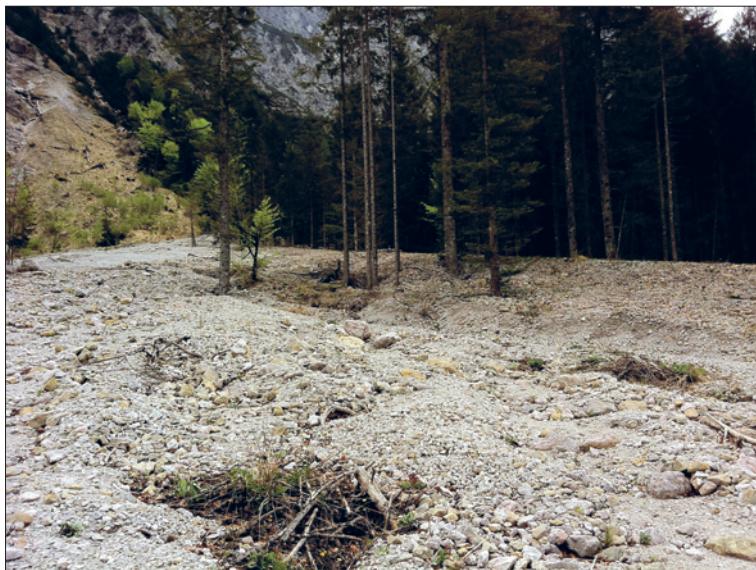
Fig. 12. Upper part of the fan-shaped body (Unit 4B of Fig. 7)

sequence of poorly-sorted coarse-grained sediments forming a 470 m long and up to 140 m wide fan-like shaped sedimentary body (Figs. 7 and 12). Unit 4B extends from 1060 m to 1013 m a.s.l.. Down the fan is progressively wider; similarly the slope of the fan decreases from 20° in the upper part to the 5° in the lower reaches of middle part. The grain size of the sediments ranges from poorly to very poorly sorted muddy sandy gravels. The transition from middle to lower part of the fan is gradual and characterised by an increase in finer-grained components. The clasts belong to Cozen dolomites and Tor Formation lithologies. Unit 4C represents the terminal part of the flow fan and is characterised only by a sand to mud fraction forming so-called "mud lake", located at 1013 m altitude (Figs. 7 and 13).

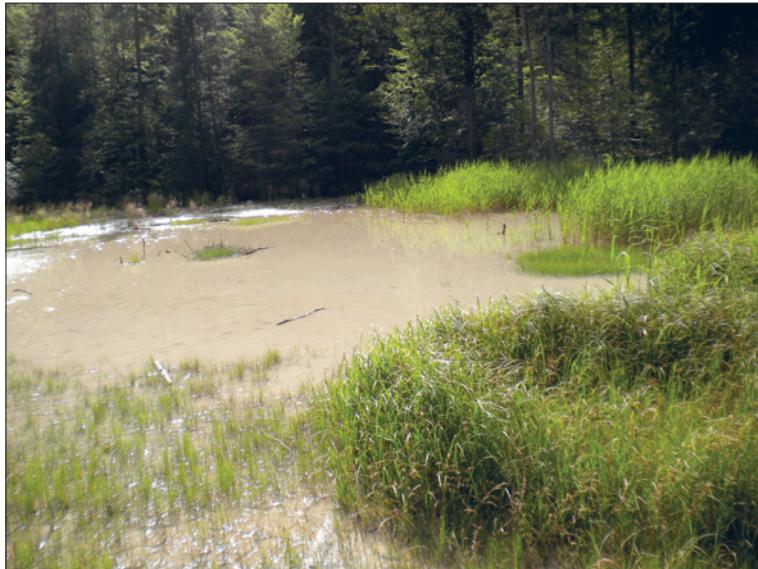
Fig. 13. "Mud lake" at the end of the Unit 4 of the Ciprnik complex landslide (Unit 4C of Fig. 7)
