ANDRZEJ ZYGMUNIAK, STANISŁAW CZAJA, KAZIMIERZ KRZEMIENÍ

KEY CAUSES OF CHANGES IN THE SOŁA RIVER CHANNEL IN THE OŚWIĘCIM REGION OF SOUTHERN POLAND IN THE 18TH AND 19TH CENTURIES

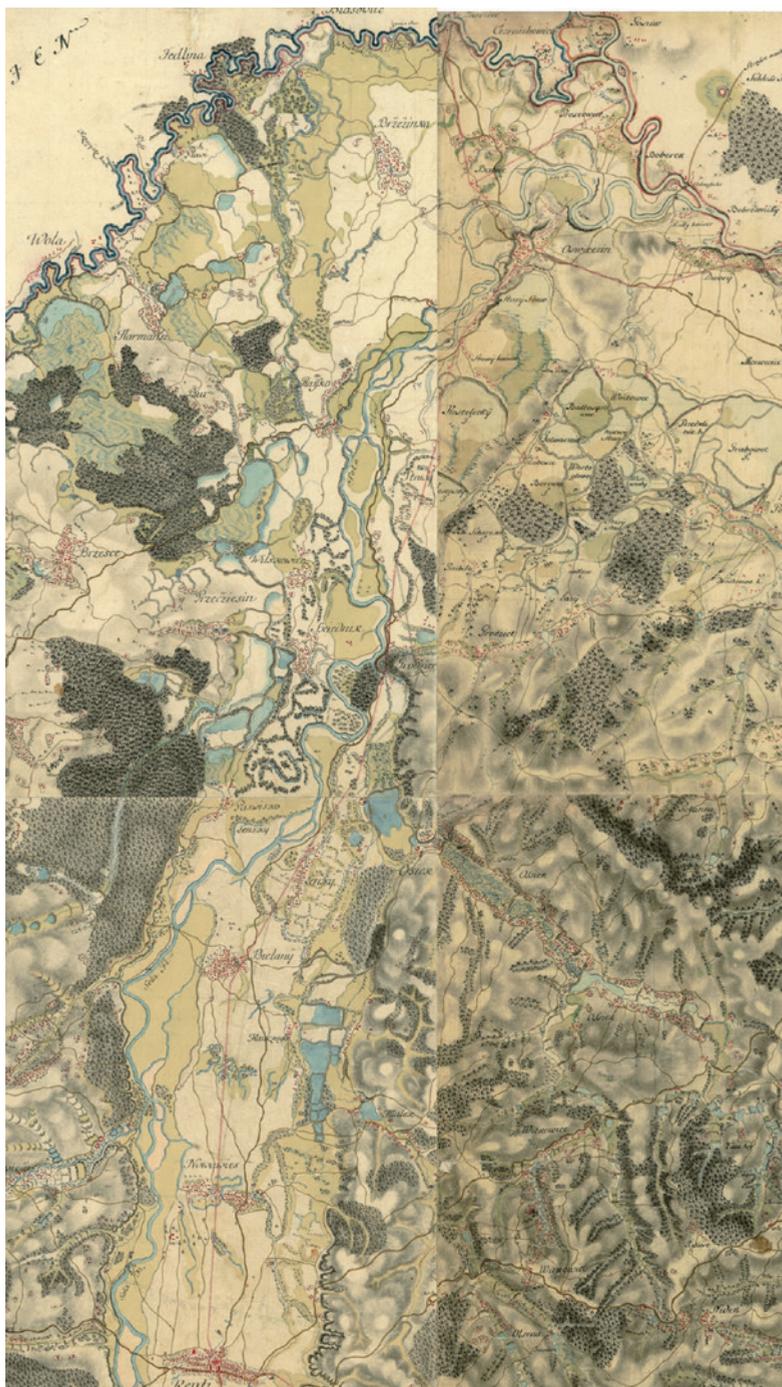
Fig. 2. Soła channel in the section from Kęty to the point of confluence of the Soła and Vistula rivers shown on a map from the late 18th century (Originalaufnahmskarte... 1779–1783)

The Soła river channel pattern found in the Carpathian foreland, as seen in the late 18th century, can be observed on Austrian military maps produced by F. von Mieg in the years 1779–1783 (Sheet 9, Column 2, Section 4 and Sheet 9, Column 3, Section 10) (Originalaufnahmskarte... 1779–1783). A fragment of this map is shown in Figure 2. Two distinct reaches may be observed in the channel section from Kęty to the point of confluence with the much bigger Vistula River. The first follows an anastomosing pattern and ends before the city of Oświęcim near Stary Staw Lake. The second reach follows a strongly meandering pattern and ends at the point of confluence with the Vistula. The width of the Soła between the town of Kęty and the Vistula River ranged from 40 to 60 meters. On the other hand, the Soła river follows multiple channels along the section from Kęty to Stary Staw – this section includes large islands that used to be part of the alluvial plain. The width of this zone ranged from 500 to 600 meters. The sinuosity of the river at this point equaled 1.41 (Fig. 2, Table 1). The second reach running from the city of Oświęcim to Stary Staw to the Vistula River followed a typical meandering flow pattern with a channel sinuosity value of 2.07 (Fig. 2, Table 1).

B. Wośkiewicz-Ślęzak (2013) considers this to be a braided channel, although at one point she states that the studied channel follows a multi-channel-type pattern also known as anabranching. He makes this observation for the Kęty region based on 15th and 16th century maps. This section of river channel was very sinuous with a sinuosity value of 2.59 and four channels. It is our view that the studied channel represents an anastomosing river channel (Teisseyre 1991) or a high-energy multi-channel (Rinaldi et al. 2016). The second reach running from Oświęcim to Stary Staw to the Vistula River had a meandering channel with a channel sinuosity value of 2.07 (Fig. 2, Table 1).

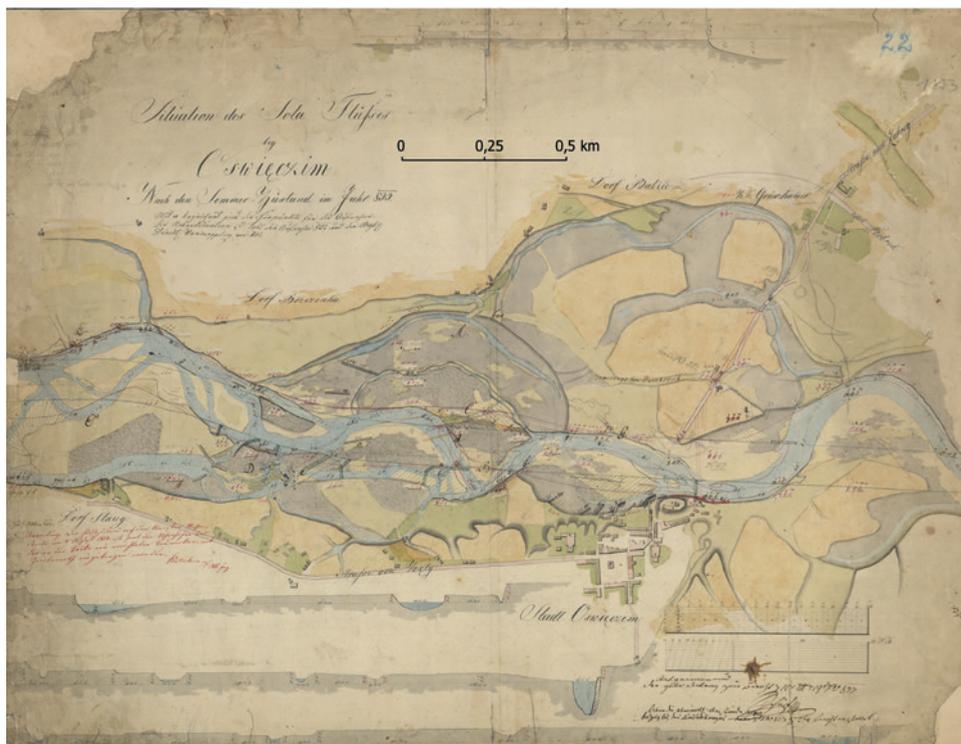
Fig. 7 Map from 1833 of the Soła channel in the Oświęcim area and location of cross sections of the Soła valley (Situation des Soła..., 1833)

A map produced in 1833 provides a more detailed cartography of the study area, along with hydrotechnical structures. The number of longitudinal and transverse embankments, spurs, and dikes significantly increased. Three longitudinal profiles of the studied river were examined and the depth of water in wet channels was noted along with the depth of dry channels. The relationship between the depth of dry river channels was noted with respect to minimum water levels in wet channels (Fig. 7). The minimum average depth of dry channels was found to be 0.85 meters. Dry channels were suspended over the main river channel at a height of 0.16 to 1.07 meters. The authors of the plan once again returned to determining the main river channel and its major tributaries. Approximately every 200 meters, the depth of the river in the channel was also measured. Analyzing the depth distribution in the Soła riverbed, a segment of the river with a length of about 200 meters was identified, where the depths in the water-filled channel ranged from 3.20 to 5.70 meters.

These almost incredible depth values were associated with the presence of dikes running across the river channel (Fig. 7). The dikes were constructed in a way such that the free flow zone along the left bank of the river was only 1 to 2 meters wide. The water flow above the dikes became halted,

while the downstream reach became much deeper and narrower thanks to the strong water current that also removed sandy and gravelly river sediments. The depth in the remaining sections analyzed ranged from a minimum of 0.10 m to a maximum of 0.90 m. The main channel of the Soła River was 3.41 km long and 40 to 50 meters wide, while its side channels were 6.57 km long and 20 to 50 meters wide. The studied water mill canal was 0.66 km long and its location pattern had not changed (Fig. 7, Table 2).
