DAWID PIĄTEK, KAZIMIERZ KRZEMIEŃ

LAND COVER CHANGES AND EROSION SUSCEPTIBILITY IN THE LARGEST SKI RESORTS IN THE POLISH CARPATHIANS

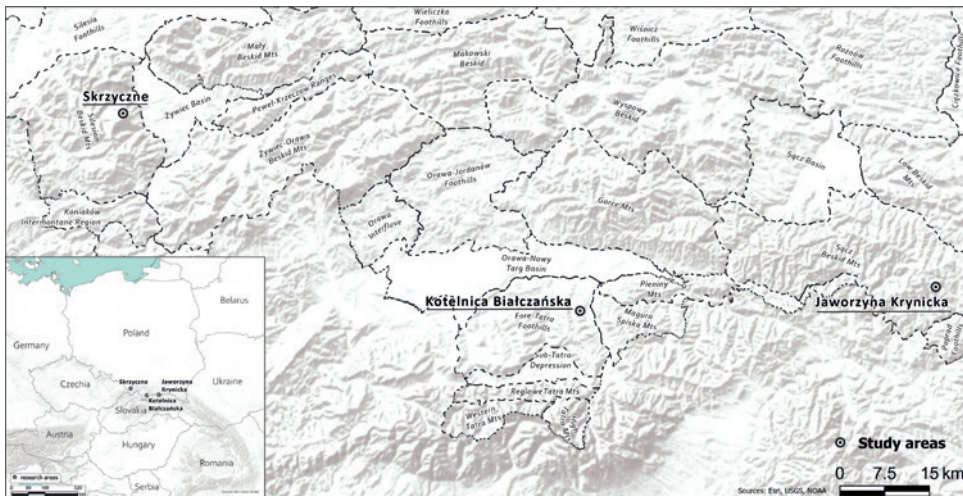
Fig. 1. Location of study areas in Poland the Polish Carpathians, based on J. Solon et al. (2018)

The following ski resorts located in the Polish Carpathians were selected for analysis (Fig. 1): Kotelnica Białczańska, PKL Jaworzyna Krynicka, ski resorts in the Skrzyczne massif: COS Szczyrk and Szczyrk Mountain Resort. These stations have the highest capacity per hour and the highest susceptibility to erosion in the Polish Carpathians (Piątek et al. 2022). They are also all characterized by a high level of ski run maintenance through prior proper profiling of the hillslopes and regular artificial snowmaking and grooming.

The Kotelnica Białczańska ski resort is located in the Fore-Tatra Foothills (Fig. 1), in the Gubałowskie Foothills and includes the slopes of Kotelnica (917 m a.s.l.) Jankulakowski Wierch (938 m a.s.l.) and Wysoki Wierch (948 m a.s.l.) The range is formed of Podhale-type flysch consisting of sandstone-shale layers and conglomerate horizons (Watycha 1972), specifically known as Upper and Lower Chochołowskie layers. The Kotelnica Białczańska ski resort began operations in 2001 and has been expanded several times since then. In the analyzed period 2009–2019, 3 new chairlifts were opened in the central and southern parts of the resort. Before the ski resort extension, the ski run areas were used as meadows and pastures. At that time, the forest area was almost unchanged (Ciołkosz et al. 2011; Hełdak, Szczepański 2011). The ski runs of the Kotelnica resort are characterized by denivelations of up to 239 m, the average gradient of the slopes is 11.7° and the maximum is 24.6°. The area of ski runs is 79 ha and the capacity is 18,770 people per hour, which is the highest capacity in the Polish Carpathians (Table 1).

The PKL Jaworzyna Krynicka ski resort is located on the hillslopes of Jaworzyna Krynicka (1,114 m a.s.l.) the highest peak of the Jaworzyna range in Beskid Sądecki Mountains (Fig. 1). It is formed from sandstones that build the Piwniczna layers, which are part of the Magura unit of the Outer Carpathians (Chrzastkowski et al. 1993). PKL Jaworzyna Krynicka ski resort was established in 1997. The only extension took place in 2009, when a new chairlift was built in the eastern part and a new ski run was prepared.

The described ski stations are located in the Skrzyczne massif (1,257 m a.s.l.) in the Silesian Beskid (Fig. 1) and cover the slopes of Skrzyczne, Małe Skrzyczne (1,211 m a.s.l.) and Malinów (1,115 m a.s.l.). It is the largest ski resort in Poland. The area is built from rocks of the Silesian unit (Godulian strata). characterized by thin sandstone layers and a high share of shales (Nescieruk, Wójcik 1997). The resort has been in operation on Skrzyczne since 1958, and on Małe Skrzyczne since the late 1960s, having been expanded several times, with the most recent and largest expansion taking place in 2017. In the part managed by COS Szczyrk, the chairlifts were replaced in 2013 and 2017. In Szczyrk Mountain Resort, 4 new chairlifts were launched in the analyzed period 2009–2019. In the area of the Skrzyczne massif first deforestation for ski runs took place in the 1950s and 1960. In the 1970s, there was a significant decrease in the area of forests cut down for the construction of ski runs, which were expanded during the period analyzed in this study. The forest area also declined significantly as a result of windthrow in 2004 and an earlier pest gradation (Durło 2010; Ciołkosz et al. 2011). The areas previously occupied by the forest in 2006 were meadows, pastures, fallow land and ski areas (Ciołkosz et al. 2011). Denivelations in the complex are the highest and reach 707 m, the average gradient of the ski runs is 14.2° and the maximum is 37.3°. The area of the ski runs is the highest in the Polish Carpathians – 110.99 ha (Table 1).

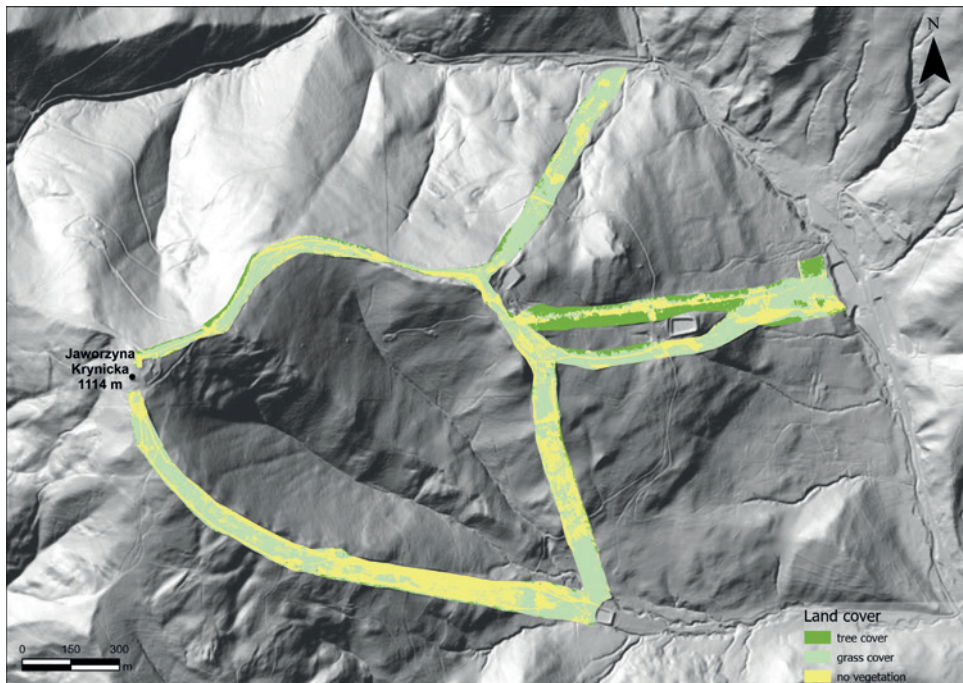
Fig. 4. Land cover at Jaworzyna Krynicka ski resort in 2009

Analyzing the changes in land cover in the period 2009–2019 for the ski resort in Jaworzyna Krynicka, attention is drawn to the smallest changes from all the surveyed stations (Figs. 4, 5). The area of Jaworzyna Krynicka is the only one of the studied areas where the proportion of area covered by grass increased, from 52.3% (22.9 ha) in 2009 to 72.2% (31.6 ha) in 2019 (Table 2). In favor of an increase in the area covered with grass, the area without vegetation decreased (Figs. 4, 5). In 2009, it accounted for 35.9% (15.7 ha) and in 2019 it has decreased to 27.8% (12.2 ha). This is mainly related to

the overgrowth of grass on the ski run in the southern part of the ski resort (Figs. 4, 5). However, the preparation of the new ski run, located in the eastern part of the complex (Figs. 4, 5), led to the felling of all the trees that grew in the area of the current ski runs. 5.2 ha of tree cover area was cut down, which represents a change from 11.8% of tree cover area in 2009 to 0% in 2019 (Table 2). The change in tree cover area is also related to the slight widening of the ski runs, mainly in the northern part of the resort (Figs. 4, 5).

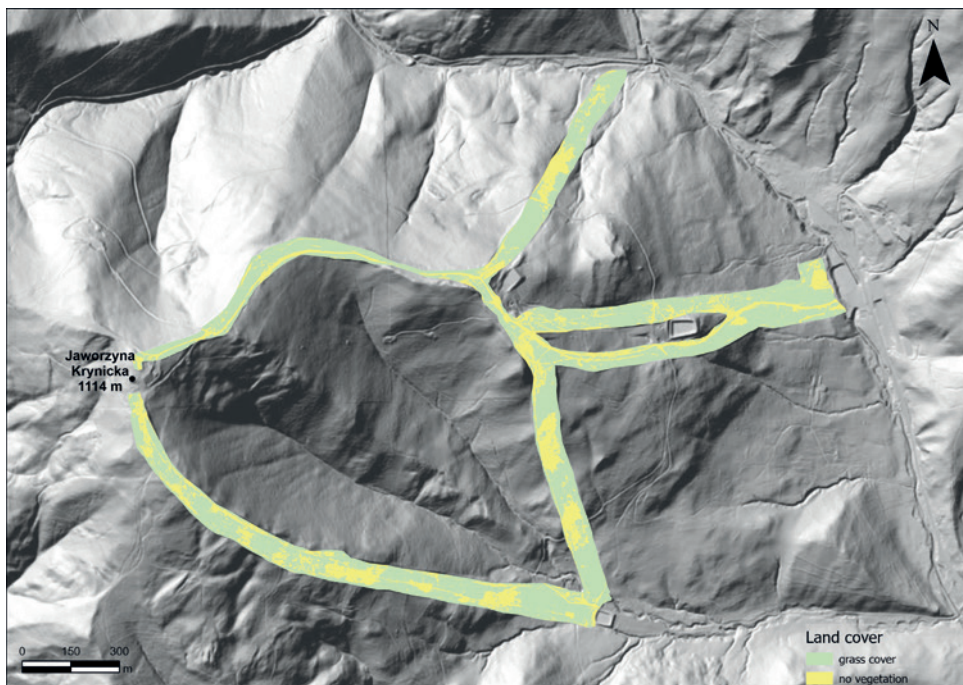
Fig. 5. Land cover at Jaworzyna Krynicka ski resort in 2019

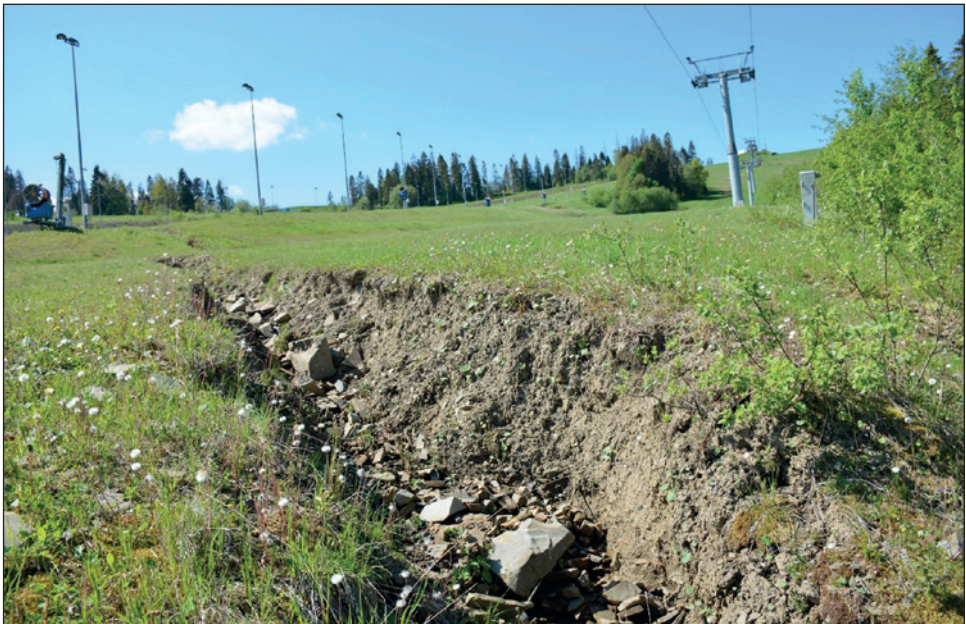
Fig. 8. Diagonally routed drainage ditch, Kotelnica Białczańska

In the area of Kotelnica Białczańska, characteristic is the different routing of the drainage ditches. The ditches here are routed diagonally to the ski run, not perpendicularly as is usually the case (Fig. 8). Their dense network results in low intensity of linear erosion on the ski runs surface. The slope of the ditches directs water off from the ski run (Fig. 8). Erosional incisions are created in the surrounding of ski runs, below the outlet of drainage ditches (Fig. 9). The depth of incisions is about 50 cm and in extreme cases exceed 1.5 m. Also in this area, sheep grazing is carried out, however, here traces of grass destruction by sheep were observed.

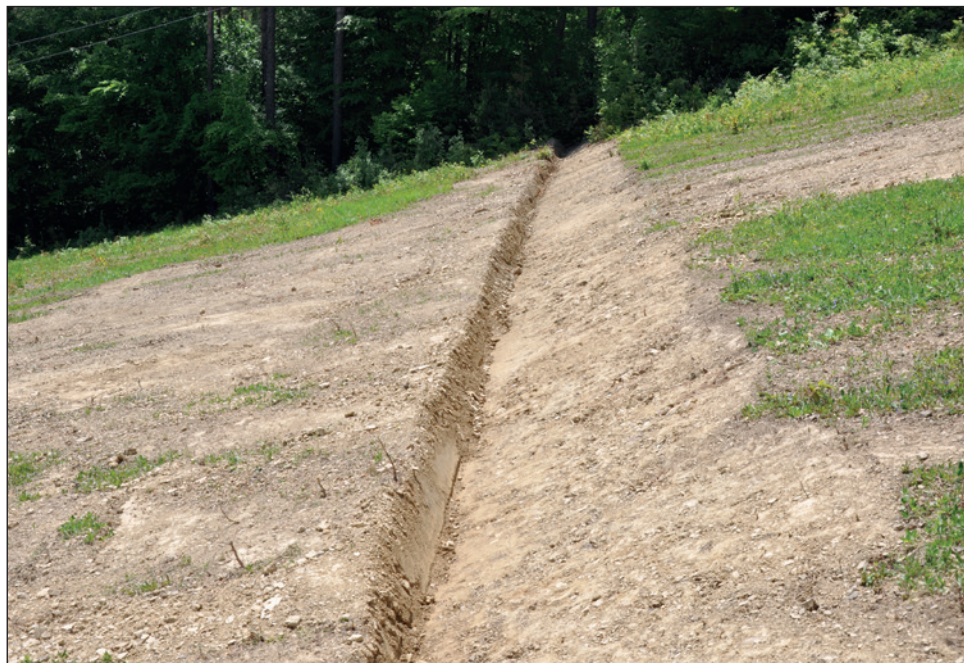
Fig. 9. Erosional incisions at the outlet of a drainage ditch from the ski run, Kotelnica Białczańska

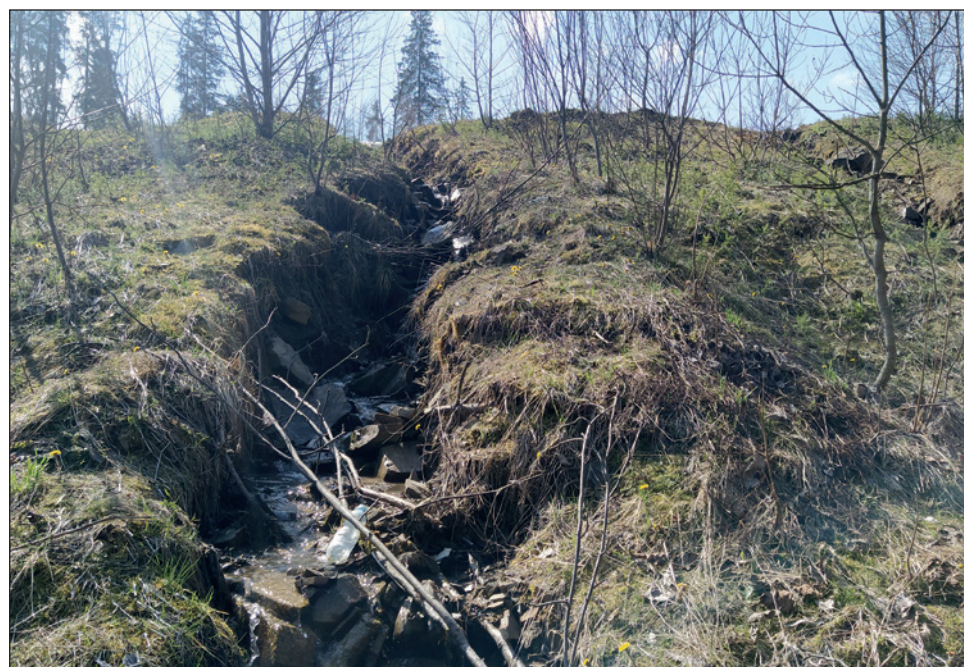
Fig. 10. Perpendicularly routed, newly deepened drainage ditch, Jaworzyna Krynicka

For the area of Jaworzyna Krynicka, the occurrence of few erosion and accumulation forms on the ski runs is typical. Field observations showed only the occurrence of 10–15 cm deep, several meters long erosional incisions in two areas of the station: on the ski run created in 2009 in the eastern part of the resort and on the north-south ski run in the southern part of the resort. Drainage ditches are perpendicular to the ski run. The slope of the ditches directs water to the center part of the ditch. This leads to filling up drainage ditches, which are regularly deepened (Fig. 10). It results in no erosion outside the ski run, at the outlet of ditches. Extensive sheep grazing was observed

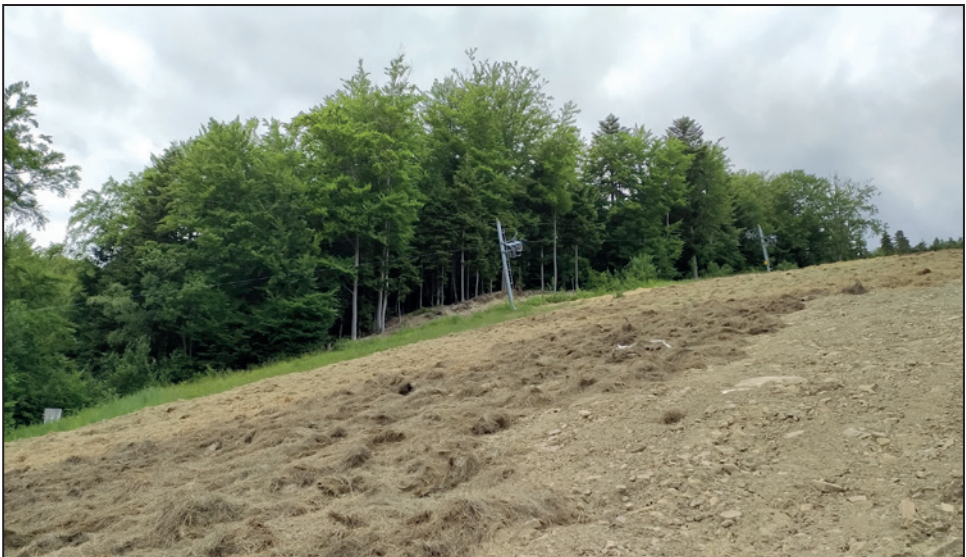
Fig. 11. Spreading hay on surfaces without vegetation, Jaworzyna Krynicka

on ski runs, with no damage to the vegetation.. Also to accelerate the growth of grass, the spreading of hay on surfaces without vegetation is used (Fig. 11).

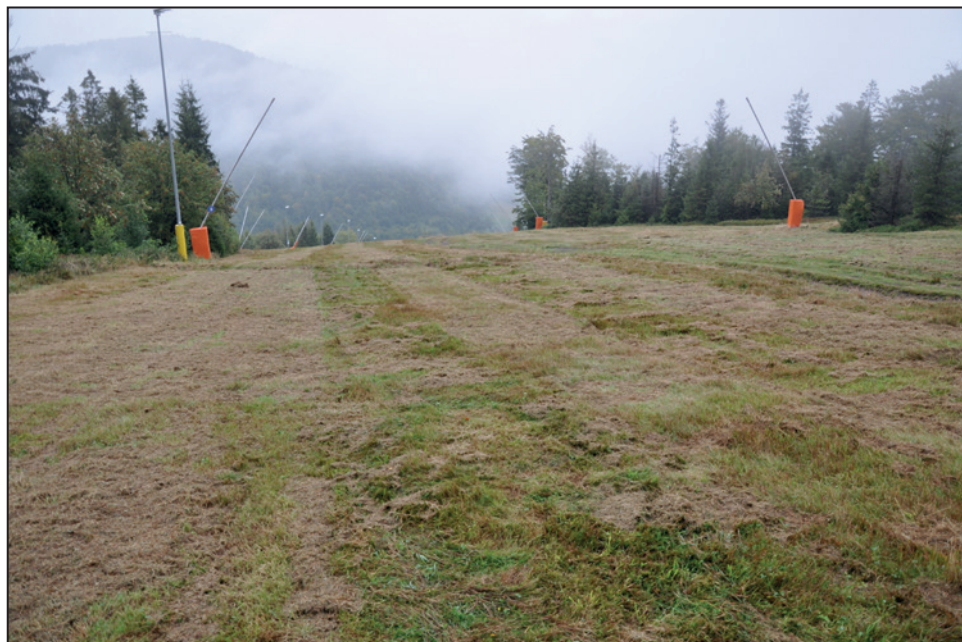
Fig. 12. Well maintained ski run surface with hay left after mowing, visible access road without vegetation, Skrzyczne massif

The distribution of erosion traces in the Skrzyczne skiing area varies greatly. The eastern part, the oldest and rarely expanded is characterized by less intensive snowmaking and only few areas damaged by snow groomers have been observed. The situation is different in the rest of the resort. Here, intensive work has been carried out everywhere on extending or building new ski runs. However, the grassed ski runs are well maintained and hay is left on the surface after mowing (Fig. 12). In this case, the only areas susceptible to erosion are roads (Fig. 12). In addition to the exposed surfaces, an important aspect that can lead to the activation of geomorphological processes is the dense network of ski runs transverse the hillslope. This involves the creation of numerous road undercuts and escarpments, which are places where landslides can potentially occur (Fig. 13). Significant effects of water erosion occur primarily on the roads running in the ski run area (Fig. 13). These are used not only as access roads, but also intensively in summer as cycle routes which contributes to additional cutting. Most of drainage ditches are perpendicular to the ski run. Some of the drainage ditches, especially those on the newly developed ski runs, are masonry with large stones (Fig. 13). This is very beneficial because protects the ditch from erosion and, due to the stone roughness, causes a decrease in the energy of the water flowing through the ditch which reduces erosion off the ski run.

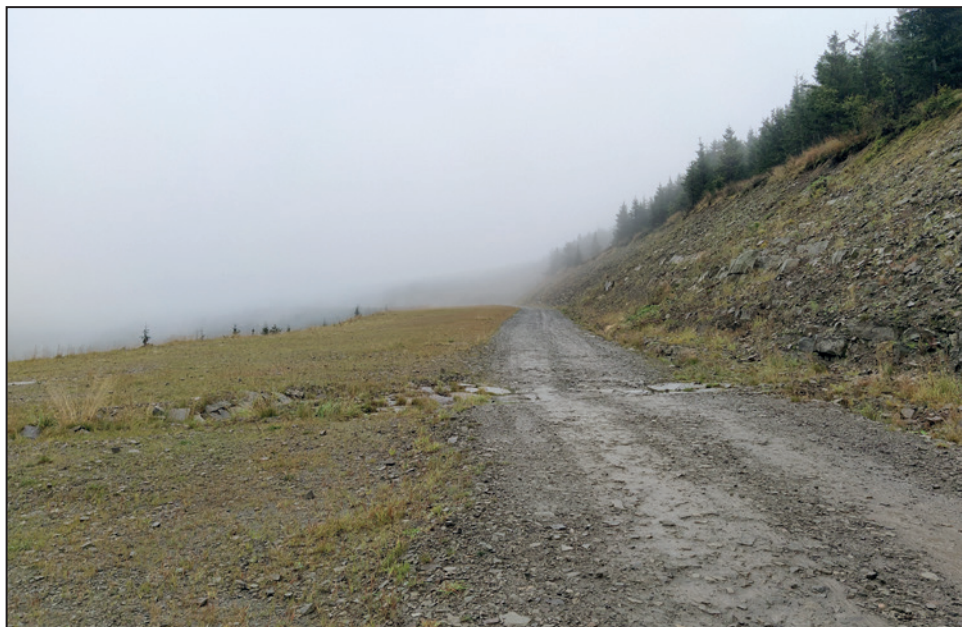
Fig. 13. Ski run in the Skrzyczne massif. Visible road undercut and escarpment, surface without vegetation and the road running in the ski run area. Drainage ditch is masonry with large stones
