GEOMORPHOLOGICAL HAZARDS

ZAGROŻENIA GEOMORFOLOGICZNE NA PRZEDPOLU KARPACKIM, TOLNA, WĘGRY

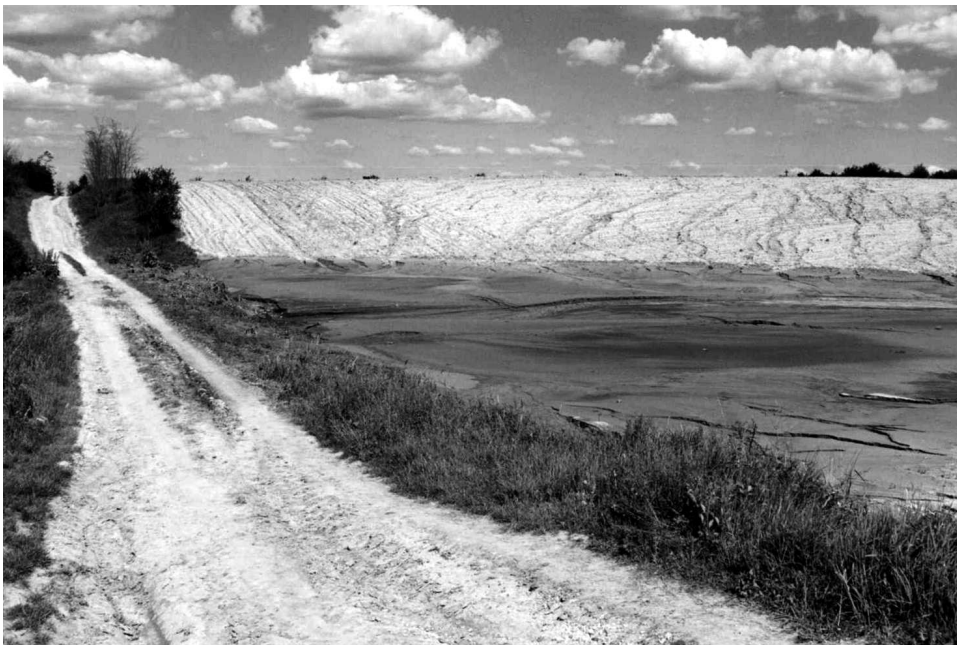
Photo 1. Street wash (Photo by Sz. A. Fábíán)

The Szekszárd Hills is one of the most erosion-prone areas of Hungary. Splash, sheet, rill, and gully erosion has removed the topsoil almost completely in places (Photo 1–5). Based on erosion modelling studies, the magnitude of the various types of erosions can be up to 0.5 metres per 100 years under intense anthropogenic land use (Huszár 1998). The wind erosion is also a potential hazard in the investigated area, predominantly in the Southern Mezőföld, where fluvial sediments are covered by a thick layer of wind blown sand (Lóki 2003). As a result of the anthropogenic effects, the relief has also changed to a great extent, primarily the shape, length, and angle of the slopes. It can considerably contribute to the observed asymmetry of the region's valleys.

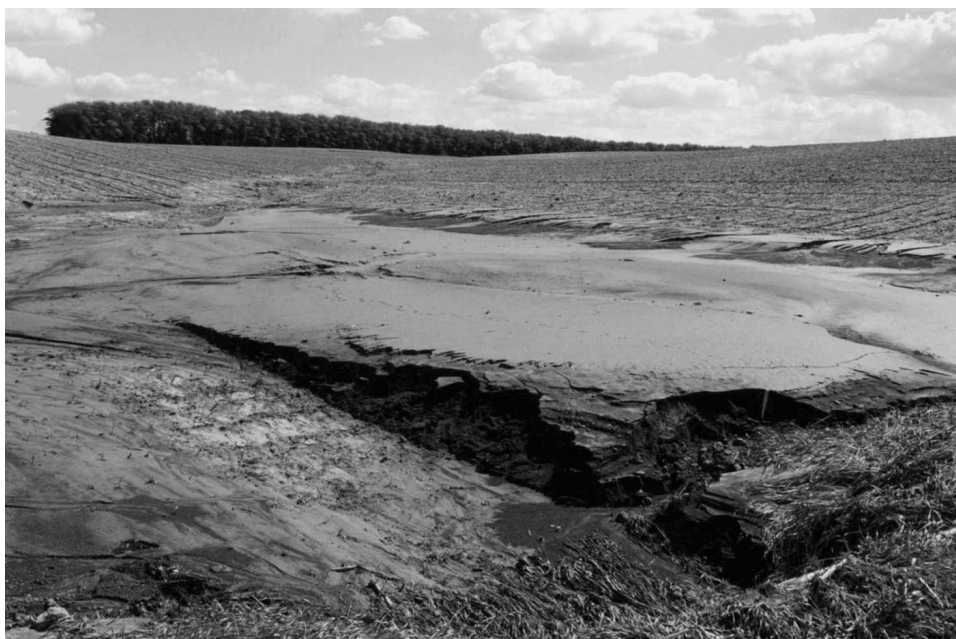
Photo 2. Eroded soil accumulated in a fan near Nagykónyi (Photo by Sz. A. Fábián)

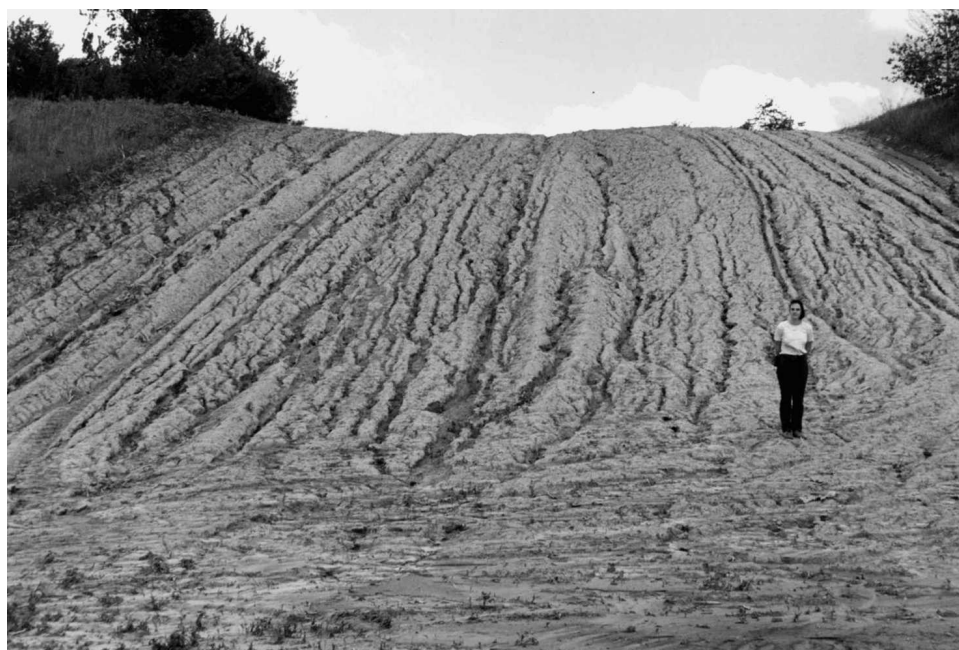
Photo 3. Gully erosion on a slope of Tolna Hills near Nagykónyi (Photo by Sz. A. Fábián)

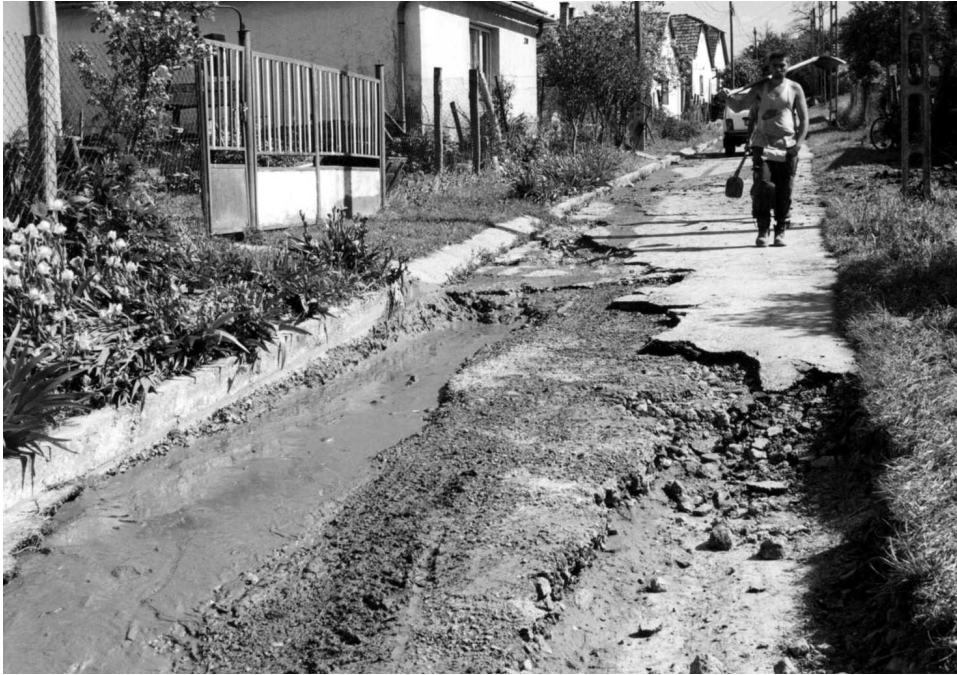
Photo 4. Erosion by flash flood in Nagykónyi. Street pavement was washed away
(Photo by Sz. A. Fábián)

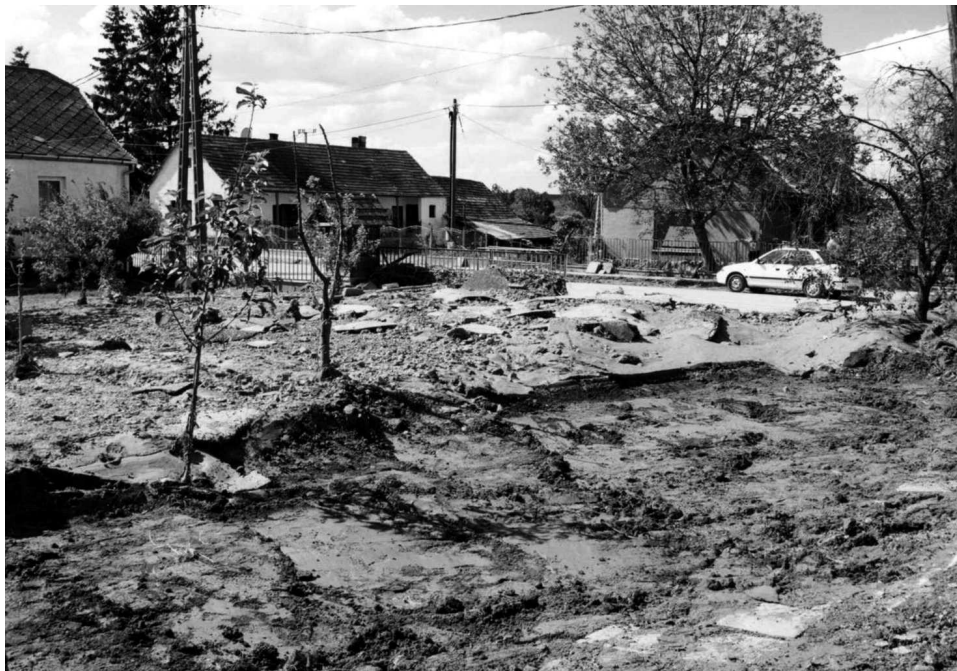
Photo 5. Debris accumulated by flash flood (Photo by Sz. A. Fábián)

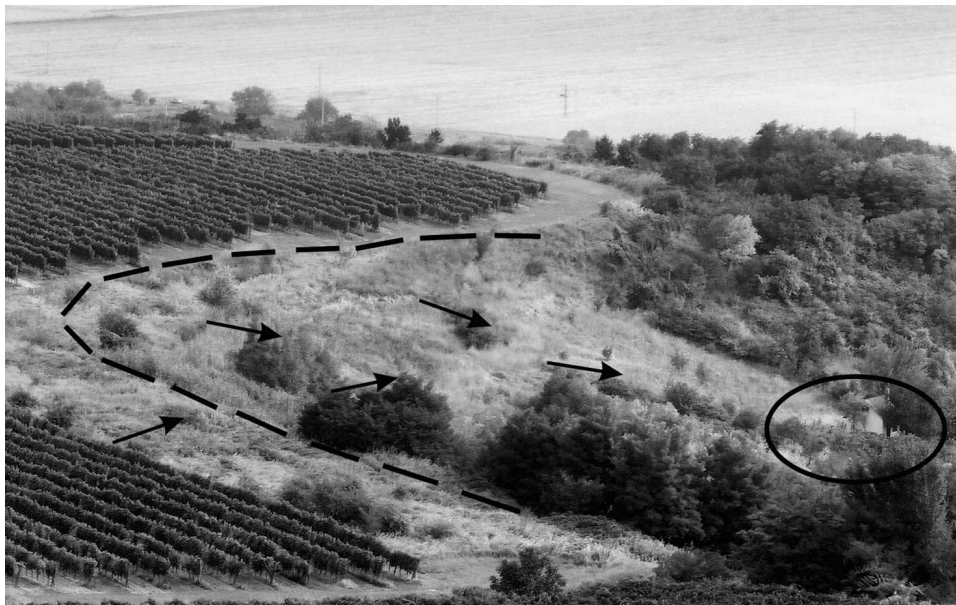
Photo 6. Recent mass movement at Decs, Szekszárd Hills (Photo by K. Lampért)

movements. The fissures among debris slowly widen into cracks. The rainwater running off along slopes broaden and deepen these cracks, thus initiating gully and rill erosion. Similar gullies developed on the steep edge of the slope with slide in the summer of 2005, when heavy rainfall took place within a short period. The gully also threatened the nearby cellar buildings. Gully erosion, expanding of ravines and extensive dissection of relief has a significant contribution to soil removal in the loess covered area. Opened ditches serving to conduct surface water and surfaced roads have been damaged in the study area. The intensification of piping under solid pavement lead to forming at least a metre and a half deep caverns locally. The resulting network of underground channels caused significant damage to the vineyards nearby. The rows of vines-stocks are tilted downslope as a clear consequence of creep and more rapid types of mass movement. It is clearly observable that a section with some ten metres of rows moved over one year (Photo 6).
