MATLIJA ZORN¹, KAREL NATEK², BLAŽ KOMAC¹ (LJUBLJANA)

MASS MOVEMENTS AND FLASH-FLOODS IN SLOVENE ALPS AND SURROUNDING MOUNTAINS

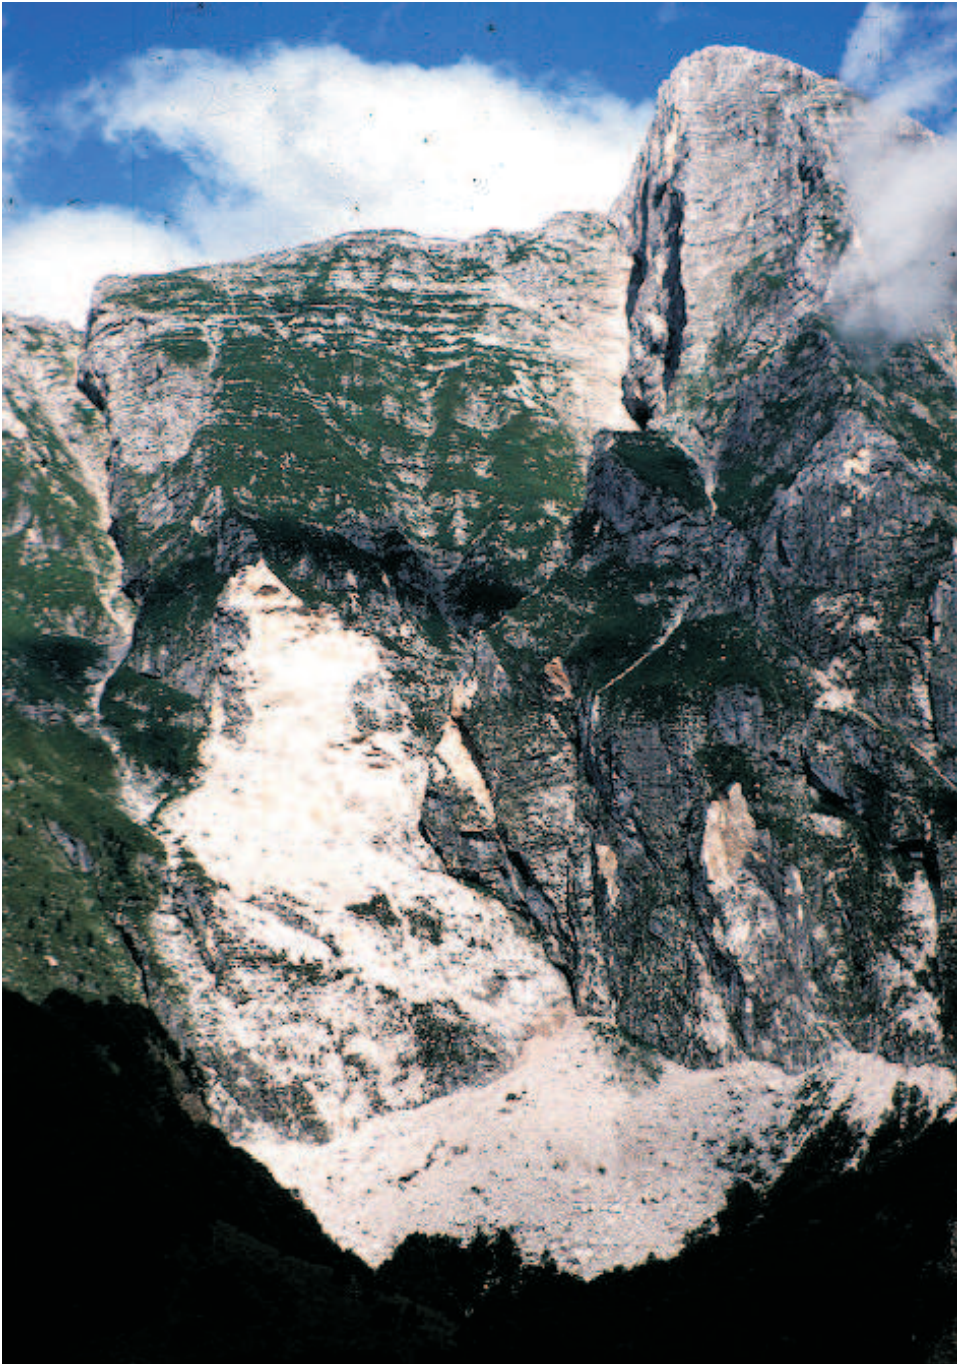
Photo 1. Rockfalls triggered by the Easter earthquake 1998 on the south-western slope of Mt Krn (Photo by K. Natek)

We tend to attribute the responsibility for rockfalls to earthquakes. A. Heim (1932, p. 177) writes that in many historical sources from the period 1600–1850 it is stated that a rockfall “was a consequence of an earthquake”. In recent years, a notion that earthquakes are the main cause of rockfalls appeared on two occasions in Slovenia. The first occasion was on April 12, 1998 when the “Easter earthquake” shook the Upper Soča area (NW Slovenia) (magnitude 5.6; EMS intensity VII–VIII). The earthquake in 1998 (Natek et al. 2003) caused over a hundred sizeable geomorphic changes in nature. Out of 52 rockfalls, two were of a larger scale (on Mt Krn and Mt Osojnica) with a volume of over a million m³ of material (Photo 1). In case of the 2004 earthquake, 44 rockfalls were registered in approximately the same area, however they were smaller correspondingly to the intensity of the earthquake (Mikoš et al. 2005).

In the past, the area was affected by at least three earthquakes stronger than the above mentioned couple. According to sources and literature, they also triggered numerous landslides and rockfalls (Lapajne 1988; Lapajne 1989; Zorn 2002a): the Villach earthquake in nearby Austria on January 25, 1348 (esti-

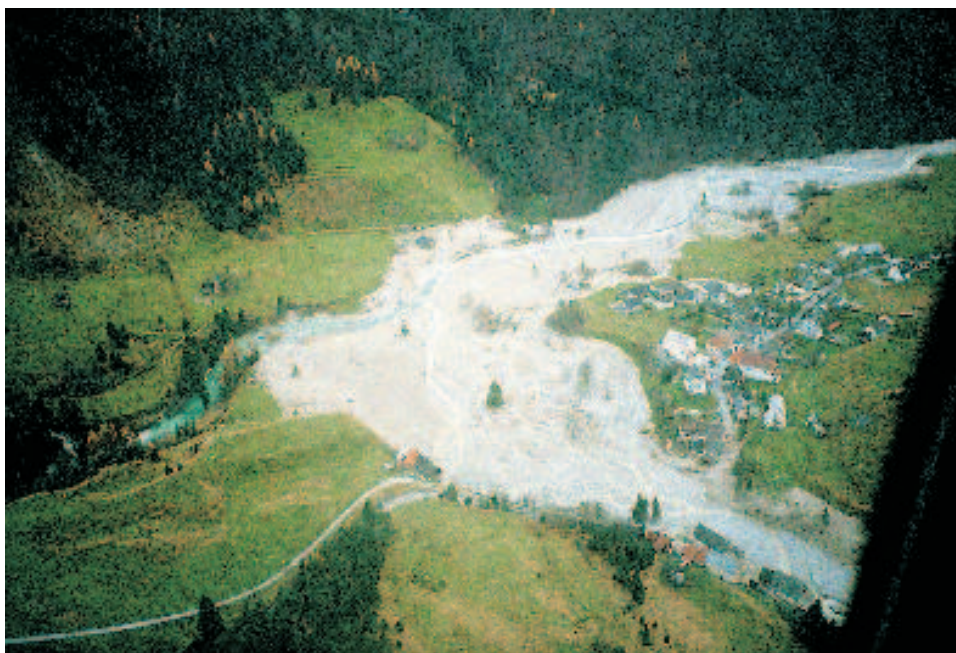
Photo 2. Debris flow in Log pod Mangartom (Photo by B. Komac, November 19, 2000)

To the west of Mt Mangart (2,679 m), a landslide was triggered on November 15, 2000 at the altitude between 1,340–1,580 m. At first, a mass of several hundred thousand cubic meters stopped at the confluence of Mangartski potok and Predelica streams. Due to massive water inflow into the material, the mass became waterlogged and on November 17, several minutes past midnight, a debris flow was triggered. In the Log pod Mangartom village, more than 700,000 m³ of material was deposited on the area of 15 hectares. The disaster claimed seven lives, 18 houses and 8 other buildings were destroyed or damaged. Total damage on buildings was estimated at € 2 million, on road infrastructure € 5 million, on other infrastructure € 3.5 million and on farmland half a million €. The survived were evacuated for almost three months (Komac 2001; *Report...* 2001).

In the sliding area which is 900 m long and 300–400 m wide, about 1,500,000 m³ of material was displaced. Of this, 1,000,000 m³ slid down to the valley while 500,000 m³ of material remained in the sliding area (Majes et al. 2000). Above the

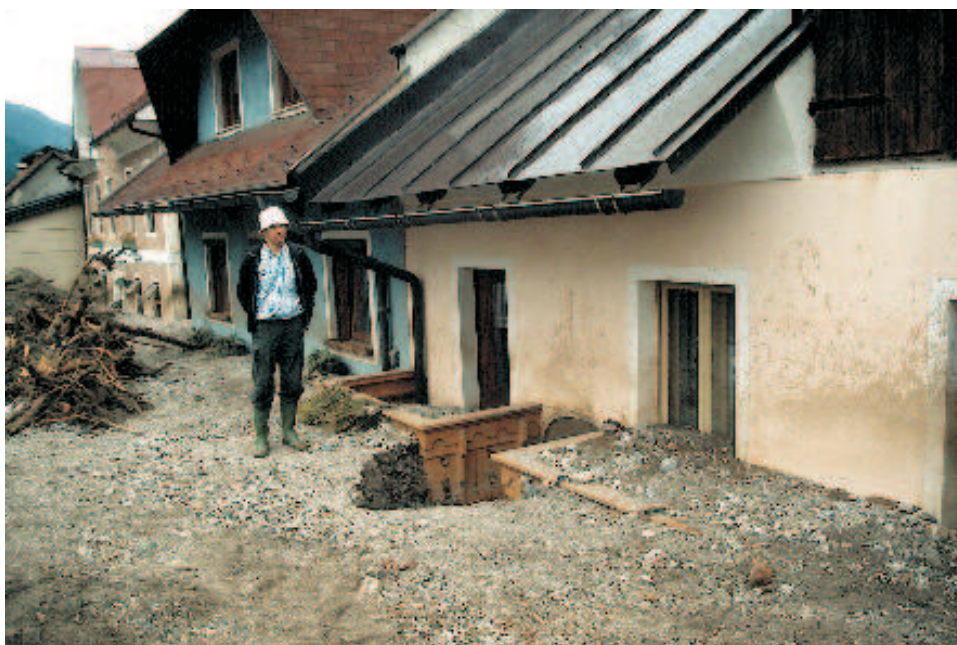
Photo 3. Debris filled the “Via 13. Settembre 1903 alluvione” Street in Ugovizza up to the second floor (Photo by M. Zorn, September 1, 2003)

More severe were the consequences of a storm several kilometers to the west in the village of Ugovizza (Val Canale, Italy). The area received more than 400 mm of precipitation at the end of August 2003 (long-term 1961–1990 August average for nearby Tarvisio is 147.7 mm; Gundel 2004). Road was destroyed by waters in 13 places and the railway link between Udine (Italy) and Villach (Austria) was disconnected. The Ugovizza stream with a catchment area of 28 km^2 buried the western part of the village of Ugovizza with debris. More than 300 people had to abandon their homes and 2 people were killed. The debris flow destroyed the village only 14 days before the 100th anniversary of a similar event that

struck Ugovizza in September 13, 1903. The street named Via 13. Settembre 1903 alluvione (September 13 flood Street) is a reminder of the event when debris reached the second floor of houses in this street (Photo 3). Below the village, a large alluvial fan composed of debris was formed. In the past, people were aware of the hazard — decades ago they built wooden bridges across the stream in Ugovizza to allow the floods or debris flows to carry them away. However, the new concrete bridge withstood the disaster and caused deposition of material in the village (Palmieri et al. 2003; Zorn and Komac 2004). Lower part of the village was also buried by debris up to the windows in October 14, 1923 when the bridge was also carried away, while according to the newspapers, fields and meadows were “covered with sand and stones in a large area”.

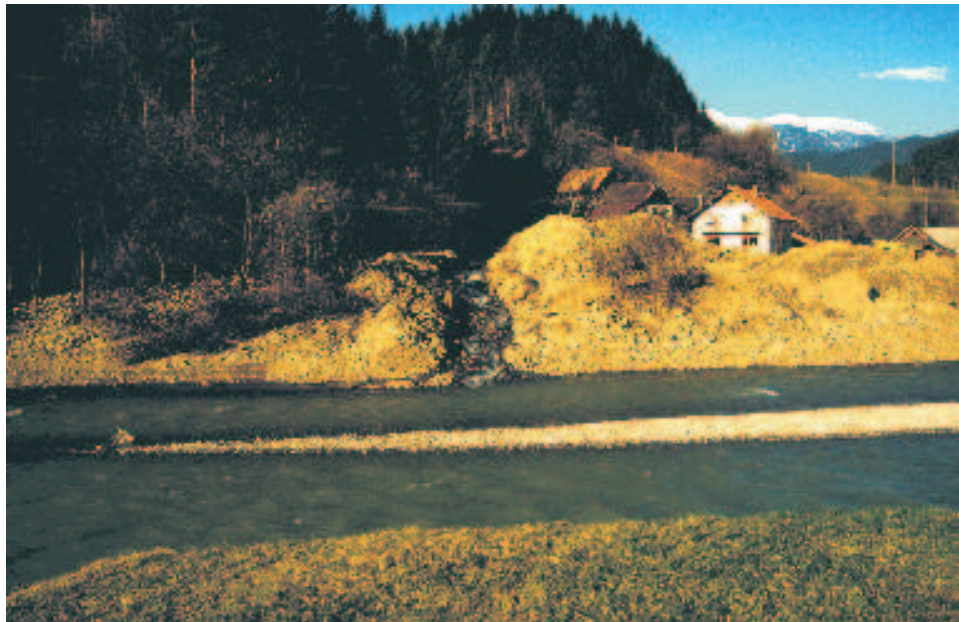
Photo 4. Material deposited by the Trbiški graben stream at its confluence with the Savinja river upstream from Ljubno (Photo by K. Natek, November 3, 1990)

alluvial fans where strong erosion and accumulation processes occur during flash-floods. Accordingly, settlements on older alluvial fans are completely flood-safe (mountain farms or small villages are almost exclusively located there), while recent alluvial fans are extremely flood-prone areas. A combination of high precipitation and landslides on steep slopes in narrow mountain valleys presents a special hazard — in these cases, devastating debris flows develop, depositing huge quantities of load in very short periods of time at the contact of alluvial fans with valley bottoms (Photo 4).
