JANUSZ CZERWIŃSKI, ROMAN ŻURAWEK (WROCLAW)

THE GEOMORPHOLOGICAL EFFECTS OF HEAVY RAINFALLS AND FLOODING IN THE POLISH SUDETES IN JULY 1997

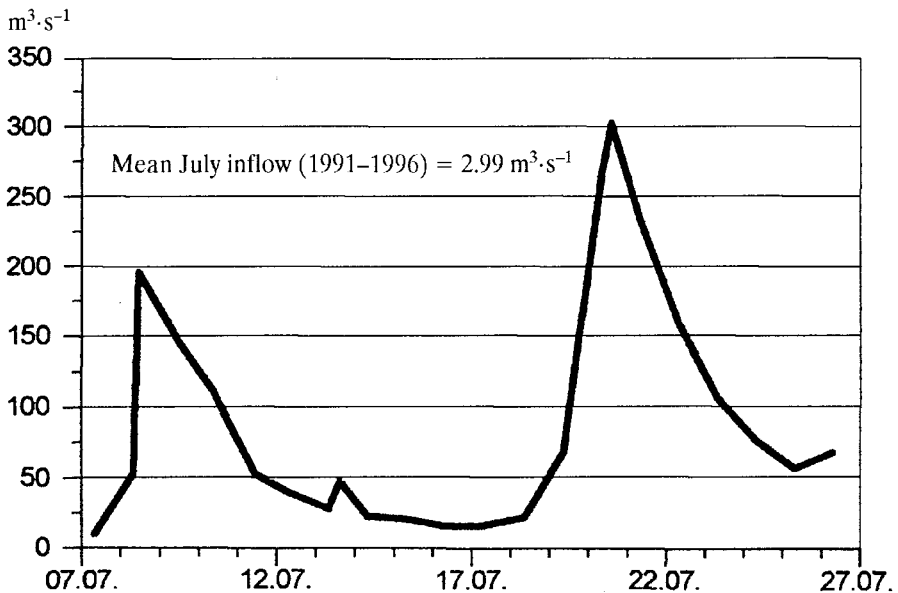
Fig. 3. Generalised diagram to show discharge of Bystrzyca river — inflow to the reservoir of Mietków (for location see Fig. 1) during flood in July 1997. Data after Okręgowa Dyrekcja Gospodarki Wodnej (Regional Survey of Water Management) in Wrocław

A new flood wave was generated by the second precipitation episode in the second decade of July, yet this was of a smaller magnitude than the former one in the East Sudetes, but higher than in the Middle and West Sudetes (Fig. 3). Absolute high water marks were exceeded along, among others, the Bystrzyca, Kaczawa, and Bóbr (gauging stations Jelenia Góra and Dąbrowa Bolesławiecka) rivers, but not on the Kamienna, Kwisa and Nysa Łużycka rivers, although even there the high water levels recorded surpassed emergency levels (Dubicki 1997).

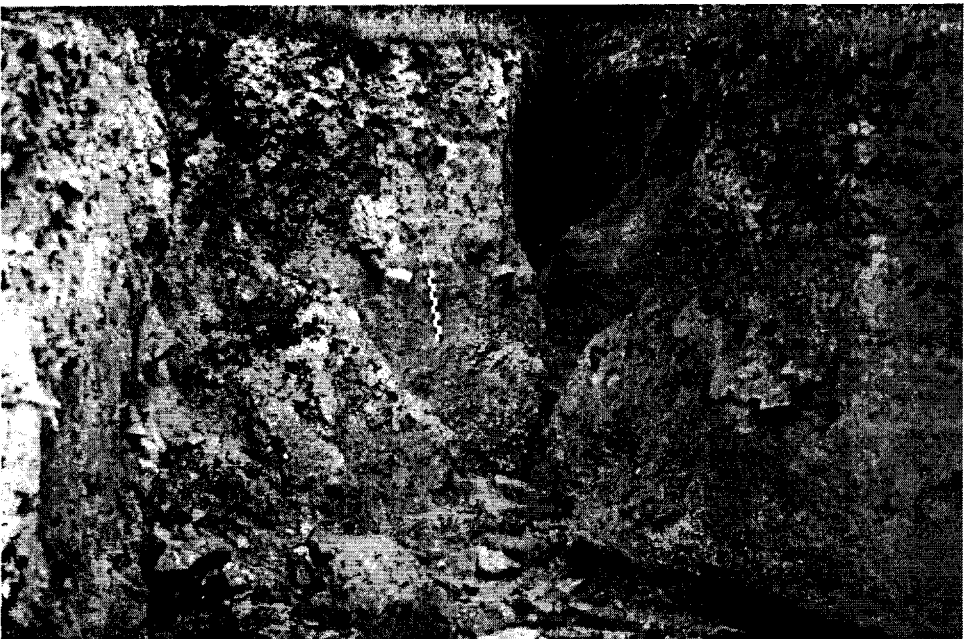
Photo 1. A gully originated in July 1997 replaced a former tourist trail on the slope of Igliczna (845 m a.s.l.), Śnieżnik Massif, East Sudetes. Bar length is 0.5 m (by R. Żurawek)

Therefore, in spite of an unparalleled amount of rainfall in July 1997, overland flow happened incidentally and at specific localities only. In the subalpine forest belt, on forested and deforested slopes alike, virtually no signs of overland flow have been observed. To some extent, this is caused by the watershed setting of this belt within the most affected area of Śnieżnik Massif. Nonetheless, we must point out that it is the presence of thick undergrowth that has played a decisive role in protecting slope surfaces against erosion. The erosional effects of heavy rainfall in July 1997 have only become visible in places stripped of natural vegetation, such as footpaths, forest tracks and logging tracks. It is there where the process of gully erosion has been most efficient and has achieved impressive results. Concentration of overland flow was taking place entirely along forest tracks (Fig. 4). The most protracted and deepest erosional gullies originated along tracks of the greatest length, and not necessarily within slope sections of the highest gradient. This confirms observations from the flysh-built areas (Słupik 1973), according to which sheet wash on forested surfaces is negligible and slope inclination does not exert any important influence on differences in its magnitude. In the Śnieżnik Massif individual gullies have reached great sizes, up to 4.3 m deep and a few kilometres long. They were initiated on forest tracks and even in watershed areas, and were increasing in size down the slope, culminating in total road destruction. Locally, we may even be justified talking about ravines replacing former forest tracks rather than just about gullies developing along these tracks (Photo 1).

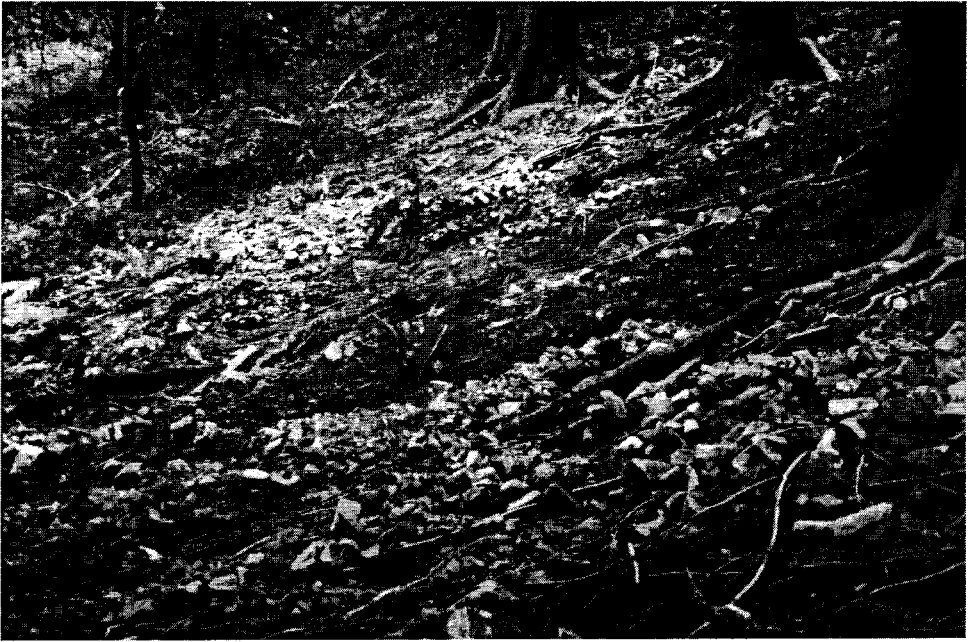
Photo 2. Results of sheet wash below the outlet of gully shown on Photo 1 (by R. Żurawek)

The most pronounced geomorphological effects of overland flow and gully erosion have taken place at the outlets of erosional gullies and below the lower limit of the subalpine forest (ca 1,000 m a.s.l.). In many places the layer of undergrowth has been totally stripped, often on the near-surface part of the slope cover (Photo 2). Debris accumulation cones have originated at the terminus of large erosion gullies, although they have lacked the features of typical torrential cones, being discontinuous and rather thin. Coarse debris has been deposited in the form of stripes extending downslope and according to the plane of greatest inclination. Low ridges built of debris and deposited on the proximal side of obstacles — mostly tree trunks — have been another characteristic form. Degradation effects of overland flow have included irregular depressions up to a few tens of centimetres deep, usually located in between tree roots across the entire area affected by surface runoff.

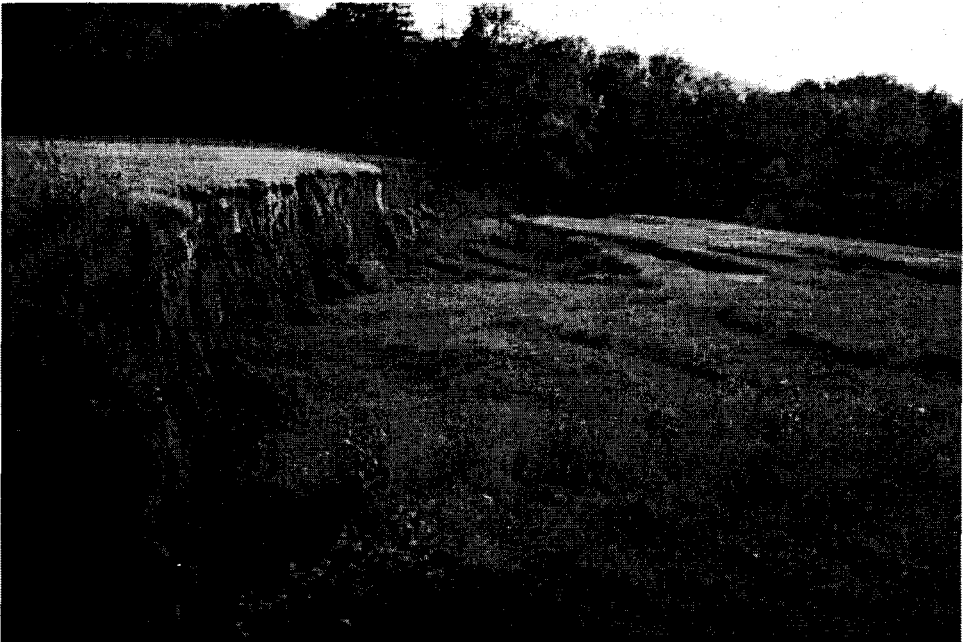
Photo 3. Initial landslide scar in Janowiec near Bardo (by R. Żurawek)

found in the village of Janowiec, at the outlet of the Nysa Kłodzka river, from an antecedent gorge between Kłodzko and Bardo in the Sudetic Foreland. The undermining of the right-hand valleyside resulted in a landslide that affected the metamorphic bedrock, and the terrace gravel, and the overlying slope cover. The width of the landslide head was ca 130 m, its perimeter was 155 m, and the original upper surface was located about 30 m above the valley floor. The landslide mass did not slip into the channel; the vertical displacement was on average of 3 m, up to 4.5 m at most (Photo 3). Other examples include landslides in the Wilczka valley (Śnieżnik Massif), Bielawica valley (Sowie Mts) and Biała Głuchołaska valley, in the gorge-like section upstream of Głuchołazy.

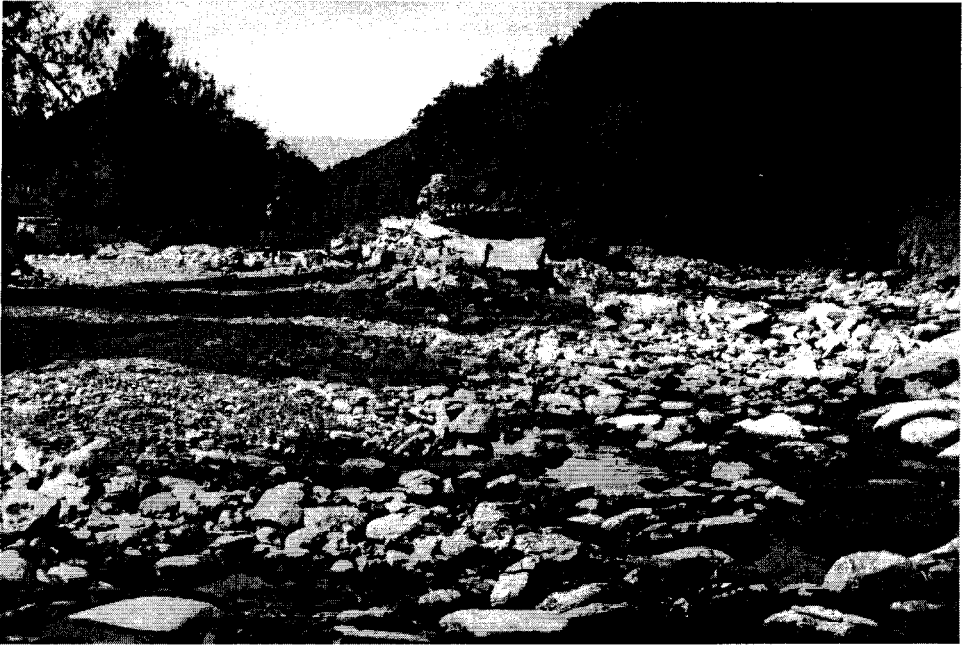
Photo 4. Pillar of a destroyed bridge on Wilczka river, where major avulsion took place
(by R. Żurawek)

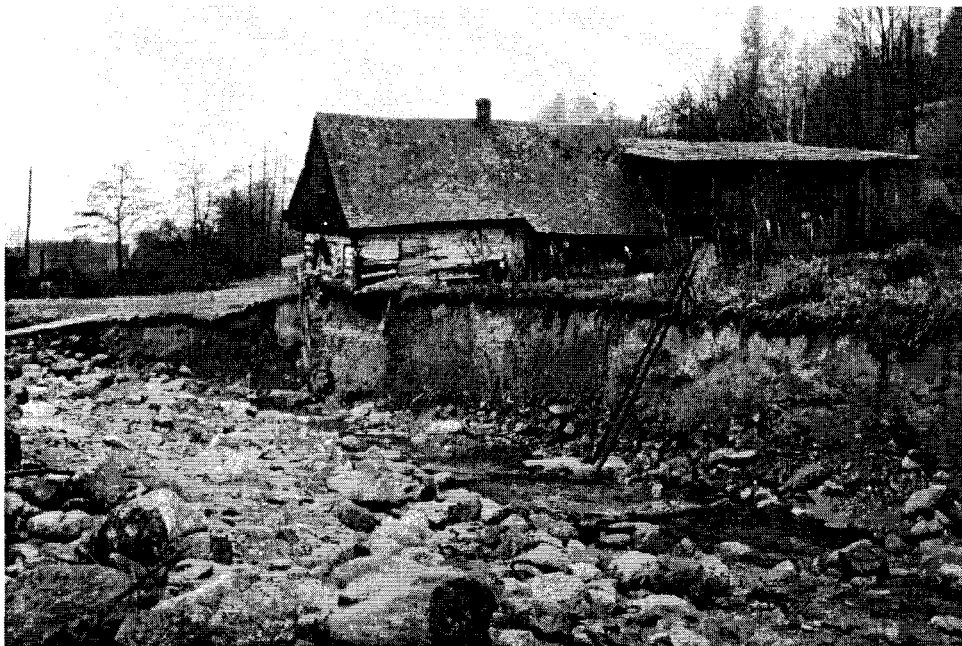
Photo 5. Effects of lateral erosion in the channel of Goworówka within the alluvial fan at the valley outlet from the Śnieżnik Massif (by R. Żurawek)

Observations made along the Wilczka river valley are paralleled, to various degrees, in other Sudetic valleys, which cut mountain fronts and were affected by flood in July 1997. These include other right-hand side tributaries of the upper the Nysa Kłodzka river (e.g. Goworówka — Photo 5, Pławna), Nysa Kłodzka itself at the marginal escarpment of the Sudetes, or rivers draining the Sowie Mountains. Yet these regularities do not appear clearly in river valleys and drainage basins of
