MOJMÍR HRÁDEK (BRNO)

GEOMORPHOLOGICAL ASPECTS OF THE FLOOD OF JULY 1997 IN THE MORAVA AND ODER BASINS IN MORAVIA, CZECH REPUBLIC

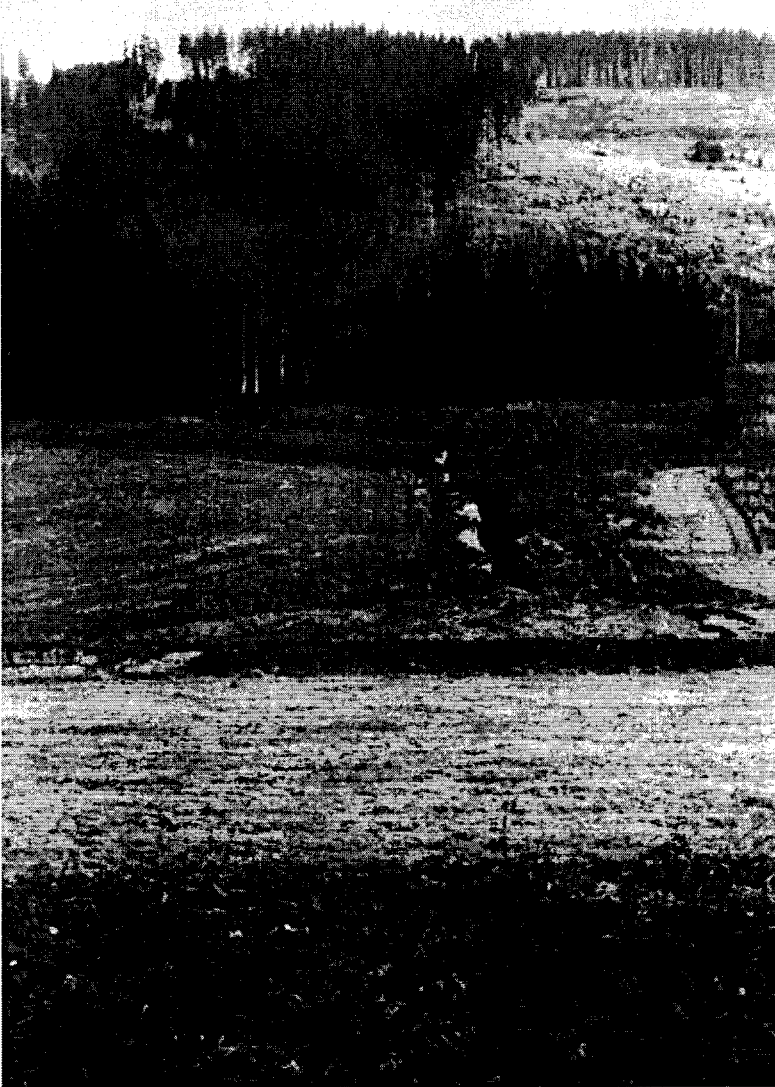
Photo 1. In Sudeten mountains the heavy unremitting rainfalls triggered gully erosion. An up to 4 m deep gully in the figure cut the sides of Opavice valley of Lower Carboniferous flyschoid slates.

Note the broad alluvial fan at the foothill of gravel debris

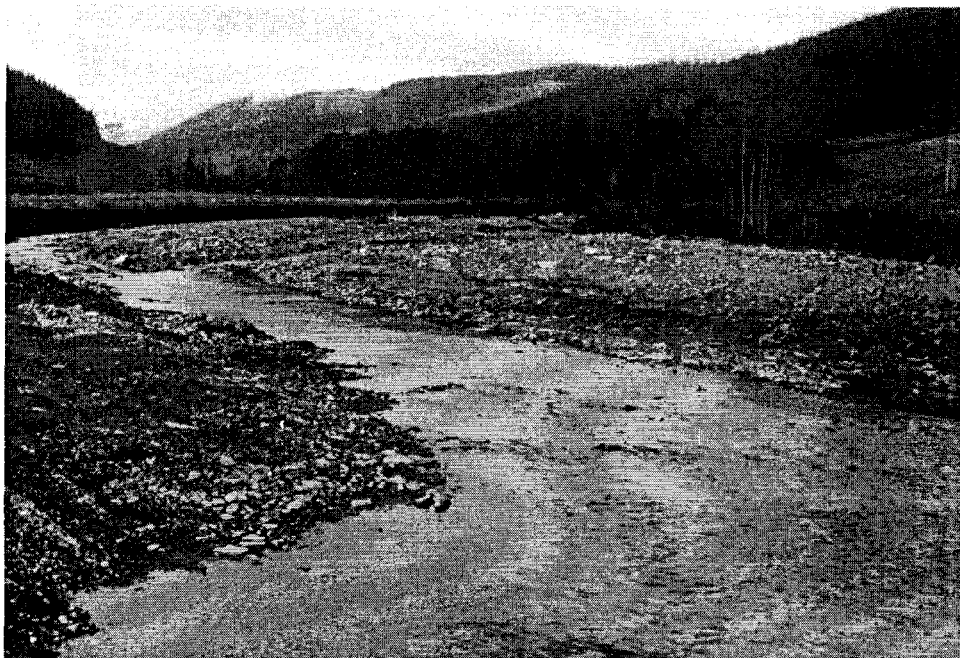
Photo 2. After stripping of fine grained floodplain deposits the reach of Opavice at Spálené with widened channel turned into a coarse-bedload stream and thus became convenient for river braiding

widened channel bed (Photo 2); the river recurred to its stage of braiding as it probably had been the situation there before 14th or 15th century. These are namely the times from which we have records on the end of panning-off for gold in the area with the formation of alluvial placers along the river course which prove the existence of coarse bedload streams still with no thick fine grain floodplain sediments. In the undercut bank wall of Opavice the alternation of coarse gravel layers with finer overbank deposits was well visible as evidence of preceding flood events.

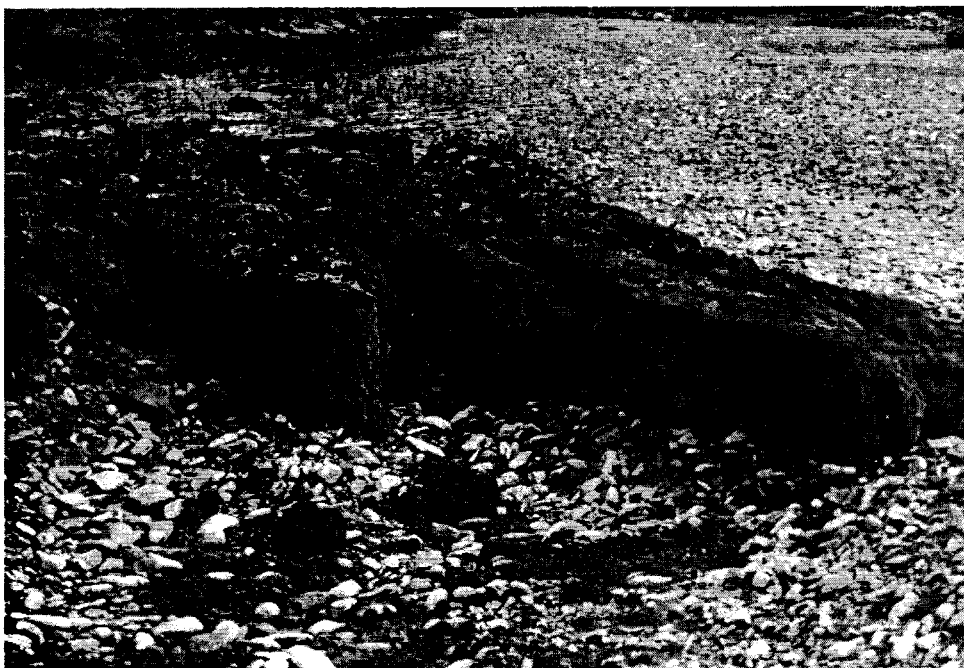
Photo 4. Stripping and erosion of the Morava floodplain below the junction of one arm of flood flow with a small torrent near Raškov. Scours separate margin of floodplain into the narrow blocks

dragged coarse gravel which filled them partly (Photo 4). The floodplain stripping and erosion was undoubtedly helped also by the pressure expansion of water in the hollows of rodent burrows. In the recession period of the flood the lowest places of the coarse gravel surface became covered by slack water transverse ripple marks of fine sand. Erosion of the floodplain has opened new space for sedimentation of fine grained slack water deposits.

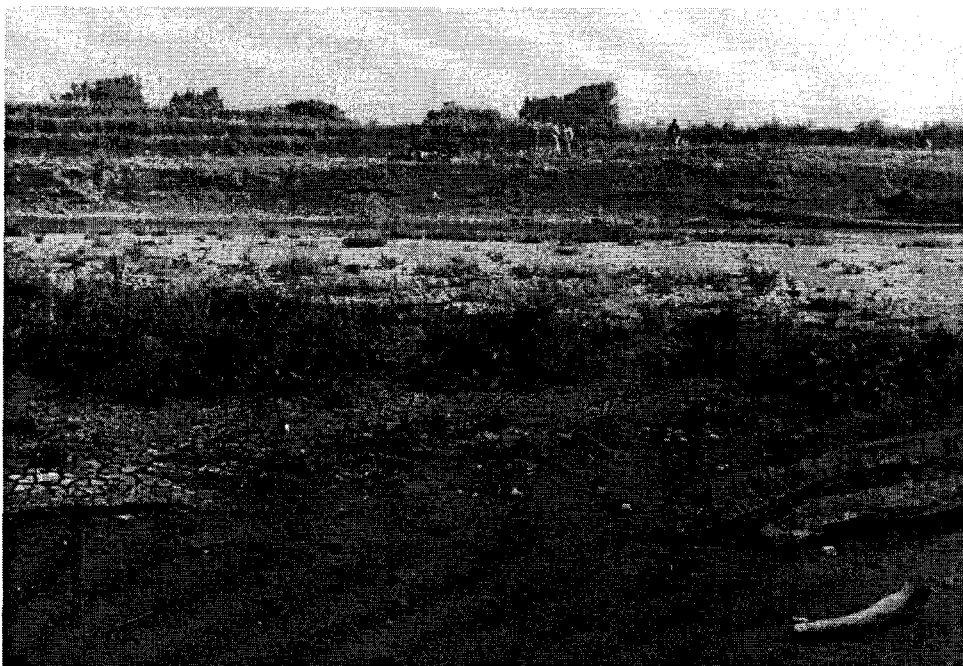
Photo 6. A composite two-stage channel of a lower meandering reach of Bečva at Osek nad Bečvou. In the foreground there are lower channel bedforms consisting of an abandoned channel with fossil logs, a lower mid-channel bar and a new active channel bounded by the left lower bank of cross-bedded gravels. In the background there is the upper channel with a mid bar separated by a dry channel from left the upper bank

Near Osek the widening formed a composite two-stage channel (Photo 6) consisting of the lower active and inactive channels and the upper widened channel limited by the upper bank. The left lower bank of the active channel uncovers cross-bedded channel gravels. The raised surface of the upper channel gravels forms a mid-channel bar at the edge between the lower active channel and the shallow depression of the upper channel. The widened upper channel is limited on the left side by the bank of the upper channel. It consists of slackwater flood silts.
