ADAM KOTARBA (KRAKÓW)

## GEOMORPHIC EFFECT OF THE CATASTROPHIC SUMMER FLOOD OF 1997 IN THE POLISH TATRA MOUNTAINS

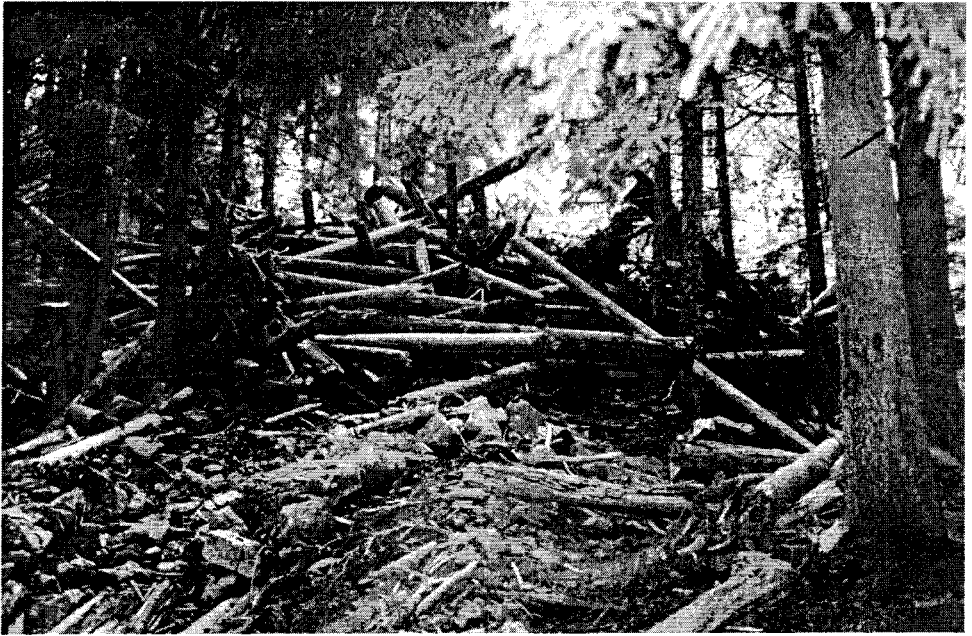
Photo 1. Frontal view to woody debris cone formed at the outlet of small V-shaped valley, Filipka Valley, Kopy Sołtysie Mt

bedrock. Here, rocky floors that have not been observed for many years in the middle-mountain forest belt of the Tatras, developed. The wood debris mixed with mineral debris, removed to the floors of the main valleys (Filipka, Złota and Olczyńska valleys), was deposited in the form of cones. In the cone composition predominated the fallen and transferred trees which in most often cases had the bark stripped off during transportation (Photo 2). In the Filipka Valley natural dams were formed across the main valley. That had slowed down the water outflow. High turbulence in the zone of the tree dams added up to erosional effect. That is evidenced by numerous erosional gullies and evorsion hollows being 1.5–2.0 m deep. The erosional power was as high as the roads reinforced with gravel became washed out and wooden bridges were either destroyed or covered with transported rubble (Photo 3 and 4).

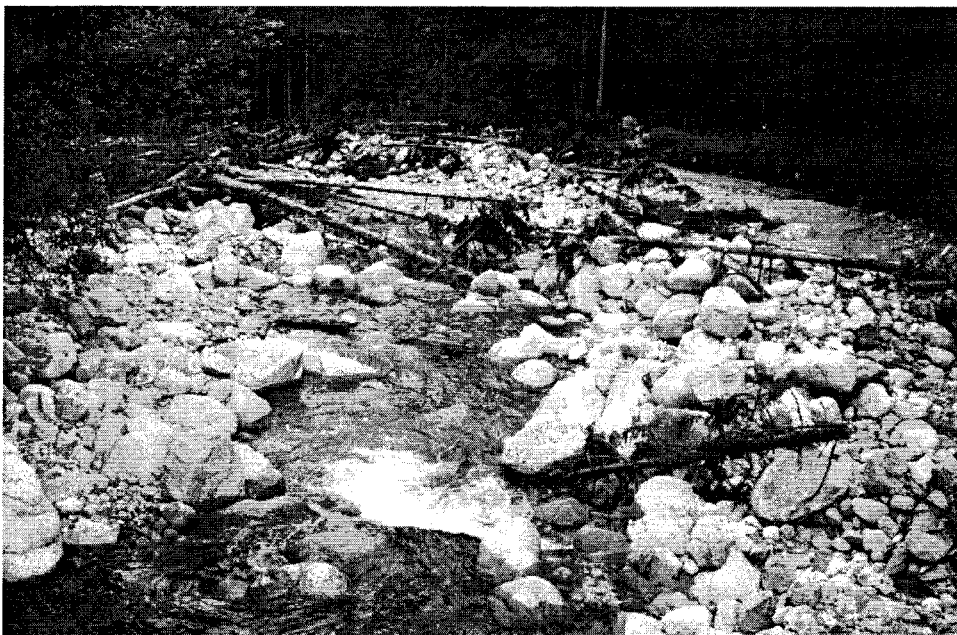
Photo 2. The Sucha Woda valley bottom after flood. Spruce tree trunks are bark-free due to transportation by flood water

The most devastating effects of the fluvial processes have been stated in the valleys of the middle-mountain forest belt of the Tatras, and especially in the Sucha Woda and Olczyńska Valleys (Fig. 4). In the Sucha Woda Valley, in the 2.5 km long reach, i.e. from the junction of the Sucha Woda and Pańszczycki Streams to the outlet from the Tatras, the main channel had been remodelled over its entire width. This re-modelling was associated with a rise of water level of the Sucha Woda Stream. During the flood, the water level rose by 2.5 m. That was inferred from tracks of the bark stripped off from the trunks and branches of the living trees that grew around the channels and that

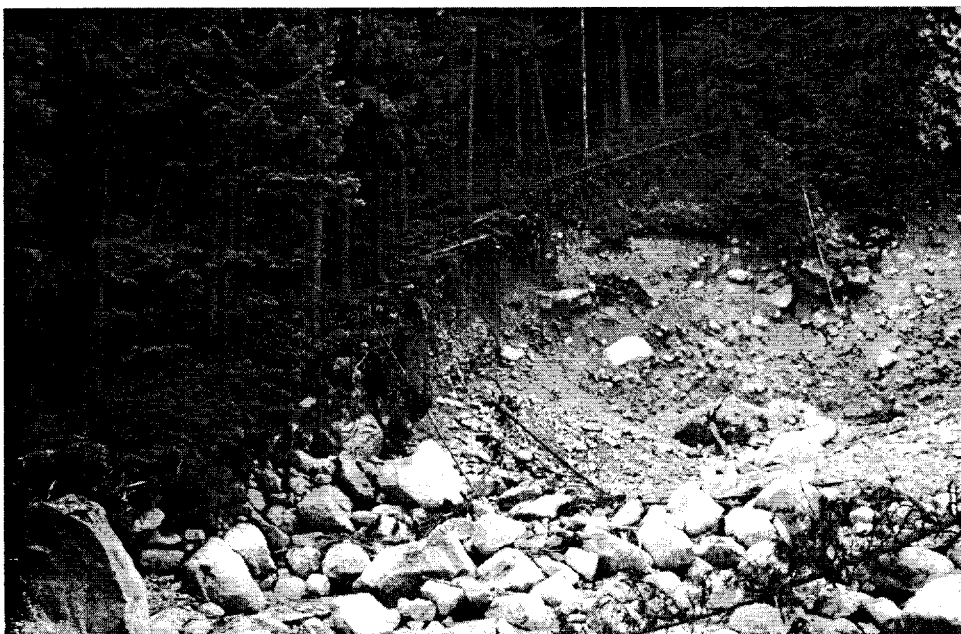
Photo 3. Streamside debris slides within glacial drift deposits of the Toporowe Stawy. Large organic and mineral supply to the main channel of the Sucha Woda valley

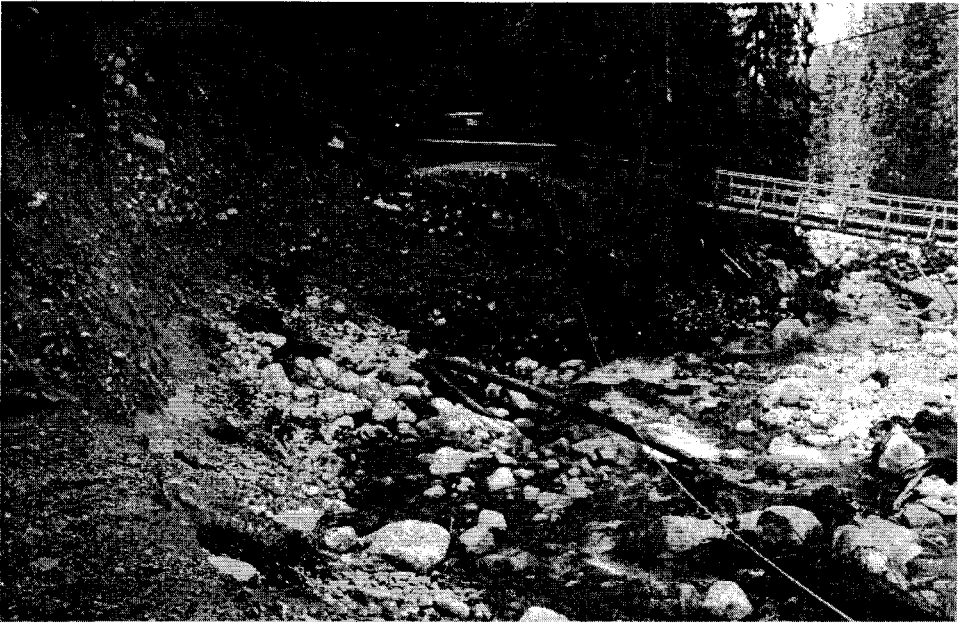
Photo 4. Erosion undercut 30 m long and 10 m wide within the main road from Brzeziny to Hala Gąsienicowa. The volume of eroded material is calculated to be around 1,200–1,400 cu. m
