RECENT LANDSLIDES AND TRIGGERING CLIMATIC CONDITIONS IN LASKOWA AND PLEŚNA REGIONS, POLISH CARPATHIANS

Abstract. Recently, intensified landsliding was observed in the Polish Flysch Carpathians. Landslides of 1997 and 2000 are examined using examples of Laskowa and Pleśna, two regions located in the middle and eastern part of the Flysch Carpathians yet in different geological settings (flysch complexes, loess-like deposits, Quaternary covers). It has been stated that in both the discussed regions weather conditions were the dominant triggering factors as the mass movements referred to various landslide types (subsequent, consequent, complex). Moreover, it has been evidenced that in year 2000 the factors conditioning the development of landslides were sequences of snowfalls followed by thawing, in opposite to year 1997 when the instrumental factor was an overlapping of the local storm downpours with continuous rainfall.

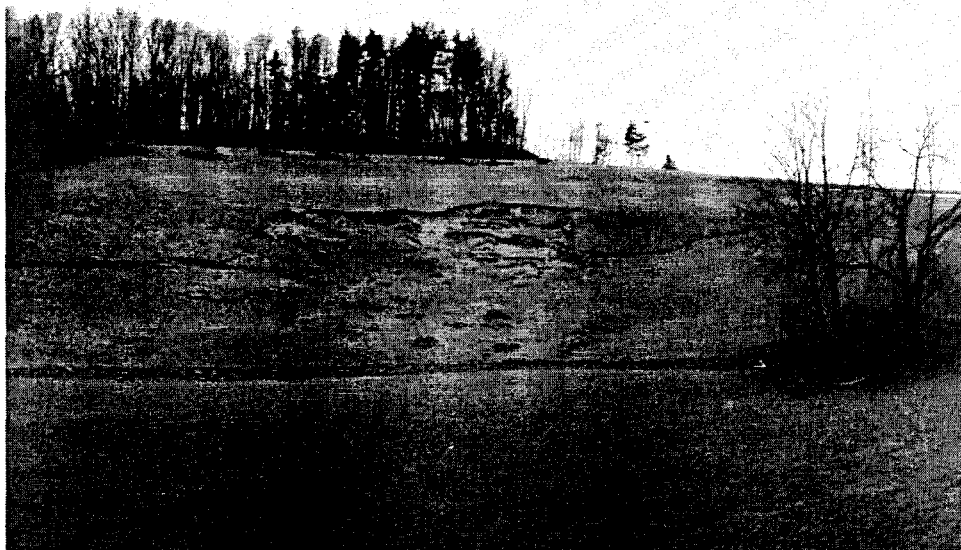
Photo 2. Scar and earthflow in the landslide niche on Jabłowiec hill (12 April 2000)

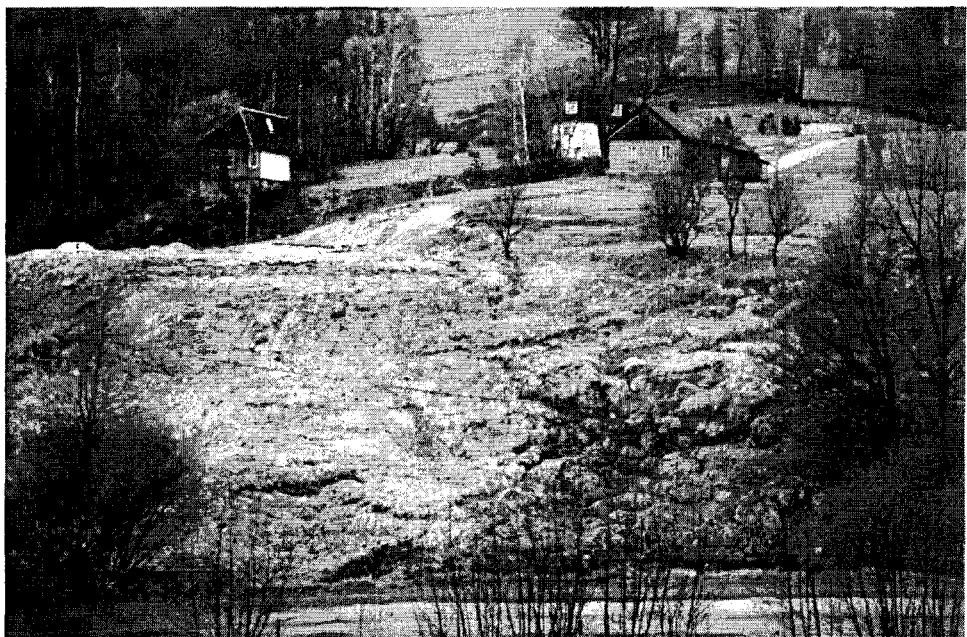
Photo 4. Lobes and cracks of the landslide on Olchawówka hill (12 April 2000)

Olchawówka landslide represents the form which was dormant in 1997 and active in spring of 2000 (Fig. 4A — site 2, asterisk). A newly developed niche has a 2 m high main scarp. The main body features numerous deep, transverse cracks and fissures (Fig. 6). The displaced material moved along several tracks, so at least two major toes can be distinguished: one stopped in the vicinity of the junction of Kamionka stream and its tiny tributary, the other just terminated at the right bank of the Olchawówka stream itself, almost above the exposure of variegated shales (Fig. 6, Photo 4).

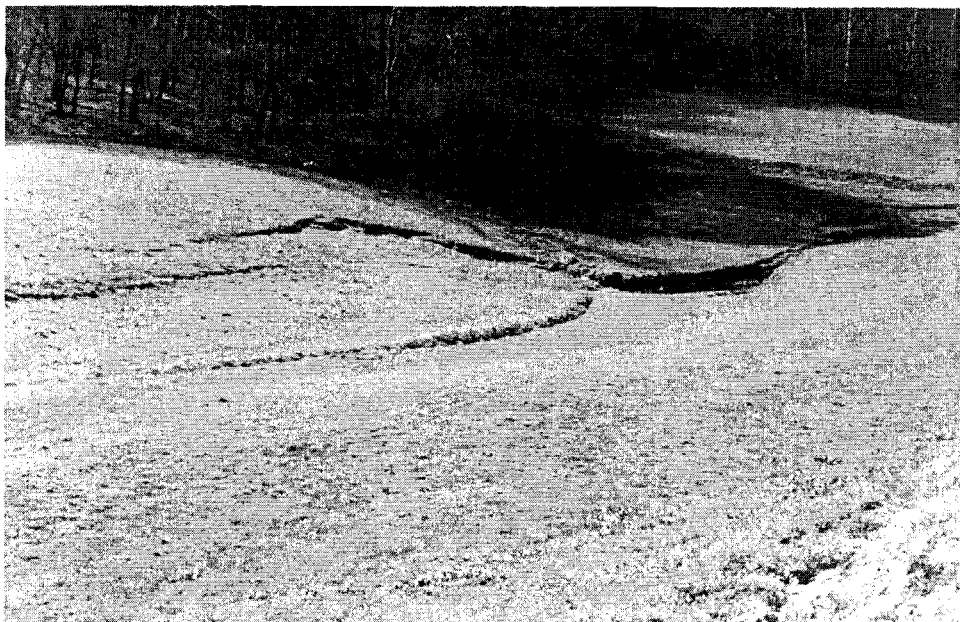
Photo 5. Niche and cracks outlining the landslide in the Sechna valley (12 April 2000)

Severe landsliding took place in the Sechna stream valley. Numerous, scars are observed on the hills sloping towards the both banks of the stream and bulging of the road Ujanowice–Dobrociesz is a typical, repeatable outcome of mass movements here (Fig. 4A — sites 4–7, asterisks). The landslide developed in the middle part of the valley on the south-east facing slopes

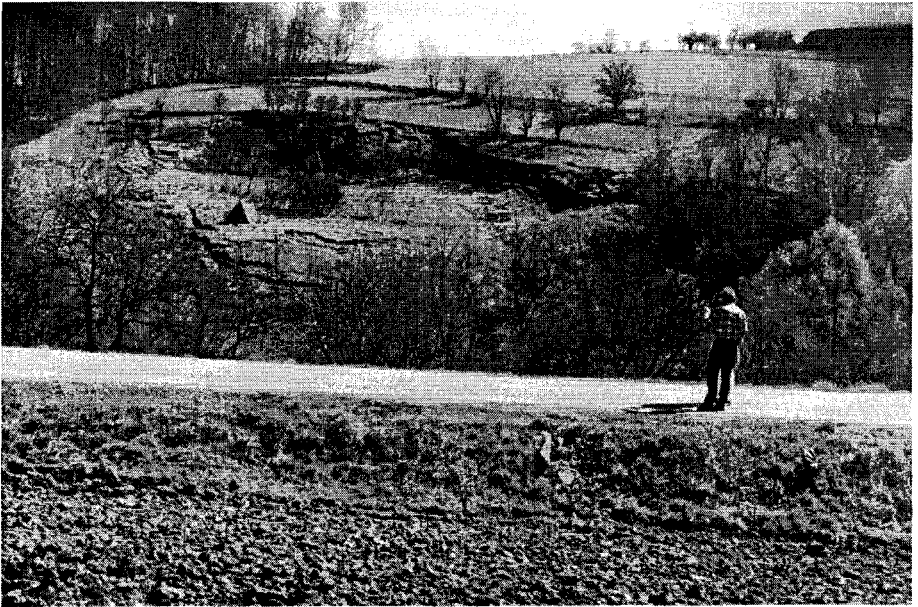
Photo 6. Landslide slope in Rychwałd, gmina Pleśna (17 April 2000)

the slope in Rychwałd with fresh landslide features which came into being just in April 2000. In opposite to the situation of 1997, in numerous cases new niches with steep scarps and displacements occurred both within the old niches as well as on the main bodies and toes of the landslides (e.g. in Łowczówek). It was especially the case of the forms developed where thick loess cover occur and is a good evidence of importance of passive factors.

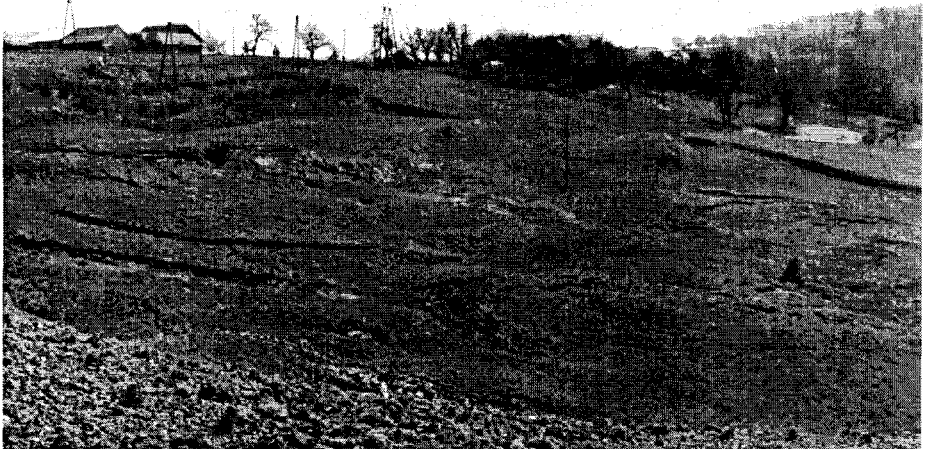
Photo 7. Landslide in Szczepanowice, gmina Pleśna (17 April 2000)

The landslide developed in Szczepanowice (Fig. 4B — site 8, asterisk) is another instance where geological settings and morphological conditioning were less important and subdued to the triggering meteorological causes. The present form of this landslide has developed in the response to weather conditions in the preceding months and the snow fall of April 2000. Huge slabs, not only of arable soil layer but also of underlying covers, slid or slumped about

80 cm down marking an arcuate outline at the head of this landslide. Secondary cracks and swamps (sometimes with water table at the ground surface) are other characteristic features of this landslide. Although activation of this form
