KAREL NATEK, BLAŽ KOMAC, MATIJA ZORN (LJUBLJANA)

## MASS MOVEMENTS IN THE JULIAN ALPS (SLOVENIA) IN THE AFTERMATH OF THE EASTER EARTHQUAKE ON APRIL 12, 1998

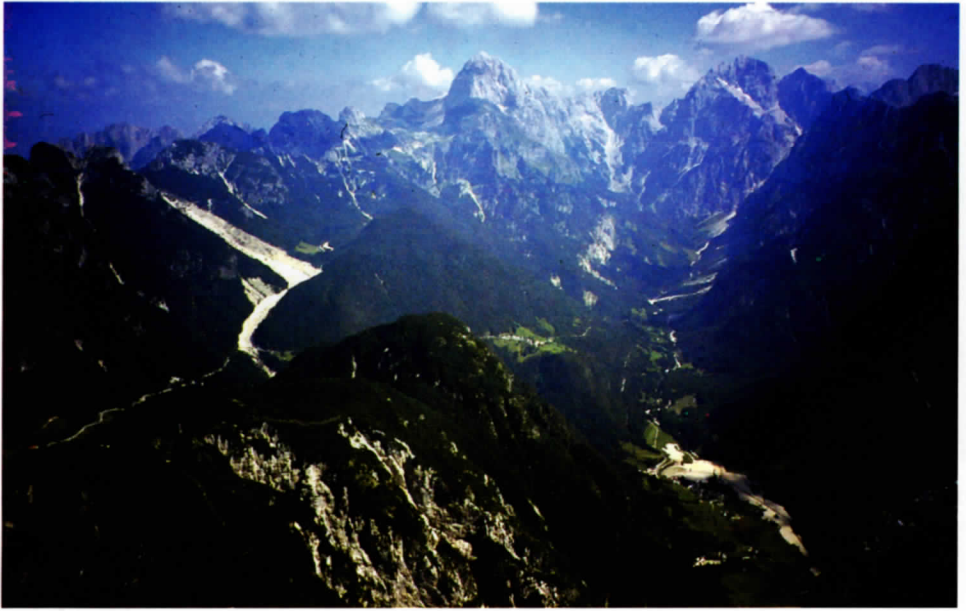
Photo 1. Debris flow above and in the Log pod Mangartom village. In the middle of the photograph is the peak of Veliki Mangart (2,679 m), to the left is the source area of the landslide of November 15, 2000. To the right below the mountain is the Koritnica River valley and the village of Log pod Mangartom with the fan deposited by November 17, 2000, debris flow (photo by Matija Zorn)

On November 15, 2000, a large landslide occurred on the Stovžje slope near the peak of Veliki Mangart (2,679 m), at the altitude of about 1,500 metres, almost 1,000 metres above the valley floor along the Koritnica River. Some hundreds of thousand cubic metres large mass at first settled in the Mangart stream valley. During the next day and a half, the region received an enormous amount of rain for, due to high temperatures, it was only snowing above 2,500 metres. Rain water and water from mountain brooks accumulated in the slided mass, which after 36 hours was completely saturated. In the night from November 16 to 17, the mass started to move as a debris flow, which roared successively down the Mangart, Predelica and Koritnica stream valleys and destroyed the mountain village of Log pod Mangartom. Seven people lost their lives, eight houses and eighteen non-residential buildings were destroyed or badly damaged. Next morning the local administration has evacuated the whole village and closed the access to the affected area. On the main road Bovec–Predel (border pass with Italy) two bridges were destroyed, too. The total damage on houses, roads and other infrastructure, and agricultural land was estimated at 14 million euro.

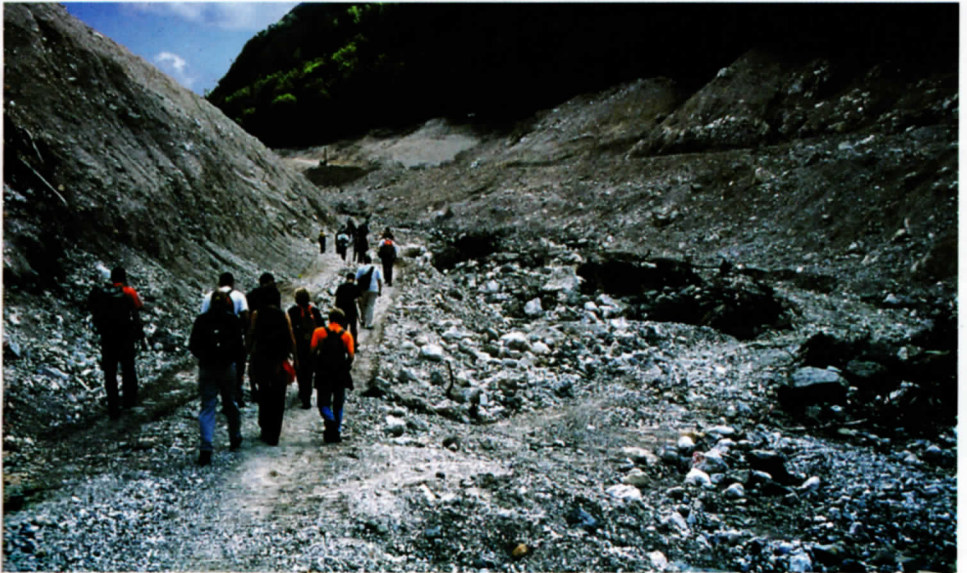
Photo 2. The path of the debris flow in the Mangart stream valley in the altitude of about 1,300 metres. On the right side of the photograph is seen how the landslide of November 15, 2000, affected the valley slopes for over 20 metres high. On the left side is the remaining part of the landslide which temporarily stopped in this place (photo by Karel Natek)
