VÍT VILÍMEK<sup>1</sup> (PRAHA), JAN KLIMES<sup>2</sup> (PRAHA), MARCO L. ZAPATA<sup>3</sup> (HUARÁS)

## GLACIAL LAKE OUTBURST FLOODS IN THE AREA OF HUARÁS, CORDILLERA BLANCA, PERU

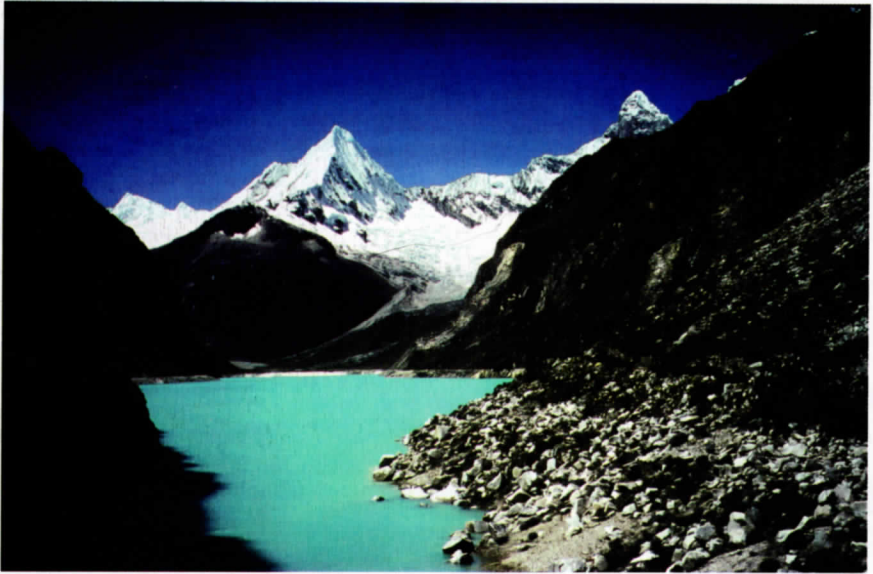
Photo 1. Lake Paron dammed by lateral moraine of glacier descending from Huandoy which includes blocks of ice. Its melting is serious danger for loosening strength of the moraine and sudden outburst of the lake is probable. This was the reason for lowering of the lake water (visible on the photo)

lakes were subject of intense scientific research focused on acquiring information about character and intensity of present geomorphologic processes not just in the Peruvian Andes (Zapata 2002; Rodbell and Seltzer 1999), but also elsewhere (Cenderelli and Wohl 2001; Richardson and Reynolds 2000). In the past, special attention was paid to lakes, which might represent a direct risk for the population settled down stream from them. Many remedial engineering works were performed to mitigate related hazards, e.g. the lowering of water level in the lake Paron by artificial gallery excavated in lateral rock wall (Photo 1).

Evaluating all criteria for potential hazard of glacial lakes with possible impact on the regional capital Huarás clearly show, that the overall hazard is rather low. Despite of that it is very important to continue monitoring of the lakes dam stability conditions and the effects of the rapid deglaciation (Mark 2002; Vilímek et al., 2005) also because of continuing increase of vulnerability of the Huarás city. The most dangerous glacier lake type is moraine-dammed lake with narrow, steep dam containing stagnant glacier ice (Photo 1).

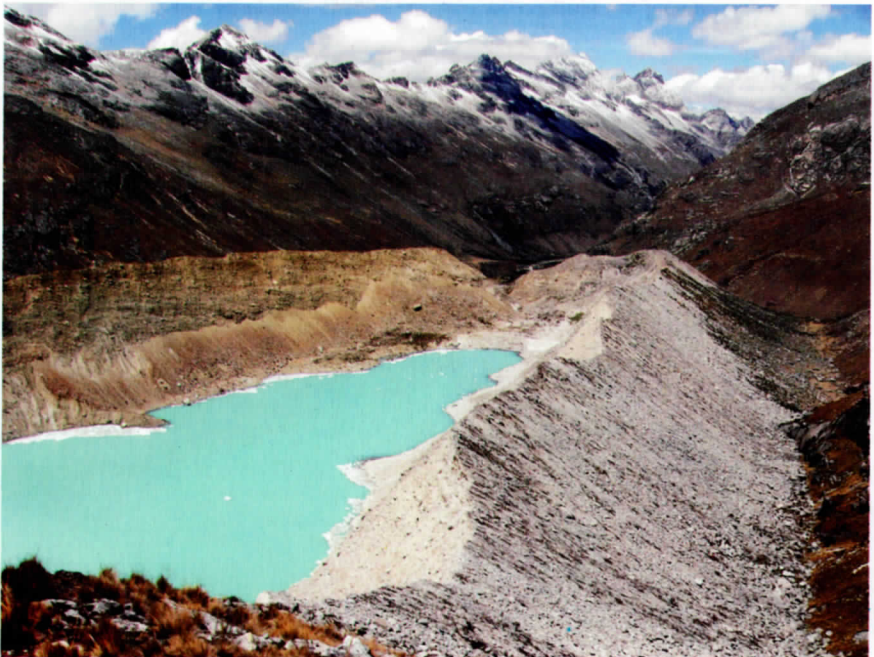
Photo 2. The water level in Palcacocha Lake dropped down significantly after the outburst in 1941. The outcoming water destroyed another lake (down in the valley) and large part of the city Huarás (Photo by Z. Patzelt)

General description of hazardous processes in the Cordillera Blanca were presented in the past by J. M. Reynolds (1989) or V. Vilímek (1995). The Palcacocha Lake outburst in December 1941 was, together with the 1970 earthquake, most serious catastrophe for the city of Huarás and its inhabitants (Photo 2). Recent studies were oriented on the dam stability of the Palcacocha Lake (Zapata et al. 2003; Vilímek et al., 2005). To evaluate potential hazard for the city of Huarás, imposed by glacial lakes, detailed field studies of two lakes with the largest volume of stored water were conducted during 2003 and 2004.

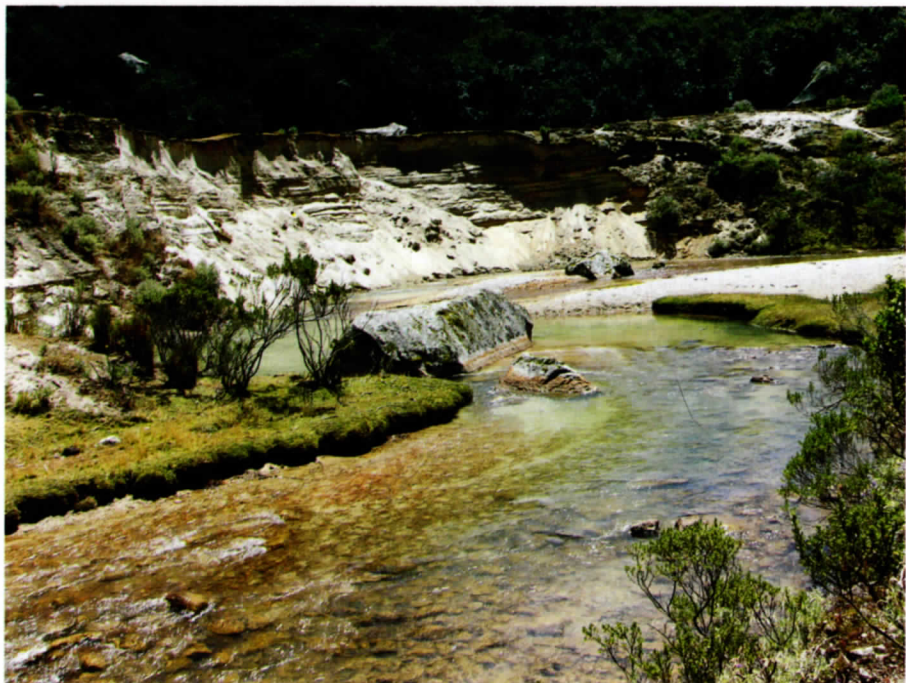
Photo 3. Lake sediments of an old lake in the middle part of Cojup valley which dam was broken during the Palcacocha outburst in 1941 (Photo by Z. Patzelt)

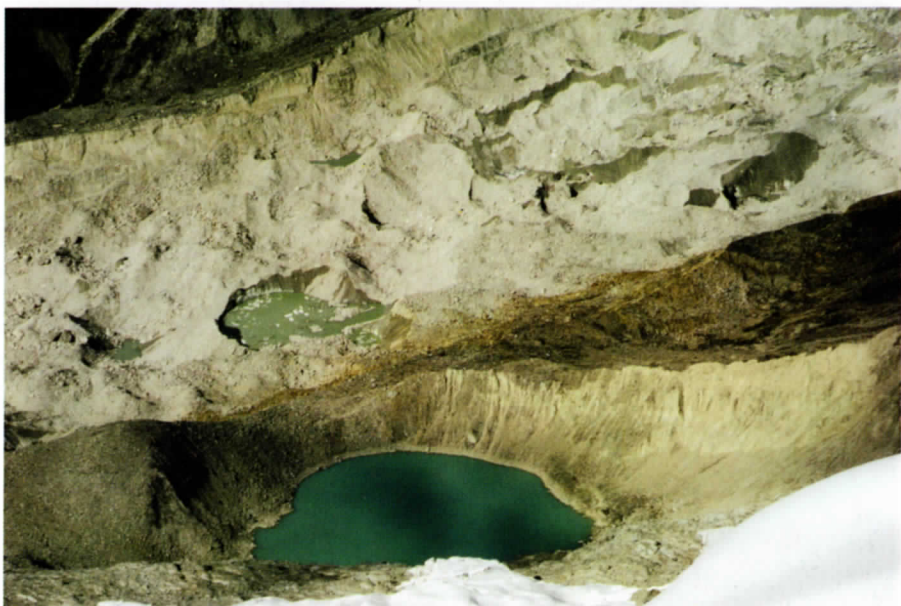
Photo 4. Small lakes which evolved in the depressions after the blocks of dead ice melted. Another, larger lake is sitting behind the moraine belonging to glacier descending from Pisco Mt. (Photo by V. Vilfimek)
