MONIQUE FORT (PARIS)

## REPEAT PHOTOGRAPHY: A USEFUL TOOL FOR UNDERSTANDING SHORT-TERM GEOMORPHOLOGICAL DYNAMICS IN NEPAL HIMALAYAS

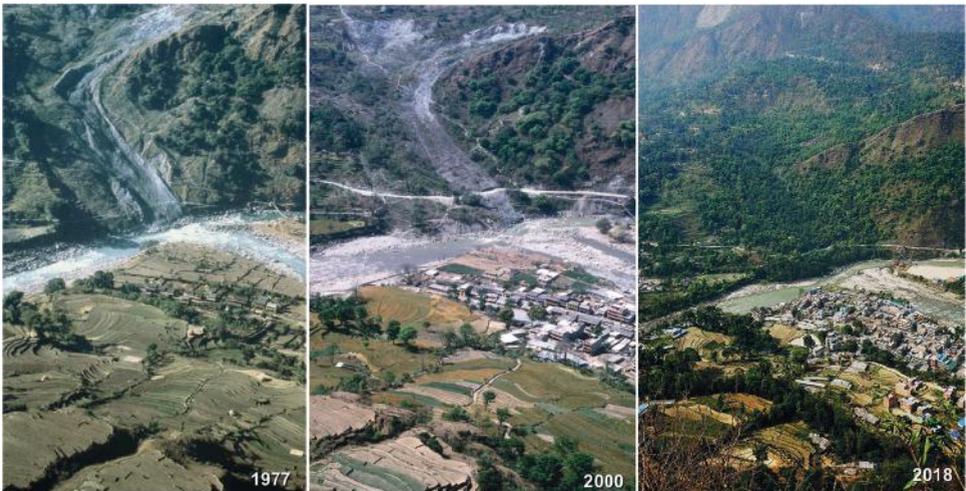
Fig. 3. The slope opposite to Beni, on the right bank of the KG river, immediately downstream of the Mayangdi Khola junction. (photo M. Fort). A: In 1977, the 1973 earthflow is still very prominent, with relics of former, larger events, as evidenced by longitudinal levees on both sides of the earthflow tongue; B: In 2000, the head scarp of the earthflow is still active, and expands laterally. The lower part is less active, allowing the vegetation to progressively regrow on both sides. Note the new rural road across the earthflow toe and, the progressive urbanization of Beni Bazaar on the opposite side; C: In 2018, the earthflow seems stabilized, as attested by the dense forest cover

The old photograph of the southern hillslope facing Beni (Fig. 3A) shows that the confluence area is potentially a dangerous area, because of its instability, favored by the presence of green, chloritic phyllites of the Lesser Himalaya. In 1973, in response to a heavy rainfall event, a large earthflow moved down to the river and nearly dammed the junction between the two rivers. Four years later, the earth-flow track is still very outstanding. 27 years later (Fig. 3B), the top of the slope is still very active, with even a renewed instability towards the south (left), materialized by head scarps caused by rotational slides. The situation has improved at the lower part of the slope, as evidenced by partial regrowth of vegetation, which no doubt reassured the populations who built a rural road at the foot of this slope, without thinking of potential adverse effects. This hillslope is crossed by a foot trail much frequented by young people whose school is located at the top.

In 2018 (Fig. 3C) the situation is somewhat different. The hillslope is now hidden by an abundant forest (*Alnus Nep.*) whose natural regrowth has been encouraged by the local authorities who have “defended” this area. But the tilting of the trunks shows that this slope can be reactivated at any time, during heavy rains. Moreover, with the opening of the new road (left bank of KG), the situation has become crucial: south and north of Beni, travelers report

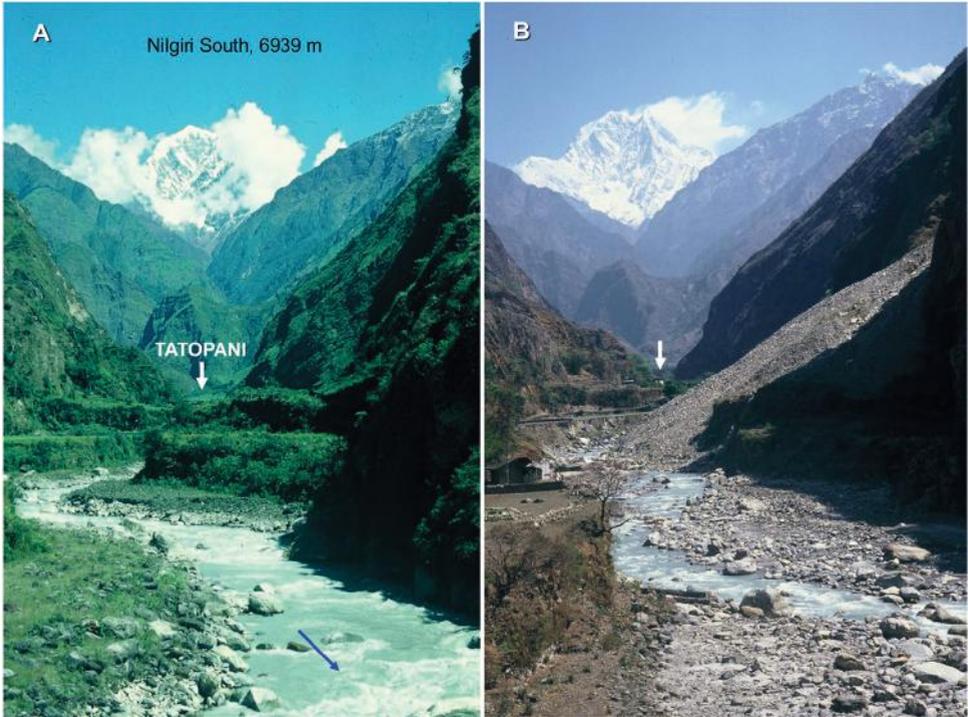
Fig. 5. More than 40 years of morphological change of the Kali Gandaki valley, downstream from Tatopani village. (All photos were taken from the suspended bridge across the KG, one kilometer south of the village; photo M. Fort). A: The Tatopani village is set on the right bank of the KG, upon Holocene alluvial terraces well developed and visible on both sides of the river (photo: October 1977); B: On 23 August 1988, a first collapse of the left bank partly buried the terraces, causing the shifting of the river on its opposite, right bank (photo: fall 1990); C: On 28 Sept. 1998, a large landslide mass caused the damming of the KG; after breaching, a mass of debris was carried downstream, widening the active river bed (photo: spring 1999); D: In December 2007, the 1998 landslide mass appears as partly revegetated, yet its toe is still under erosion by the KG. 2007 also corresponds to the final completion of the construction of the road, which appears as a new asset in threat. E: In October 2016, the landslide toe is nearly stabilized, except downstream where a gully is still active during the monsoon season. F: No significant change 18 months later (April 2018): most of the river bed morphology remained also quite the same after the 2018 monsoon, despite a higher discharge episode in August 2018 (see Figs 6C and 8F)

A first failure developed on August 22, 1988, as a large debris cone that partly buried the left bank terraces of the KG and caused river diversion on its right bank (Fig. 5B). On September 1998, at the end of a long and abundant rainy monsoon season (1172.5 mm during the three months that preceded the event) (Sikrikar, Piya 1998), a dramatic landslide occurred at 7:00 pm, as a rock wedge in the upper slope, evolving into a rock avalanche downslope. One hour later, the collapse was still in progress, releasing in the atmosphere a dust cloud of crushed rocks whilst in the valley bottom the debris piled up (estimated volume=  $1.5 \cdot 10^6 \text{ m}^3$ ; M. Fort et al. 2010) and impounded the river flow (Fig. 5C and Fig. 6A). A lake formed (photo in M. Fort 2014). At 4 p.m., the lake drained out naturally, and released both coarse and fine solid discharge. However, the drainage was not complete, and a shallower (5–3 m deep), smaller ( $90,000\text{--}60,000 \text{ m}^3$ ) lake persisted 9 months more until the next monsoon high flows restored a continuous flow of the KG River (Fort et al. 2010; Fort 2014). In fact, if the collapse did not cause human losses, the consequences on river dynamics were important. More specifically, the landslide mass caused the diversion of the KG river course along its right bank, hence favoring bank undermining and triggering of shallow landslides.

Ten years after the 1998 event (Fig. 5D), these shallow, retrogressive landslides are rapidly expanding upslope (colluvial material) and have become a direct threat to the stability of the under-construction road (2007) built 20 m above the river bottom (Fort et al. 2010). On the opposite left bank, the stabilization of the landslide hillslope is increasing, as evidenced by the progressive regrowth of an *Alnus Nepalensis* groove, a species adapted to instable, wet soils. In October 2016, the new road is operational, still it is locally threatened by small debris slides that may cause traffic interruption for a few hours or days, whereas the left bank hillslope is nearly entirely revegetated (Fig. 6B), except for a small ravine outlet which remains locally active (Fig. 5E). Two years later, in spring time (April 2018), the KG does not display many changes compared to 2016, yet the abrupt rainfall events which affected the areas 20 km upstream from Tatopani created a flood wave which propagated downstream (Bell et al. 2021) and was efficient in eroding again the loose landslide material, as observed in November 2018 (Fig. 6C).

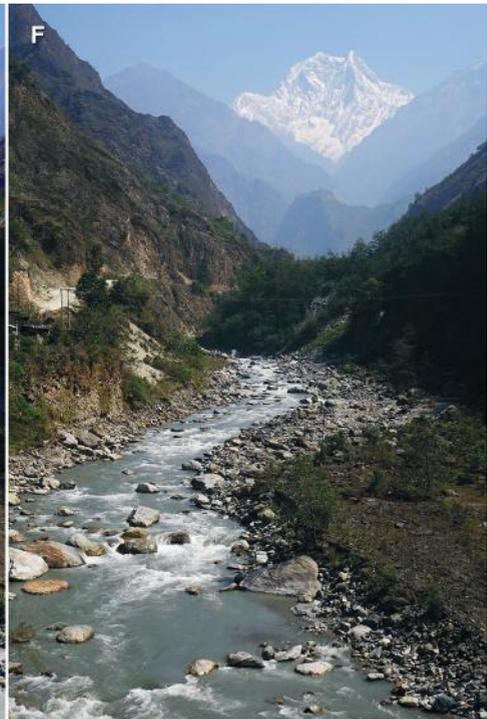
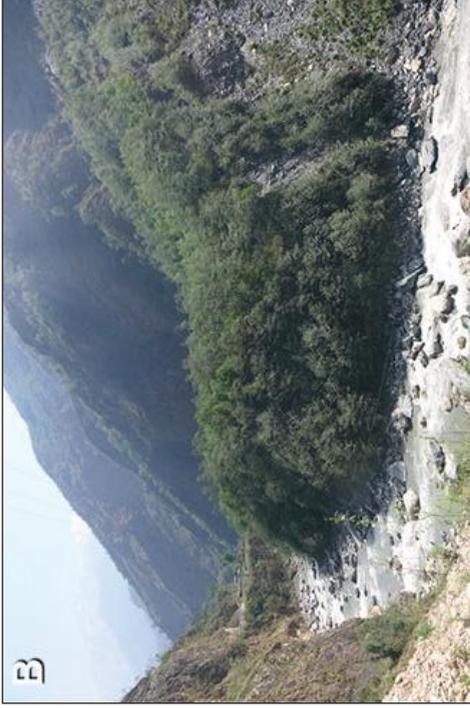
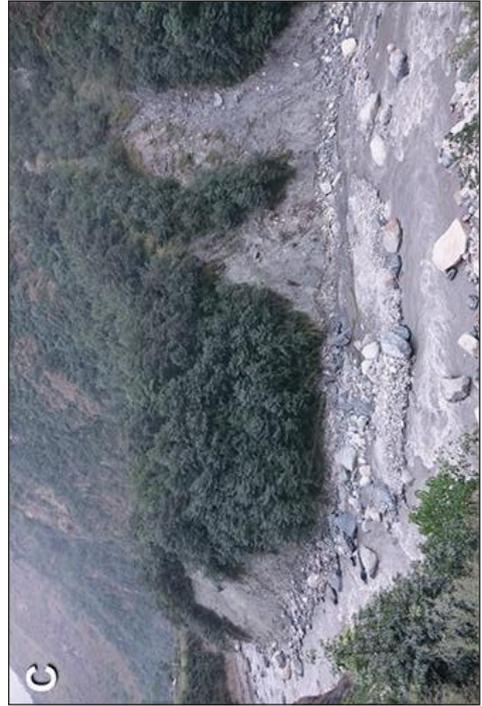
Fig. 6. Tatopani landslide toe and its impacts, viewed from the road, downstream from Tatopani village. The narrow section of the KG valley, locally controlled by quartzitic outcrops, favored the valley damming by the landslide in 1998 and is still influencing the river response to exceptional discharge events. (photo M. Fort). A: In December 2000, the KG river bed morphology clearly displays the impacts of the 1998 landslide dam after the complete draining of the residual lake in June 1999. The relicts of this lake are still visible, with white sands and gravels upstream from the former landslide dam; B: In April 2018, the 1998 landslide toe is nearly totally revegetated; C: In November 2018, after an intense monsoon season characterized by two exceptional rainfall events, the higher KG flows severely eroded the 1998 landslide toe again, hence illustrating an ongoing hillslope-channel coupling process

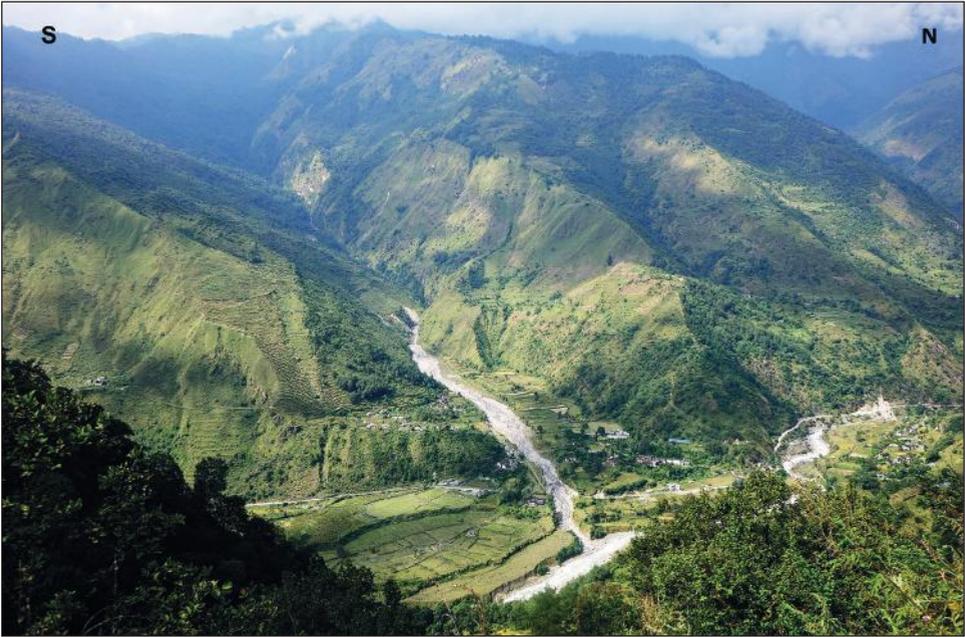
Fig. 7. The Ghatte khola (GK) catchment at Dana (1,450 m a.s.l.), viewed from the opposite Garpar ridge (1,800 m a.s.l.). The KG river flows from right to left. Note the contrast between the dip slope to the south (left), facing the counter-dip, steep slope to the north (right). The width of the torrential stream bed, without any vegetation, is clear evidence for repeated hyper-concentrated flows events. The size of the GK's fan reflects the abundance of sediments brought by this torrent over the decades and, explains the position of the river bed of the KG, pushed back on its left bank. (November 2016) (photo M. Fort)

tributary of the right bank of the KG (Fig. 7). This Ghatte Khola catchment is typically a “landslide catchment” (*sensu* Starkel 1972, 1976), characterized by pulsating, short debris-flows or hyper-concentrated-flows events initiated by landslide outburst floods (LOFs), as witnessed during our very first visit in Nepal in 1974 (Fort 1974, 2014). The pronounced asymmetry of this east-west elongated basin (upper ridges at 3,420 m a.s.l., confluence with the KG River at 1,400 m a.s.l.) is due to the northward general dip of the Himalayan structures, with sharp contrasts in lithology (the Main Central Thrust controls the catchment orientation; Fig. 1). The gentler, north oriented dip slope (micaschists), covered with a widespread mantle of landslide-derived debris is facing the steep, south-exposed counter-dip slope (quartzites and gneisses) affected by rockfall processes. In most parts of the catchment the stream actively cuts into the bedrock. During heavy cloudbursts, active landslide masses from the south slope may clog the river flow, where the channel bed is at

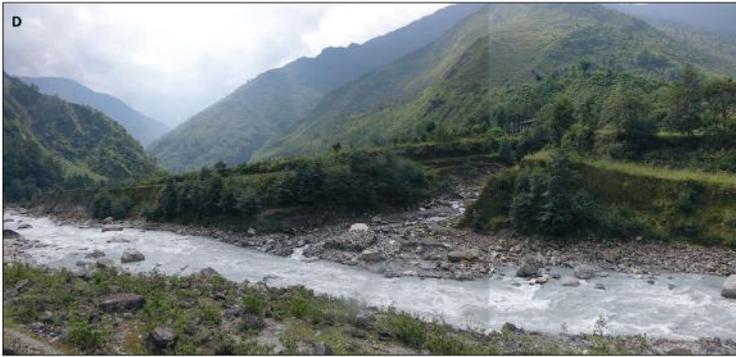
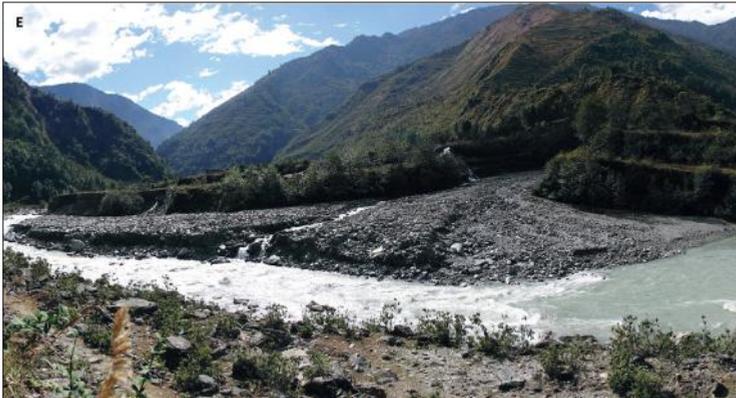
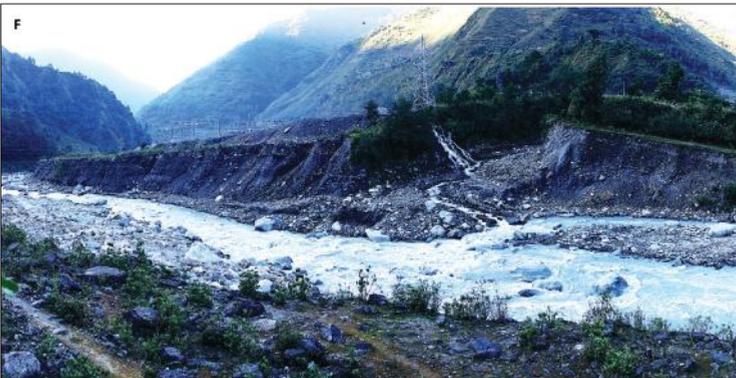
Fig. 8. 2010–2018 sequence of photos showing the rapid changes at the junction (1,412 m a.s.l.) between the KG river (foreground) and the GK. The repeated photos have been taken from the opposite bank, at the playing ground of the school of Garpar (1,420 m a.s.l.), (photo M. Fort). A: April 2010. The GK fan displays a rather complex morphology, with several small cut-and-filled fans into the main, higher fan, upon which the houses (police station) are built; B: April 2014. Note that if there is some refreshment of the lower fan scarp, the larger boulders observed along the GK channel close to the KG river bed have not been removed; C: April 2016. The GK activity has been significant: a large amount of debris has built the present active fan, whereas the lower Ghatte fan (left) is nearly totally eroded; D: November 2016. A few months later, after the rainy monsoon season, most of the fine sediments were washed away. A few large boulders remain on the surface; the white one, a few meters from the confluence, was

buried in April 2016, whereas it was already in place in 2010 (A) and 2014 (B); E: In November 2017, a vast debris fan more than one meter thick was built by the massive inflow from the GK, impeding the flow of the KG, as suggested by the relatively calm waters of the river upstream. The downstream extension of the fan is attributable to the powerful current of the KG river that redistributed the coarser debris; F: In late October 2018, the situation is completely different. The confluence has become “ordinary”, with a small torrential river joining a major axis, the KG, which caused much destruction during the previous monsoon. The fan visible in 2017 has completely disappeared as well as part of the perched fan that towered it, whose banks have also been eroded. Note the new electricity pylon and the top backfilling of the original cone, in conjunction with the construction of a transformer field (in the background), and the diversion of the canalized waters formerly used to irrigate the fields on the main upper cone, before the transformers

The series of photos taken during the last decade provide good evidence of the very dynamic functioning of this watershed. In April 2010 (Fig. 8A), like in April 2014 (Fig. 8B), a relatively common situation can be observed at the outlet of this torrential river which, each summer, is depositing abundant sediments composed of fine and coarse elements, transported for the most part from the upstream part of the watershed, with additional boulders (gneisses) that have been dislodged by the torrent from the downstream banks of the fan (KG alluvium, overtopped by Ghatte khola debris). Nevertheless, this sediments heterogeneity bears evidence of the power of the flows reinforced by an increase in their density due to the presence of fines (schistose elements). These hyper-concentrated flows are triggered by irregular stormy episodes occurring upstream of the catchment area at the beginning (Fig. 8C), or at the end of spring, as in 1974. In autumn, a few weeks after the end of the monsoon, it is very often observed that most of the debris fan's inflow has been cleaned off by the abundant but regular monsoon rains as well as by the high waters of the KG (Fig. 8D).

Nevertheless, during some specific episodes of intense rainfall during the monsoon, the aggradation can be exceptionally voluminous ( $5,000 \text{ m}^3 \pm 1,000$ ), as was the case in August 2017 (Fig. 8E) according to the inhabitants we interviewed. But the most unprecedented situation was observed in autumn 2018, after a monsoon that was marked by a few episodes of exceptional rainfall that caused a wave of erosion along the KG valley that propagated from the south of Mustang to Dana, as shown in Fig. 8F. The previously deposited fan was completely stripped off, and the edge of the upper cone was also eroded, the whole representing a volume of  $8,500 \text{ m}^3 \pm 1,000$  (Bell et al. 2021).

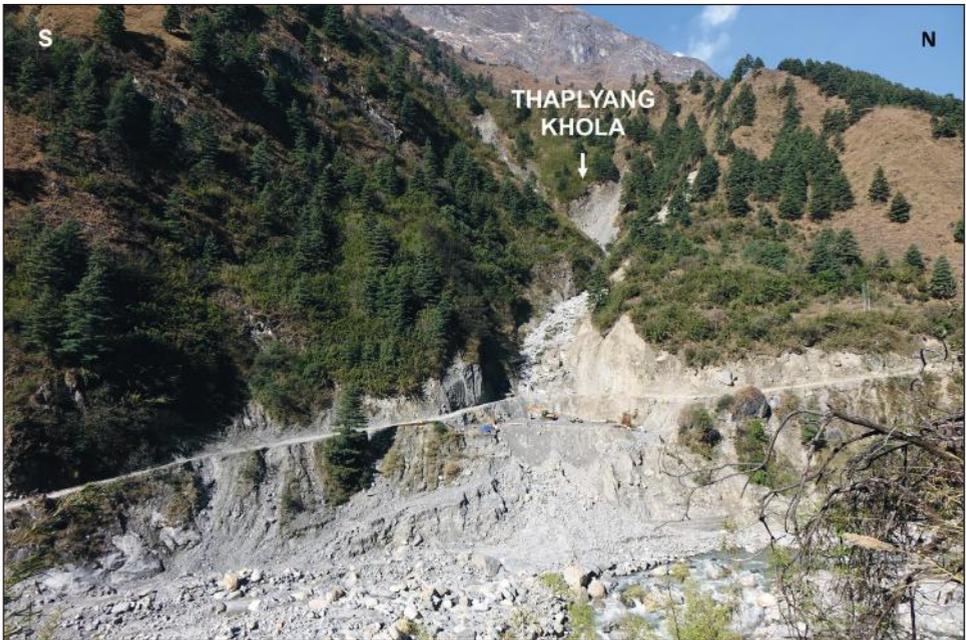
Fig. 9. Geomorphological context of the Thaplyang catchment (lower section), seen from the left bank of the KG (December 2019). The right bank of the ravine (left) is made up of gneiss from the Higher Himalayas (NNE 50°–60° dip). The left bank, strongly eroded, consists of landslide material (age unknown). Under the road (“Kali Gandaki Corridor”), perched some 40 meters above the river bed, one can identify the remains of the ancient debris cone that formed in 2014 (see Fig. 11A). Not initially planned, the construction of a passageway to safely cross the ravine became necessary. But the chosen solution – a bridge – poses technical problems because the anchoring of the piers to the north, where the landslide material outcrops, is far from being solved. (photo M. Fort)

Thaplyang is our northernmost site along the KG river. Located south of Ghasa, this W–E oriented catchment (3.6 km<sup>2</sup>) is a very steep, right bank tributary developed at the contact between a north dipping, gneissic hillslope (NNE 50°–60°) and a large prehistoric (yet undated) rockslide outcropping along the northern hillslope (Fig. 9). Until recently, there was no mention of this particular site, but during the monsoon 2014, a large collapse affected the rockslide material in the lower catchment and blocked the road (1,915 m a.s.l.). Debris were transported downstream to the KG bed (1,865 m a.s.l.) and deposited as a large fan, that nearly dammed the valley.

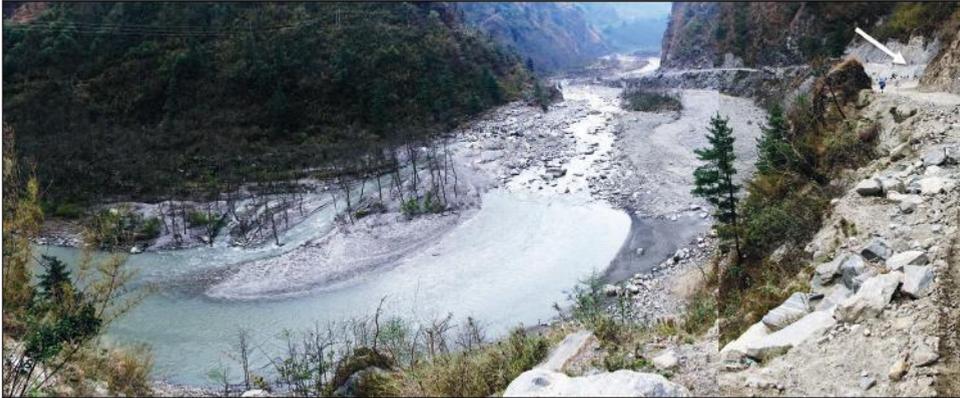
Fig. 10. KG Valley, downstream view from the road (November 2016). On the left (upstream), the river is subdivided into several channels, which have invaded the ripisylve, as evidenced by the dead trees and pebble accumulations that lie across it. This evolution is linked to the partial dam formed by the debris cone originating from the Thaplyang ravine (not visible, right, see the white arrow), which caused the water to rise and slow down upstream. Downstream of this area, debris inflow from the Thaplyang khola obstructed the former channel of the KG (right bank, rocky hillslope), whose waters were diverted to the left bank. (photo M. Fort)

The physiognomy of the KG valley has been completely modified (Fig. 10). Upstream of the cone from the Thaplyang valley, the KG River flow was

blocked for a few hours, a period of time sufficient to submerge the forest of the valley bottom and favor the deposition of finer sediments transported in suspension. On the other hand, at the cone section and downstream, it is the abundance of boulders that predominates in the riverbed. Similarly, the active channel of the KG has been abandoned as the river was diverted on its left bank by the Thaplyang debris (Figs 10, 11A, 12A). But in 2018, the river returned to its former channel, following heavy monsoon flows that allowed it to carry away most of the materials stored within the cone of the Thaplyang khola (Figs 11B, 12B).

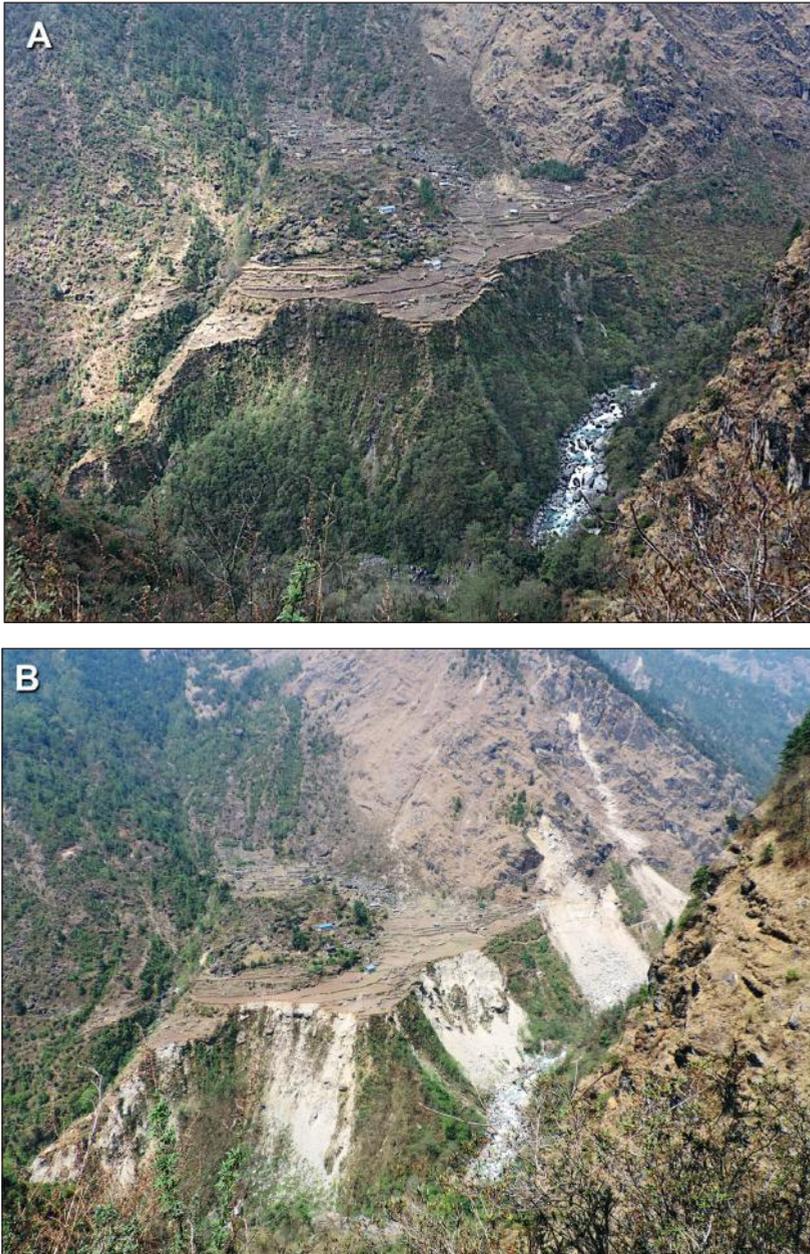
Fig. 13. The site of Nakchung, as observed south of Lukla, from the trail to Surkhe (photo M. Fort). A: March 2015, before the Gorkha earthquake. The village is settled on a terrace of the Dudh Koshi, partly covered by a massive rockfall cone. The edges of the terrace are vegetated and rather sharp; B: October 2015, after the Gorkha earthquake. The terrace edges were affected by thin collapses, revealing a rockslide material overtopped by the Dudh Koshi river gravels. Upstream from the village, rockfalls developed from a paragneissic ridge ( $35\text{--}40^\circ\text{N}$  dip), along the  $50^\circ$  steep slope above the Dudh Koshi

The Nakchung village (2,225 m a.s.l., site 5) is settled on a right bank terrace of the DK river, opposite to the Lukla airport. This cultivated terrace (+ 60–65 m) is bounded by sharp, vegetated banks and displays irregular contours (Fig. 13A). During the earthquake sequence, the Nakchung site was affected by two types of landslides: rockfalls and debris slides (Fig. 13B). According to the villagers, the slopes were first destabilized during the April 25 earthquake, but the major collapses occurred after the May 12, main aftershock (Fort et al. 2019). North of the village, two rockfalls developed along the 50° steep slope overlooking the DK: the rockfall tracks (350 m long for the northernmost one) suggest that most of the blocks run across the slope down to the river. In addition, several debris slides affected the edges of Nakchung terrace, hence revealed a loose, alluvial material superposed on old rockslide deposits probably part of the Lukla rockslide (Goetz et al. 2015). Interestingly, these new debris slides collapsed mostly at the same sites as those previously affected by bank erosion generated by the 1985 DigTsho Glacial Lake Outburst Flood event, which took place more than 30 km upstream (Vuichard, Zimmermann 1987).
