This paper is not only meant to be a final report, supplemented by a number of maps and a photo album made in the course of various on-site visits, but its aim is to show the gradual stabilization of this large landslide valley during last 20 years.

THE ENVIRONMENT

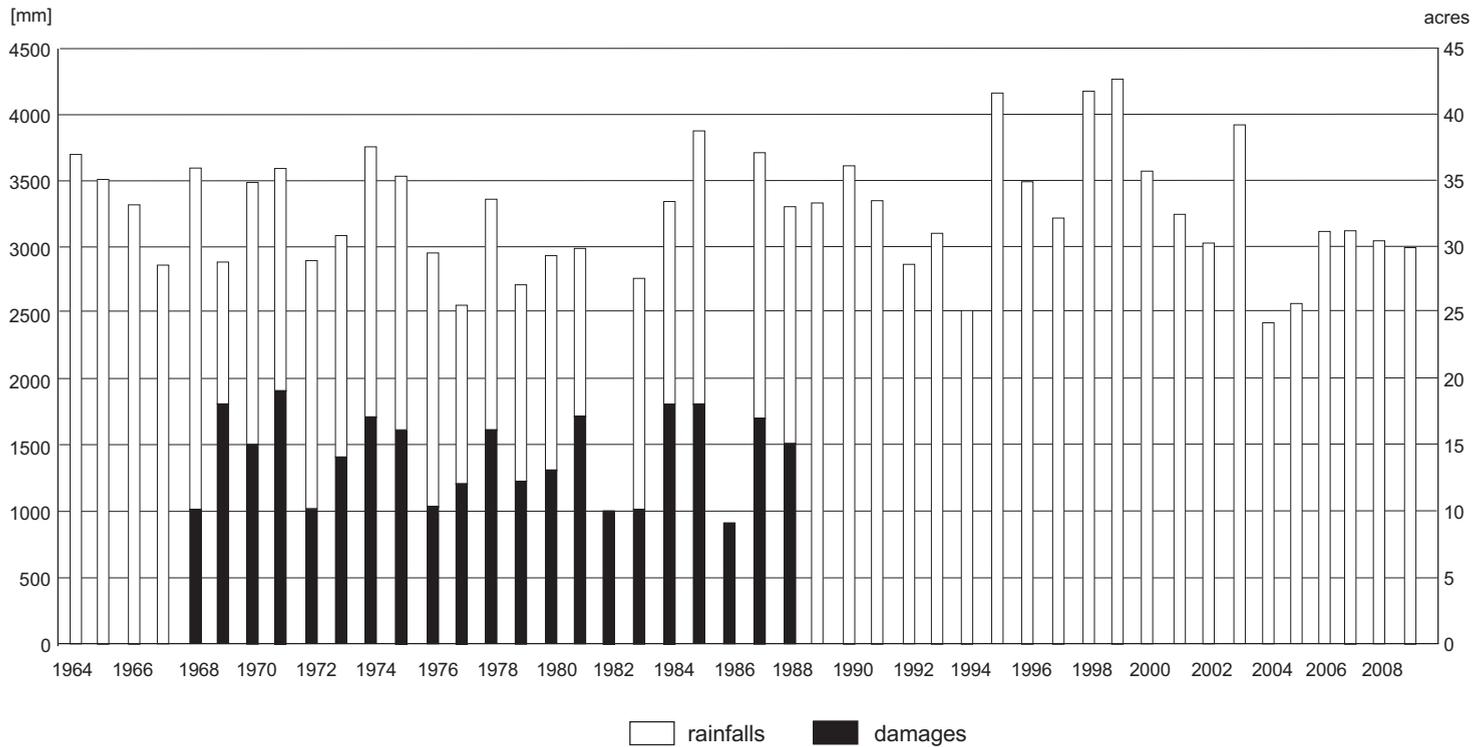
Fig. 2. Annual rainfall at the Ambootia TE between 1964 and 2009. Areas with damage in black (in acres)

Total rainfall in Ambootia fluctuated from 2,500 mm to 4,335 mm (Fig. 2) between 1964 and 2009. Even greater amounts of rainfall were recorded on Kurseong Ridge and towards the edge of the mountains where mean annual rainfall reached 5,000 mm. Between June and early September, it rains mainly in the afternoon or evening. During the summer months, total rainfall increases to 500–1,000 mm. Every year, 10 to 30 days with over 50 mm of rainfall are recorded (Tab. 1). Frequently, heavy rainfall occurs on consecutive days and can cause soil saturation, which leads to an excess supply of groundwater.

Annual rainfall between 1969 and 1982 fluctuated between 2,700 mm and 3,760 mm (Fig. 2). Rainfall over 3,400 mm had been recorded in 1970–1971, 1974–1975, and 1978. Unfortunately, no rainfall data is available for 1982.

Over the course of the 20-year observation period, annual precipitation fluctuated between 2,500 mm and 4,300 mm (Fig. 2). A clustering of years with higher precipitation can be observed in 1998–2000, when not only did annual totals frequently pass the 4,000 mm, but maximum daily rainfall also did pass the 200–300 mm mark and the number of days with rainfall over 50 mm reached 24–26 per year. On the other hand, the 2004–2005 period was characterized by very low values for all of the above parameters. The year 2009 was characterized by two episodes of heavy rainfall.

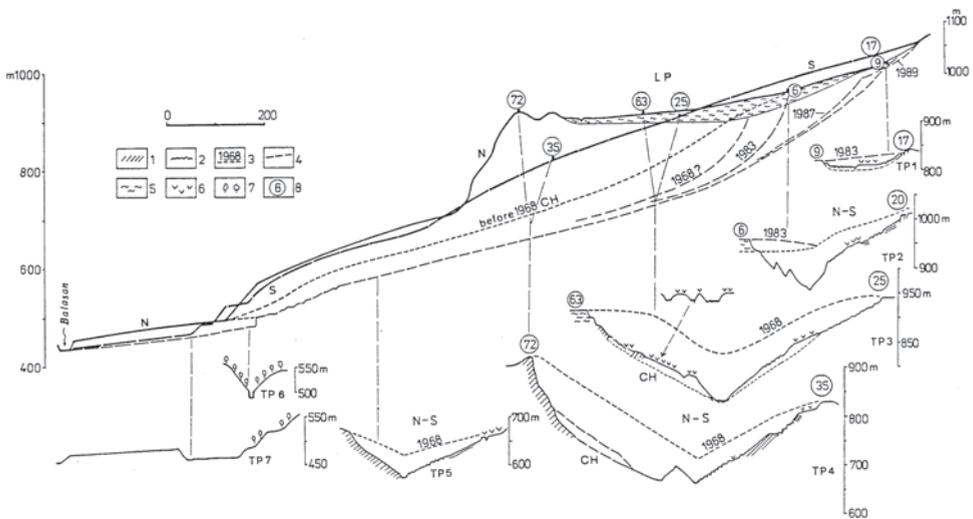
Fig. 3. Longitudinal (LP) and transversal (TP) profiles of the Ambootia valley – showing gradual expansion prior to 1989 (Froehlich, Starkel, Kasza, 1991, 1992). Northern and southern edges (N.S). 1 – exposed bedrock, 2 – blockfields, 3 – calculated surface channel profile prior to the 1968 landslide, 4 – surface after October of 1968, 5 – thick colluvial series, 6 – revegetated slopes, 7 – jungle, 8 – control points

It is clear that the subsequent transformation included a continuous retreat of right side niches, supplied by groundwater from a colluvial aquifer, as well as an extension of shallow slips and the formation of deeper cracks in the left slope. A simultaneous deepening of the main channel by debris flows led to the undermining of the upper parts and the dissection of the lower parts of valley sides by new chutes and slips (Fig. 3).

Our detailed survey, produced in November of 1989, was preceded by seven rainy seasons following the inspection of the landslide by the Kurseong team. The reconstruction of extent of the main niche between 1983 and 1989 (Fig. 3), associated with the undermining of the upper part of the landslide, shows not only a retreat of about 230 m prior to 1987 and another 70–80 m in the last two years, but also the damage inflicted on many homes. In the mean time, the colluvial fan had been dissected several meters deep because its main surface is no longer active and is covered by a variety of vegetation, including some pioneer trees several meters high.

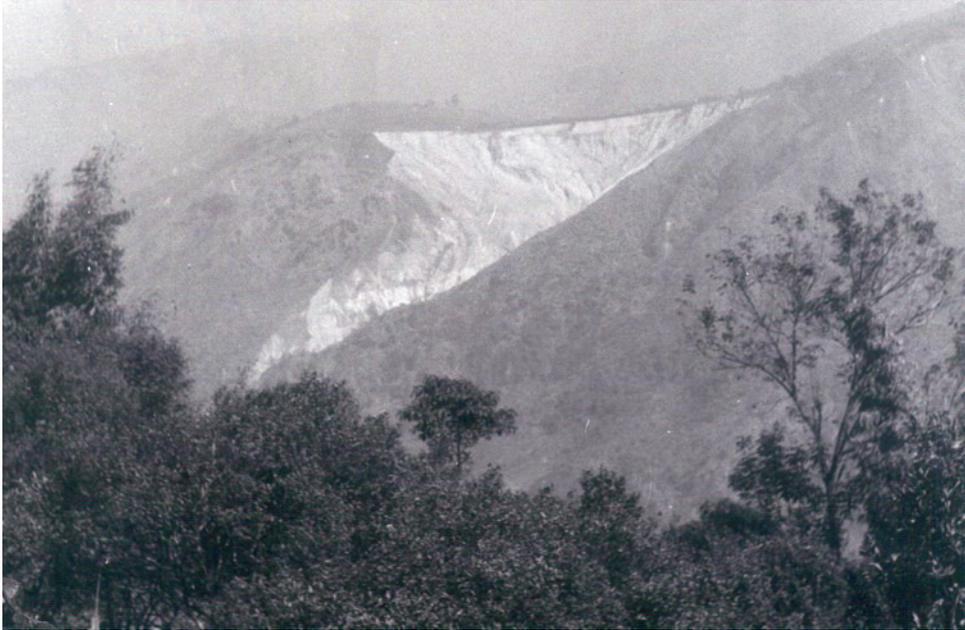
In March of 1983, the main upper landslide niche resembled an amphitheater with its edge reaching probably no higher than 980 m above sea level. All area slopes had fresh features. At the outlet of the main valley, a large colluvial fan was found to be completely without vegetation. This indicates that – at least prior to 1983–1984 – the landslide must have been very active (Photo 1).

Photo 1. Ambootia landslide – northern scarp. View from the opposite side of the Balasan River valley (July, 1984)

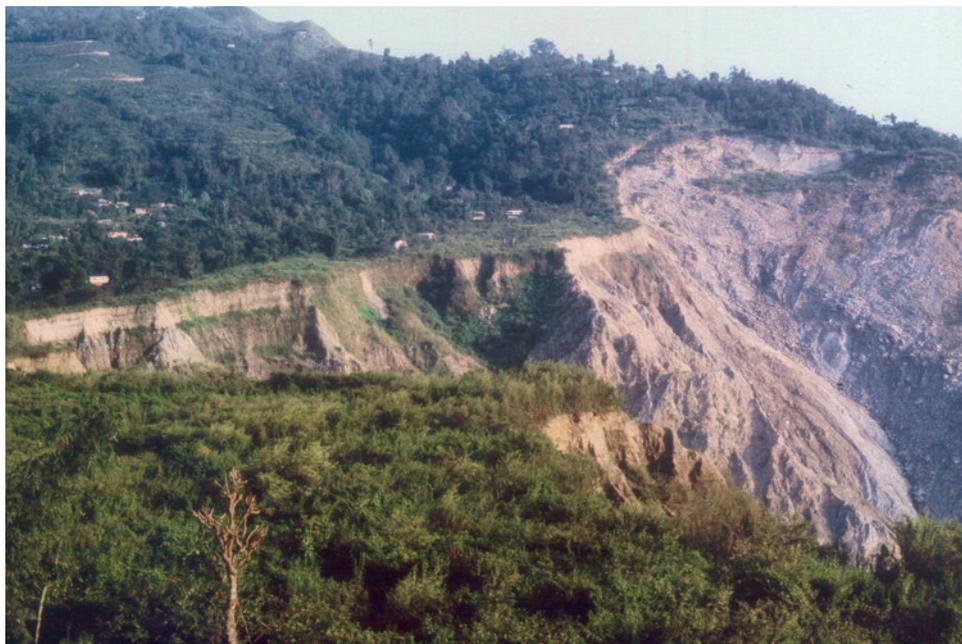
The uppermost part of the landslide found over 1,000 m above sea level had been actively shaped by sliding in the fractured bedrock, up to 20 m deep. Several deep cracks were also visible above the upper niche. Deep cracks could also be found in the walls of homes in the area (Photo 2).

Photo 2. Upper retreating part of landslide and extensive colluvial fan, undermined by niches (November, 1989)

The right (northern) slope was more diverse. Its eastern side had undercut an extensive colluvial fan sloping 3–6°, overlaying deeply weathered bedrock. Its upper part had cut into 30 m thick colluvia forming two-story high niches of mainly inactive slumps with many seasonal springs. The middle and lower parts of the slope were carved in bedrock and formed alternating debris flow channels and sharp crests, which were gradually being revegetated by herbs and shrubs (Photo 2).

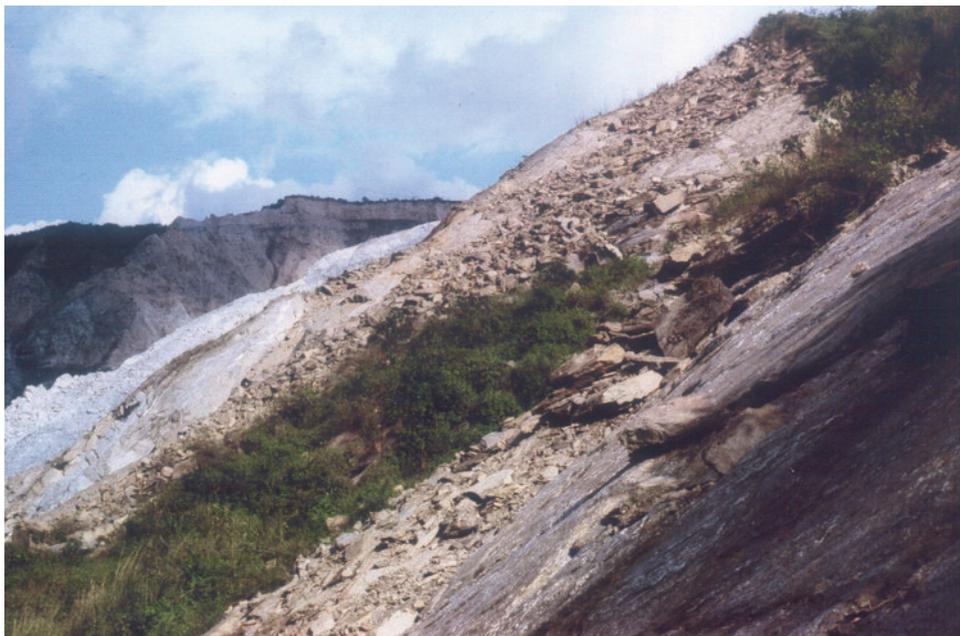
The left (southern) deep slope had a straight or convex profile with an inclination of 25–45°. Areas of bare rock were exposed in the upper part. Fresh crevices — up to 4 m deep — indicated that the upper niche was still active and retreating. Further downslope, the bedrock was covered with blockfields — talus-type in

Photo 3. Fragment of pene-structural slope still actively being shaped by slips, creeping, and debris flows (November, 1989)

many cases (Photo 3). In the middle portion inactive revegetated plots existed, separated by block streams continuously incising.

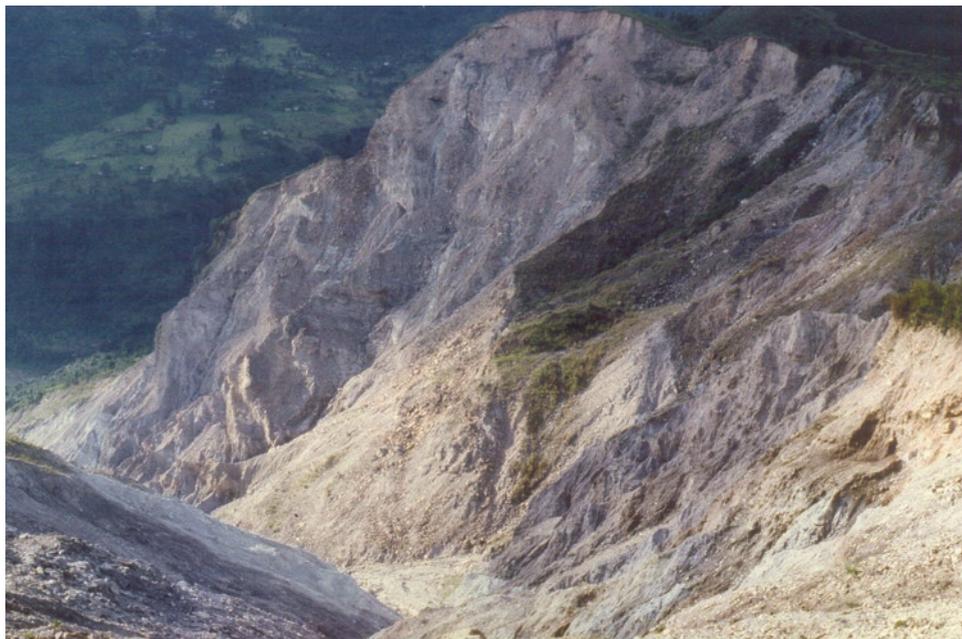
The lower central part of the right slope was steeper – up to 250 m high. The upper part consisted of a rocky cliff with fresh break-offs. The debris fan was dissected by chutes below. The absence of larger rockfall masses indicated that the falling of rock is a continuous process supplying the main outflow channel (Photo 4).

Photo 4. Western active part of right slope with rockfalls and chutes (November, 1989)

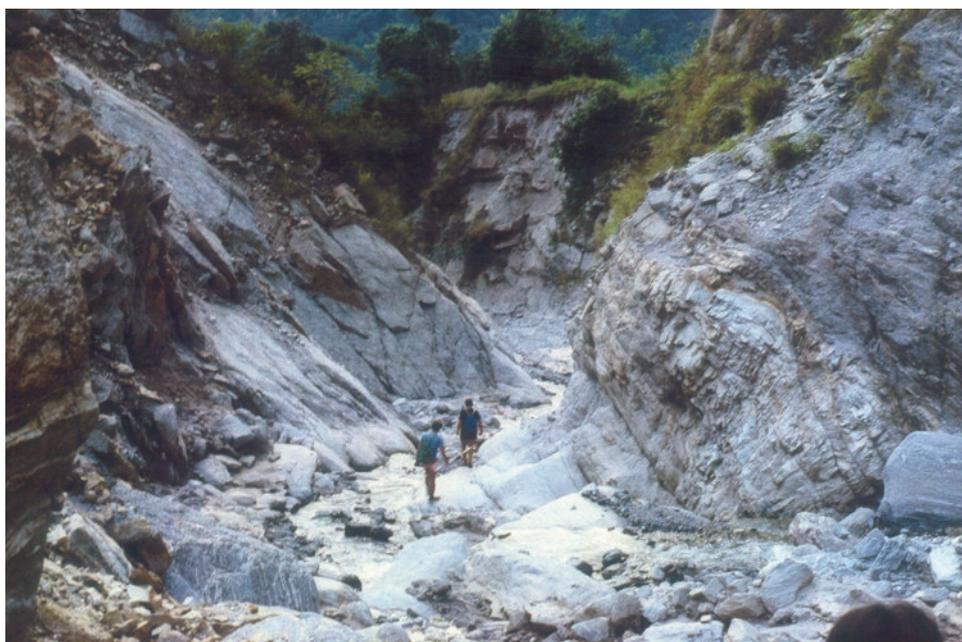
The floor of the main canyon-type valley was deeply cut in the bedrock with rocky steps (up to 5 m high), large boulders, and remains of unsorted debris flows formed during episodic floods (Photo 5).

Photo 5. Lower section of main landslide gully shaped by debris flows (November, 1989)

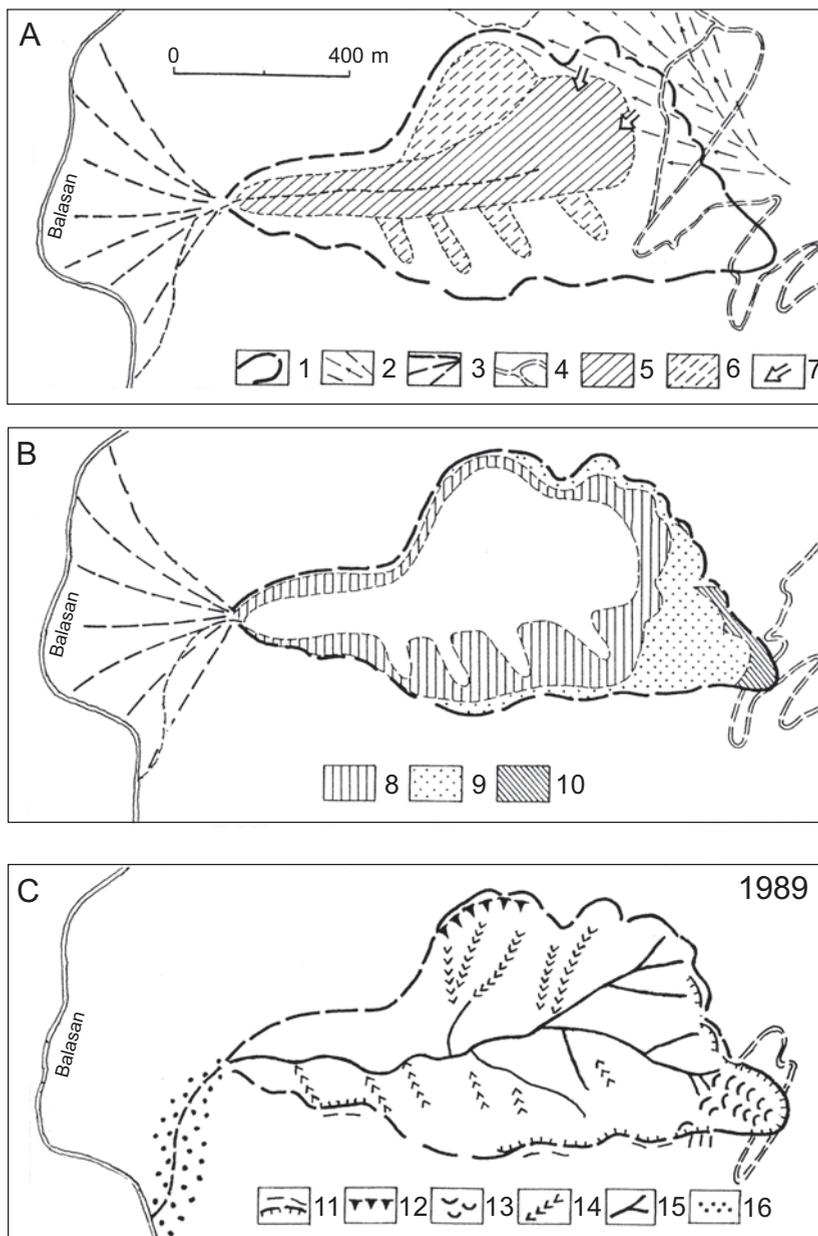
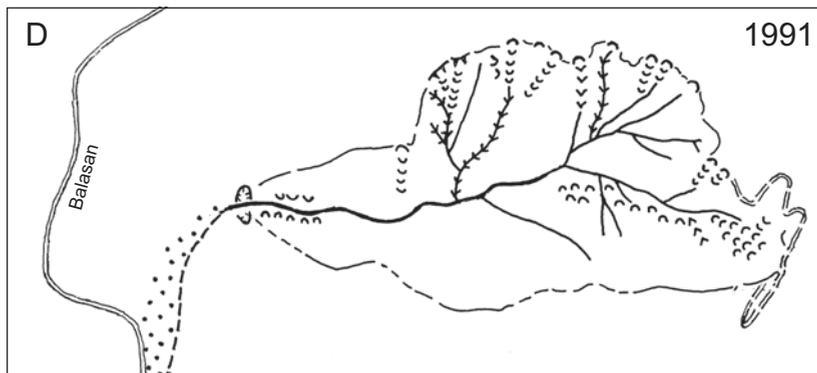
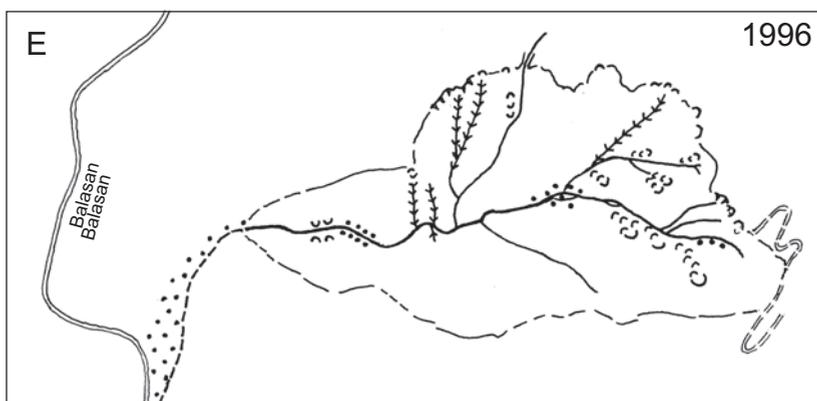
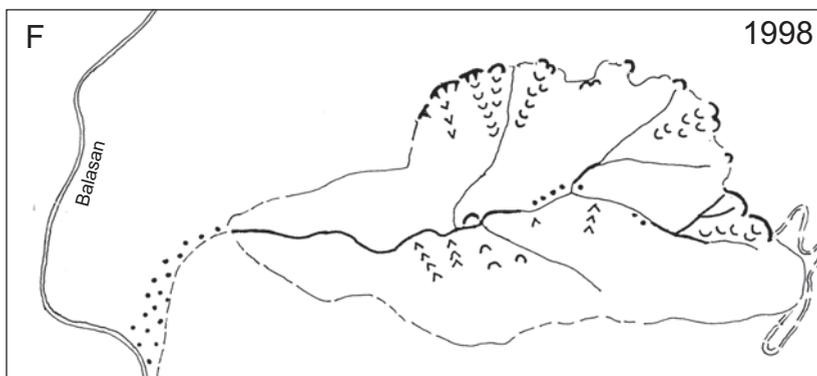
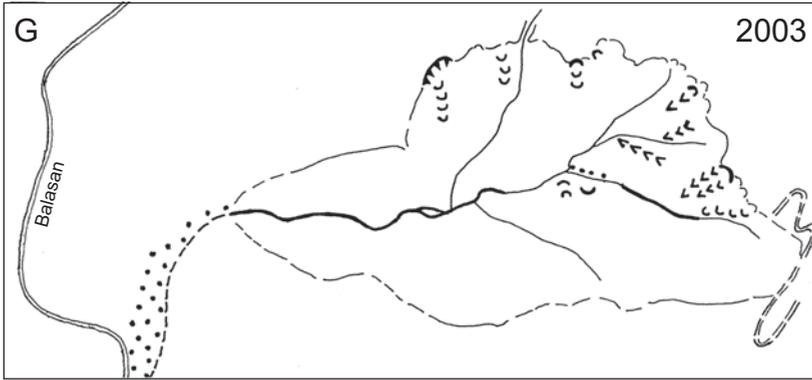
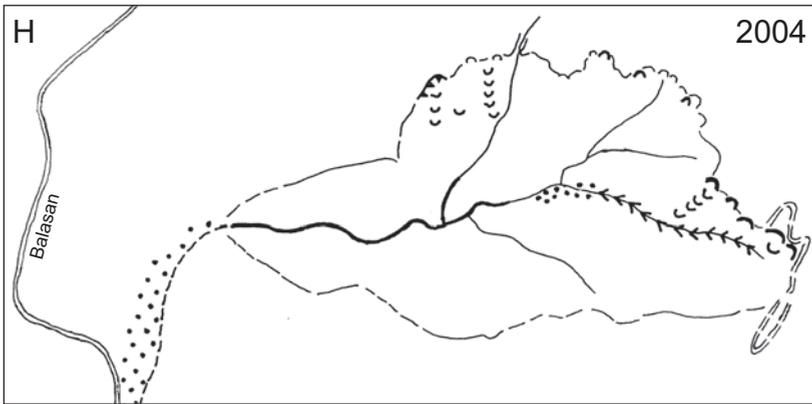
Fig. 4. Changes in the landslide valley – reconstructed for 1968–1989 – then surveyed and analyzed for 1989–2009 (L. S t a r k e l)

A. 1968, B. 1968-89, C. 1989, D. 1991, E. 1996, F. 1998, G. 2003, H. 2004, I. 2005, J. 2007, K. 2008, L. 2009. Signs: 1 – main edge of landslide, 2 – old upper colluvial fan, 3 – Ambootia landslide fan, 4 – road, 5 – earth masses removed in 1968, early phase, 6 – 1968 – late phase, 7 – subsurface drainage direction, 8 – extension in 1968–83, 9 – extension in 1983–87, 10 – extension in 1987–89, 11 – active niches and cracks, 12 – rockfall niche, 13 – sliding massed, 14 – block stream – debris flow, 15 – chutes and canyons experiencing downcutting, 16 – debris fans

The colluvial fan, 300–400 m long and more than 500 m wide, had earlier pushed the Balasan River channel to the opposite western bank. It was now covered by vegetation and dissected upto 15–20 m. The lower surface was as much as 100 m wide – a braided channel formed of gravel and several boulders as large as 1–2 m in diameter and supplied by debris flows. This surface continues down along the Balasan River, forming extensive gravel bars (Fig. 4).

Between 1989 and 2009, I made controlled measurements as well as additional observations partly with my colleagues. The aforesaid records are represented herein by rainfall data, sketches of the active parts of the landslide (Fig. 4), as well as photographs. The observations were made in December of 1991, January and November of 1993, January of 1996, January and November of 1998, November of 1999, November of 2000, November of 2001, February of 2003, March of 2004, November of 2005, 2006, 2007, 2008, and 2009 (Fig. 4, Tab. 1).

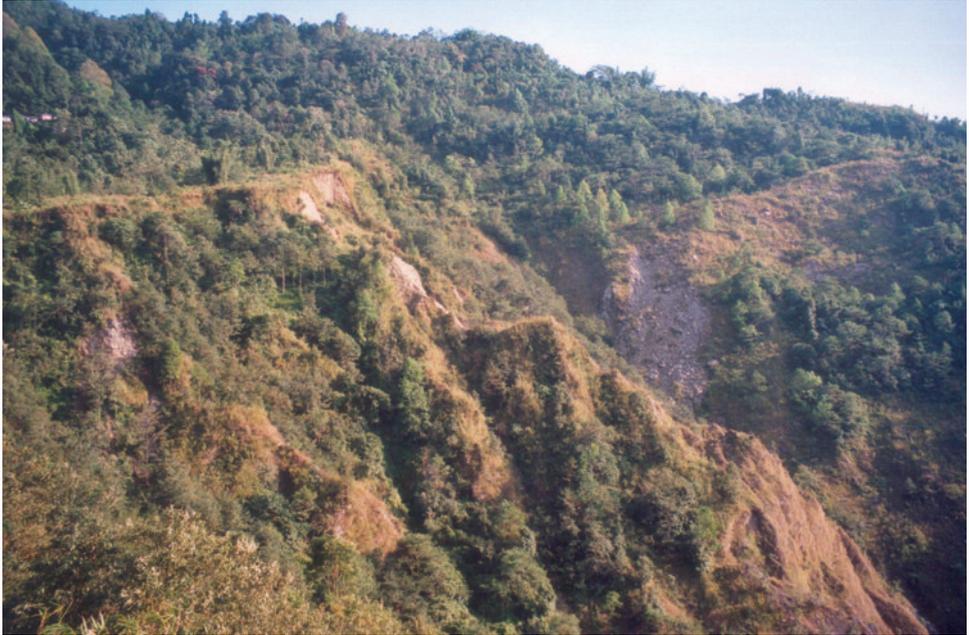
Over the course of the next three years (2006, 2007, 2008), annual rainfall increased to about 3,000 mm, but with no major rainstorms. Revegetation continued to make progress and only small slumps could still be observed on a number of steep slopes (Photo 6 and 7).

Photo 6. Upper revegetated part of landslide with single slides on steep slopes (November, 2008).
Compare with Photo 2

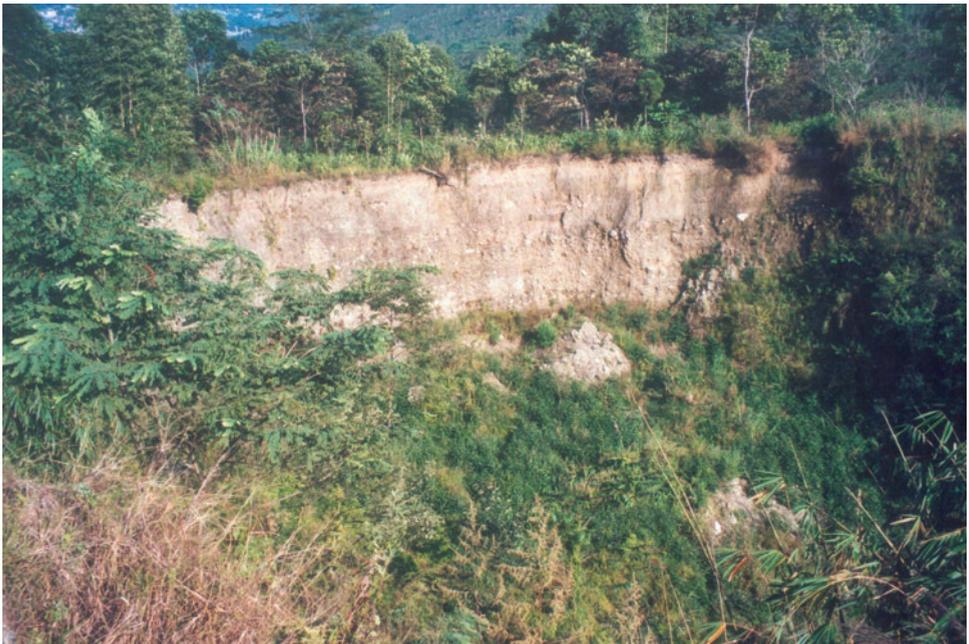
Photo 7. Shallow slide on the reforested northern scarp, formed of thick colluvial sediments
(November, 2008)

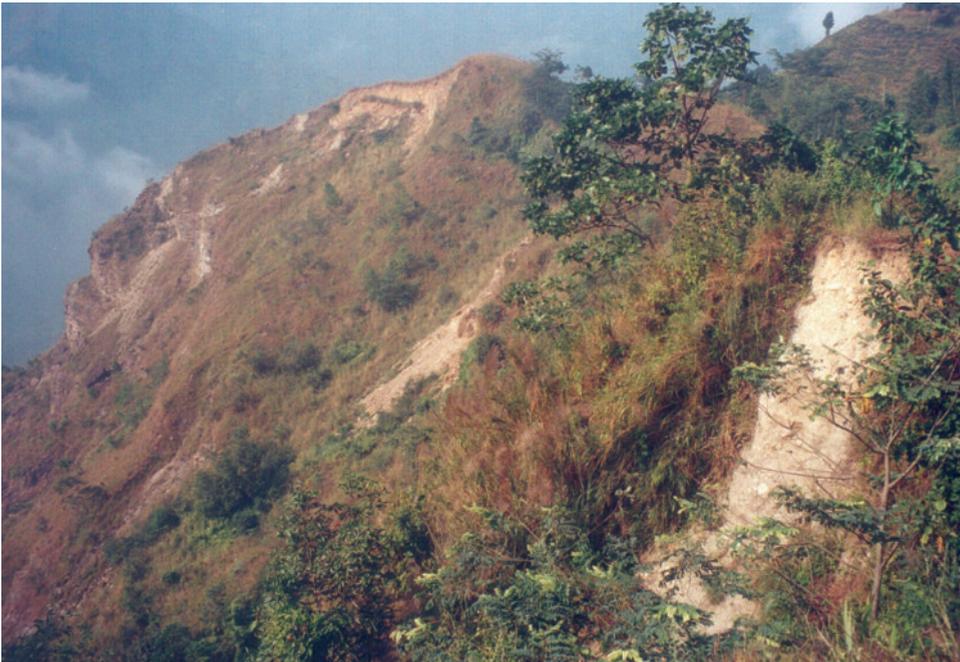
The year 2009 was affected by two rainfall events connected with cyclonic circulation in late May and late August, which caused a lot of damage in other parts of the Darjeeling Himalaya. In Ambootia, the first rainfall event brought 257 mm of precipitation in one day (over 335 mm in three days), while the second rainfall event brought 356 mm of precipitation in one day. While revegetation was widespread, only two existing bare slumps had become reactivated. A number of niches formed in colluvia saturated by water had also become reactivated (Photo 8). I was also able to observe several fresh fractures and block sliding in the uppermost part of the landslide.

Photo 8. Western part of revegetated right slope with small falls and slumps (November, 2009). Compare with Photo 3.
