STUDIA	GEOMORPHOLOGICA	C A R P A T H O - B A L C A N I C A
ISBN 83-88549-56-1	VOL. XL, 2006: 79–92	PL ISSN 0081-6434

LANDFORM EVOLUTION IN MOUNTAIN AREAS Recent geomorphological hazards in Carpatho-Balcan-Dinaric region

GEOMORPHOLOGICAL ASPECTS OF NATURAL HAZARDS AND RISKS IN THE CZECH REPUBLIC

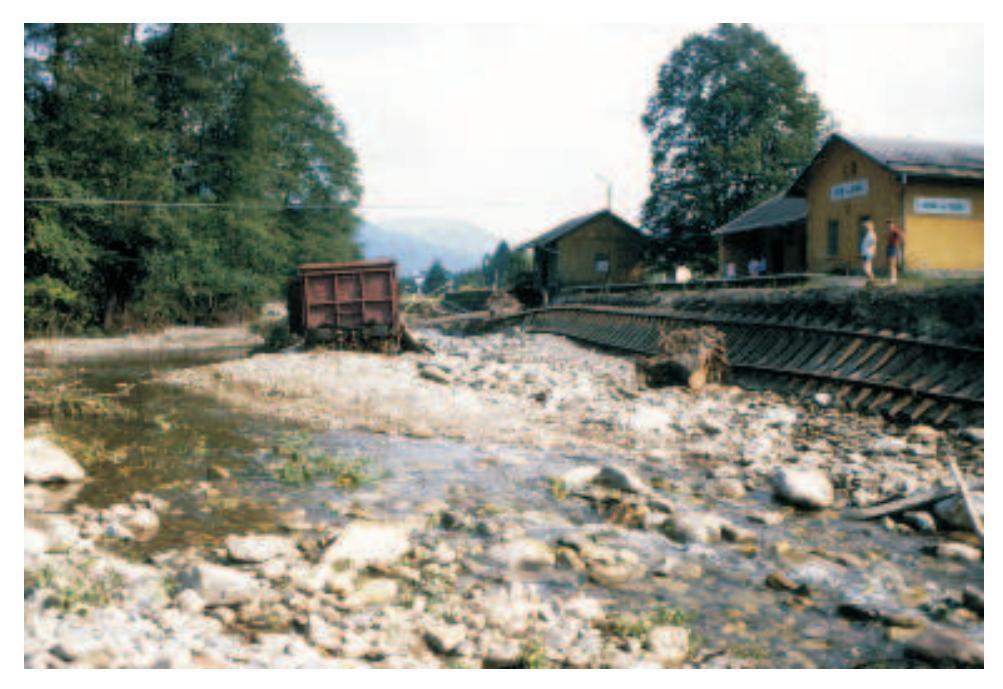
Photo 1. Railway station in the Northern Moravia destroyed by the Desná River during flood in summer 1997 (Photo from the Archive of the Agency for Nature Conservation and Landscape Protection of the Czech Republic)

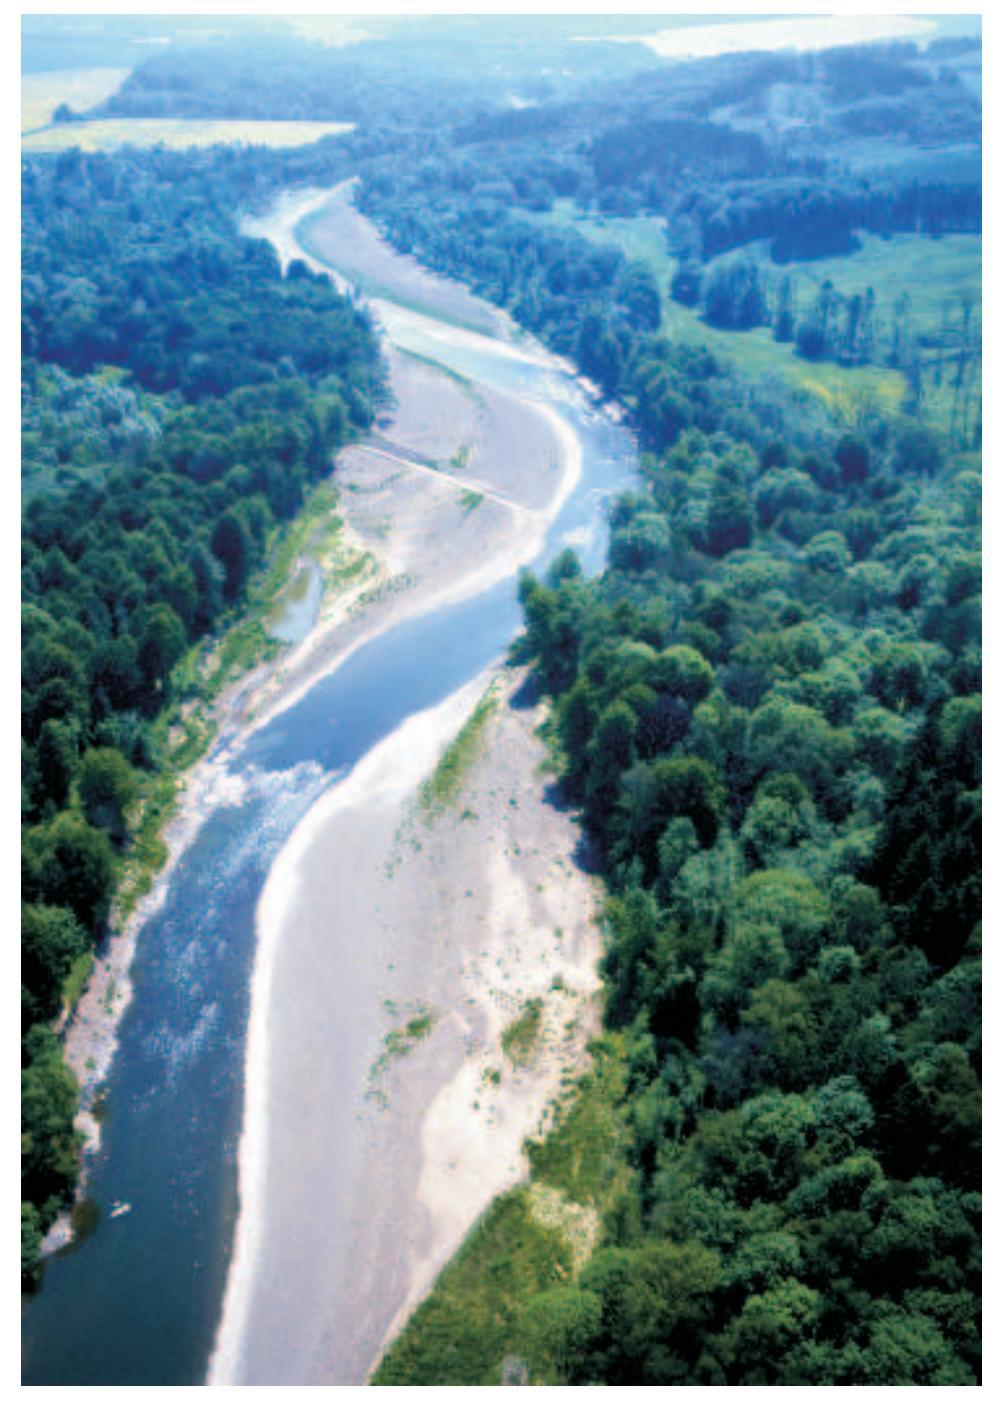
Photo 2. River bed of the Bečva River in the Moravian Carpathians after flood in summer 1997 (Photo from the Archive of the Agency for Nature Conservation and Landscape Protection of the Czech Republic)

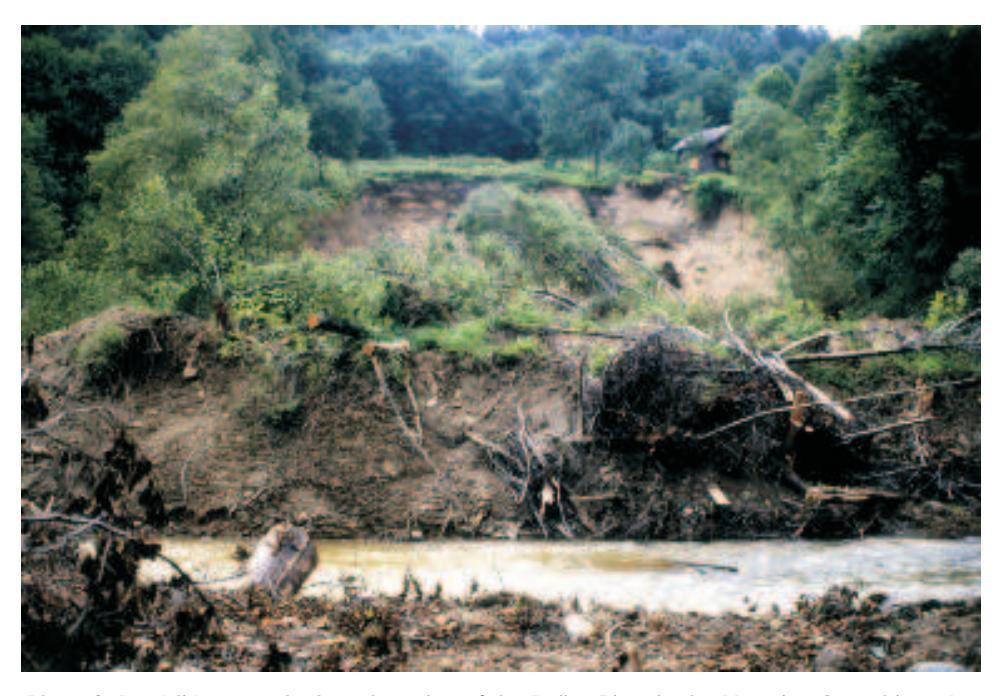
Photo 3. Landslide cause by lateral erosion of the Bečva River in the Moravian Carpathians during flood in summer 1997 (Photo from the Archive of the Agency for Nature Conservation and Landscape Protection of the Czech Republic)

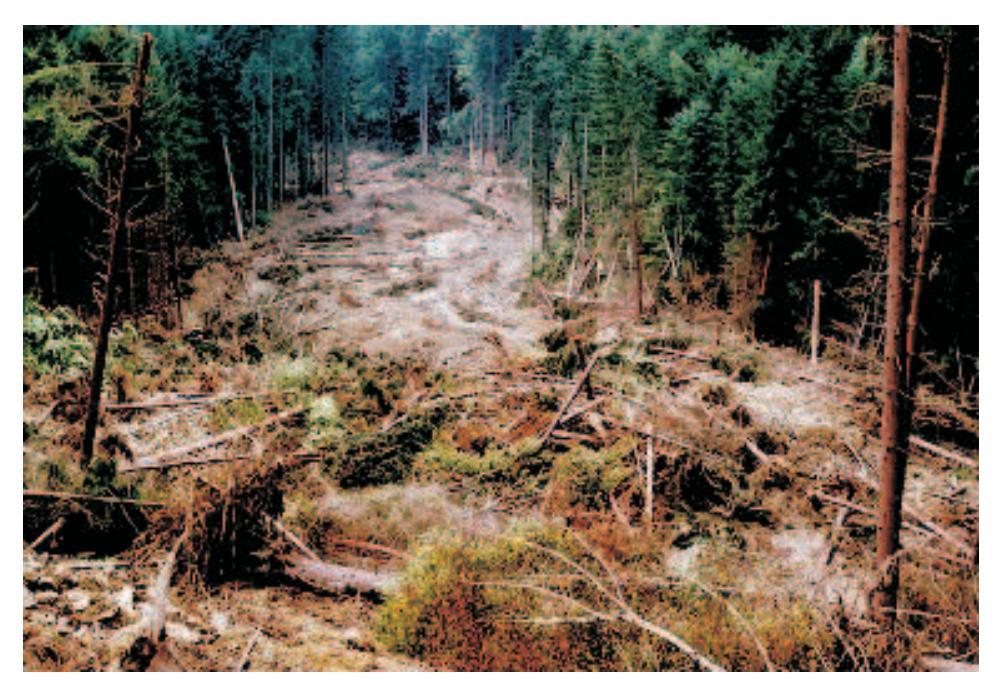
Photo 4. Accumulation part of the catastrophic landslide Brodská near the town of Vsetín in the Moravian Carpathians cause by heavy rain in summer 1997 (Photo by O. Krejči)

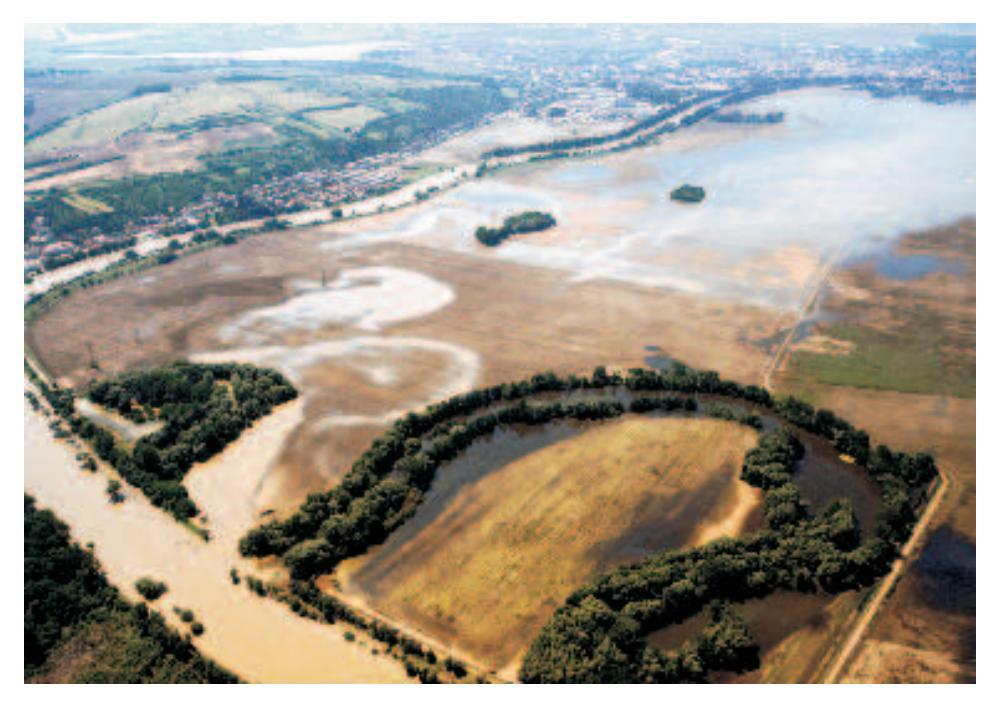
Photo 5. Flooded floodplain of the Morava River during summer flood 1997. Patterns of abandoned river meanders are clearly seen (Photo from the Archive of the Agency for Nature Conservation and Landscape Protection of the Czech Republic)

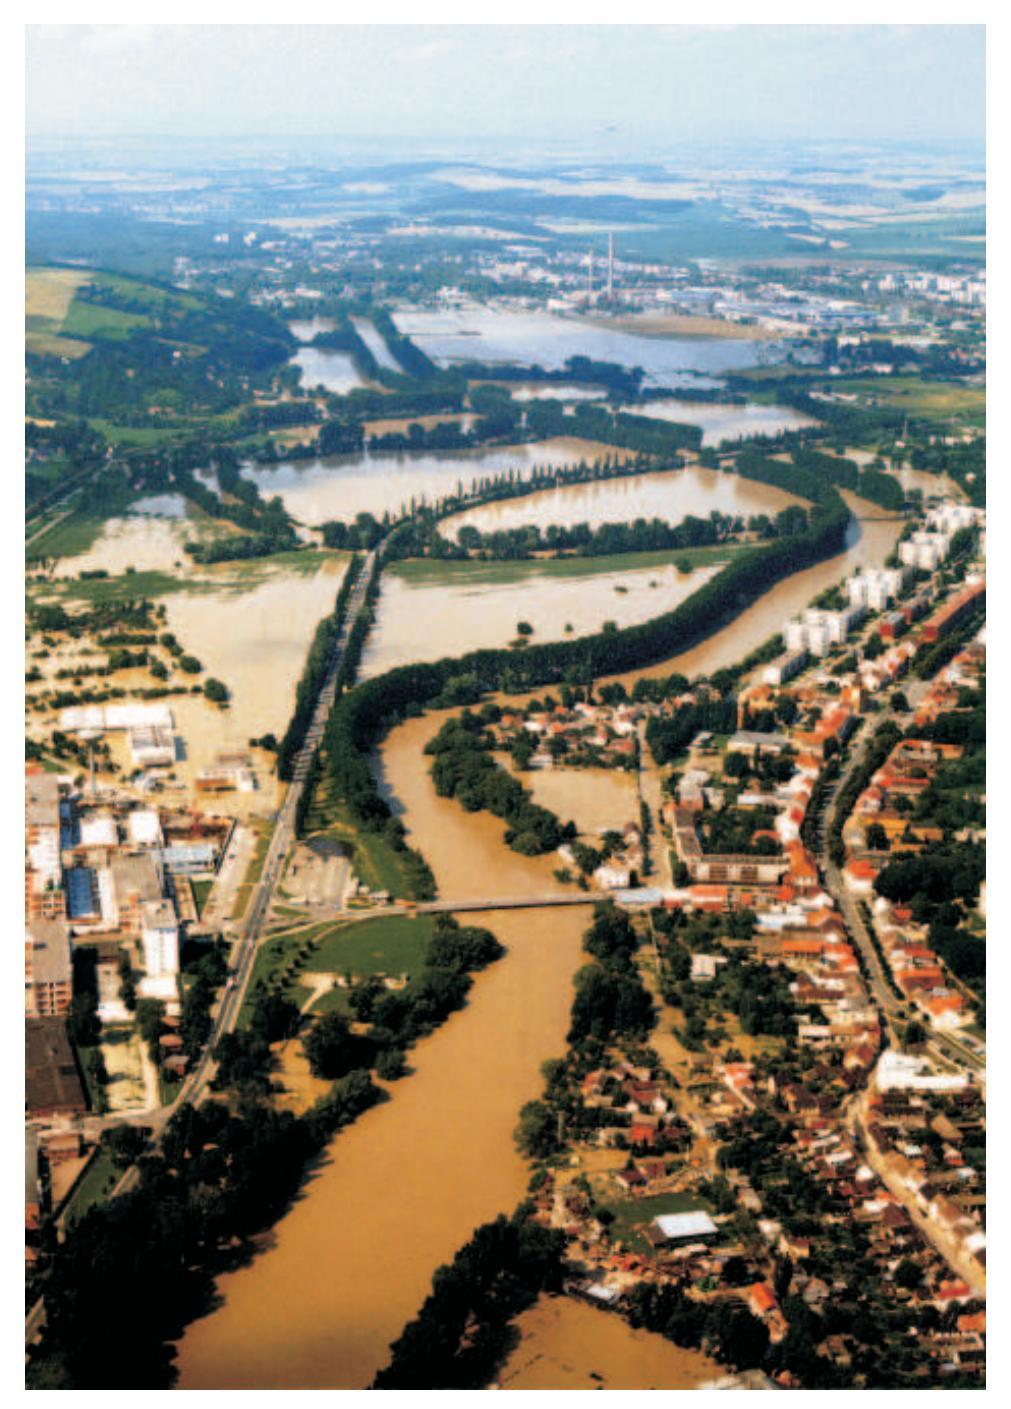
Photo 6. Totally flooded floodplain of the Morava River between towns of Napajedla and Otrokovice in the central part of Moravia during flood 1997 (Photo from the Archive of the Agency for Nature Conservation and Landscape Protection of the Czech Republic)
